SOIL VAPOR SAMPLING ASSESSMENT  
Former Gasoline Service Station  
2547 East 27<sup>th</sup> Street  
Oakland, California

**File No. 0396**

Date:  
April 13, 2010

SOIL VAPOR SAMPLING  
Former Gasoline Service Station  
2547 East 27<sup>th</sup> Street  
Oakland, California

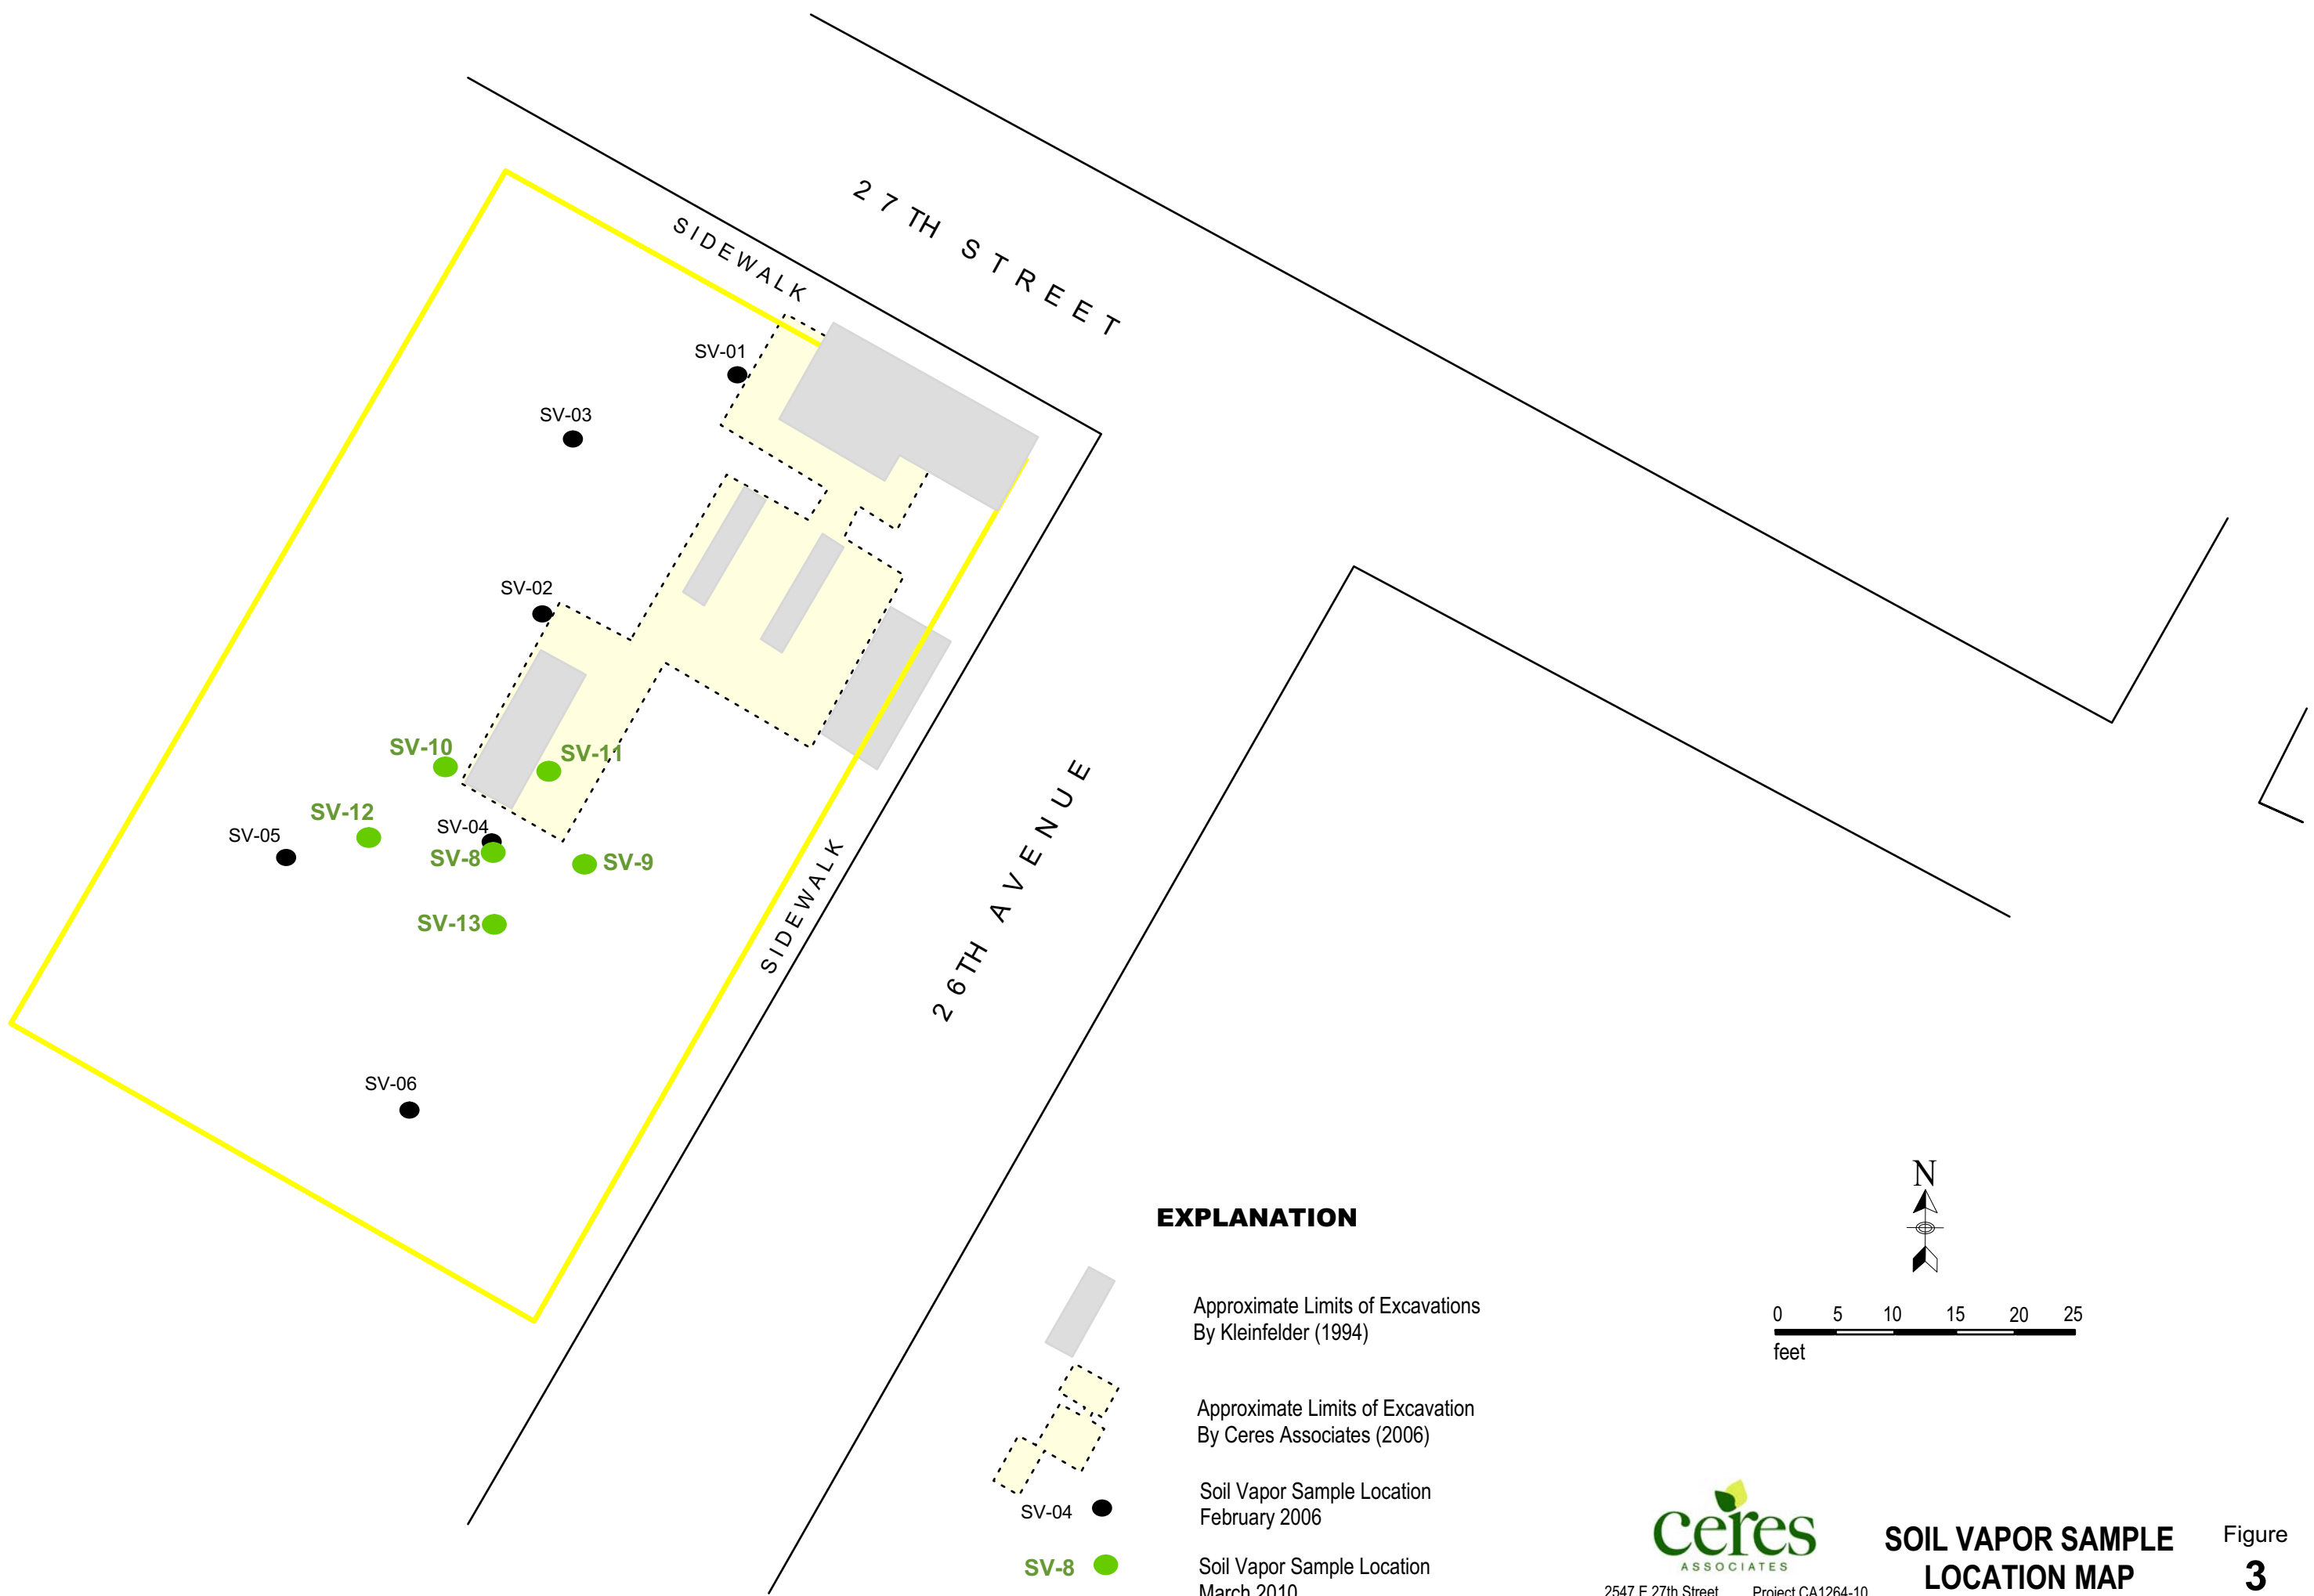
Figure 3

**EXPLANATION**

Approximate Limits of Excavations By Kleinfelder (1994)
-

Approximate Limits of Excavation By Ceres Associates (2006)
-

SV-04 ● Soil Vapor Sample Location February 2006
-

SV-8 ● Soil Vapor Sample Location March 2010

**SOIL VAPOR SAMPLE LOCATION MAP**

A map of soil vapor sample locations is provided as Figure 2. The soil vapor sampling points were positioned as closely as practical to those suggested by Alameda County Environmental Health Department in its approval letter of the work plan that proceeded this investigation.

Ceres Associates supervised the collection of six samples of soil vapor in the near vicinity of sample location SV-04 from the previous soil vapor sampling assessment (refer to Figure 2 – Soil Vapor Sample Location Map), as directed by Alameda County Environmental Health Department. The location of SV-04 was measured on the Property as accurately as possible from the Soil Vapor Sample Location Map in the previous report. SV-8 was placed as close to SV-04 as could be determined from the map and measurements in the field. Soil vapor samples, SV-9, SV-10, SV-11, SV-12, and SV-13 were each placed within less than 10 feet surrounding SV-04 (Figure ??).
