Re: Additional Site Investigation Report and Case Closure Request
Former Chevron Station 9-8341
3530 MacArthur Boulevard
Oakland, California
LOP Case RO0000405

figure 2
 SITE PLAN
 FORMER CHEVRON SERVICE STATION 9-8341
 3530 MACARTHUR BOULEVARD
 Oakland, California

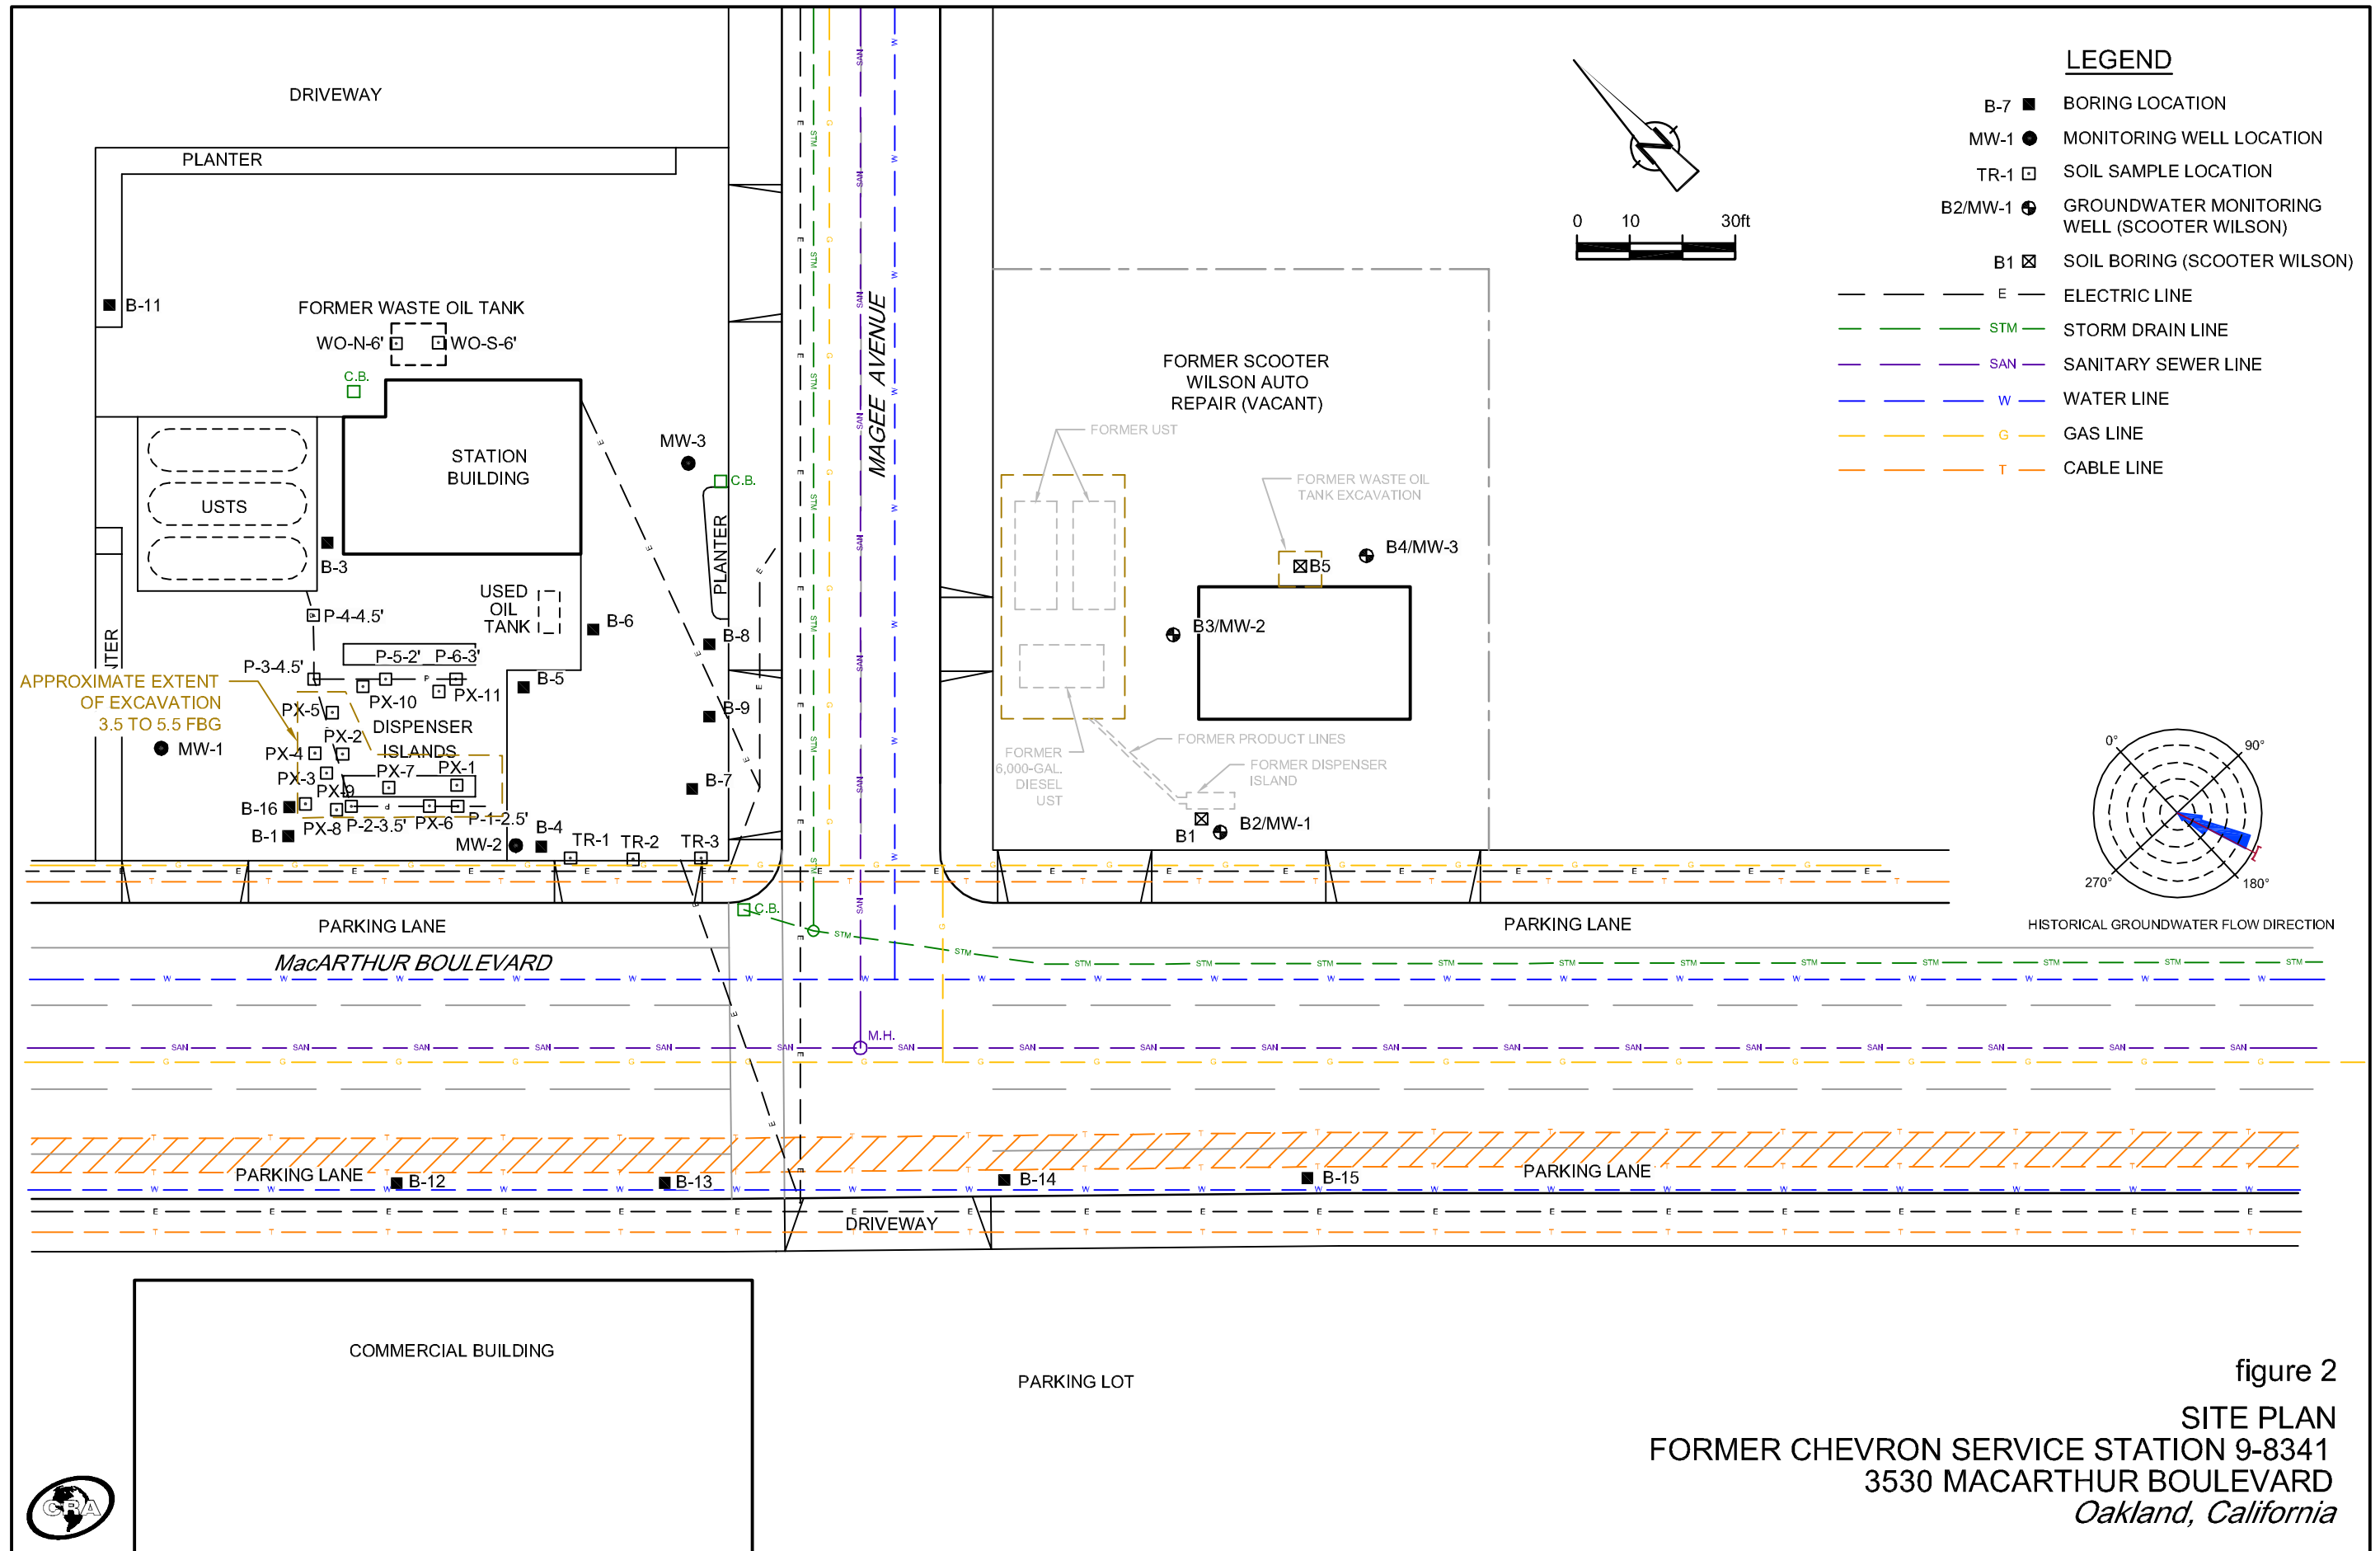
Surrounding land use is mixed commercial and residential. The site is bounded by MacArthur Boulevard to the southwest, a small commercial building with accompanying residence behind the building to the northwest, an alleyway to the northeast, and Magee Avenue to the southeast. An open fuel (gasoline and diesel) release case (Scooter Wilson at 3600 MacArthur Boulevard; a former service station and auto repair facility) is present across Magee Avenue to the southeast; this facility is currently vacant and investigation to evaluate the extent of contamination is ongoing. However, it appears that no work has been performed since 2006 due to a recalcitrant property owner. Based on historical aerial photographs, a service station has been located on this property since at least 1946. Current and former site facilities and the adjacent facility are shown on Figure 2.

Environmental investigation at the subject site has been ongoing since 1993. Prior to the current investigation, groundwater monitoring wells MW-1 through MW-3 have been installed, and borings B-1, B-3 through B-9, and B-11 have been drilled. Remedial activities have included over-excavation of impacted soil (approximately 285 cubic yards), and the removal of approximately 25,000 gallons of impacted groundwater during the 1994 UST system upgrade. A summary of the previous environmental work is included as Attachment B. The approximate well, boring, and soil sample locations are presented on Figure 2.

Borings B-12 through B-15 were drilled in MacArthur Boulevard to the southwest/south of the site to further evaluate the extent of petroleum hydrocarbons in soil and groundwater.

Boring B-16 was drilled onsite near previous sample PX-8 (as close as possible due to product piping) to evaluate the vertical extent of petroleum hydrocarbons in soil. The approximate boring locations are shown on Figure 2. The details of the investigation are presented in the following sections. Fieldwork was performed by CRA Staff Scientist Chris Benedict under the supervision of James Kiernan, P.E.
