**Additional Site Characterization for Delineation of
PCB-Impacted Soils Beneath the East Parking
Lot Located at 6121 Hollis Street
Emeryville, California**

Project 2180

September 6, 2001

**SOMA Environmental Engineering, Inc.
2680 Bishop Drive, Suite 203
San Ramon, California 94583**

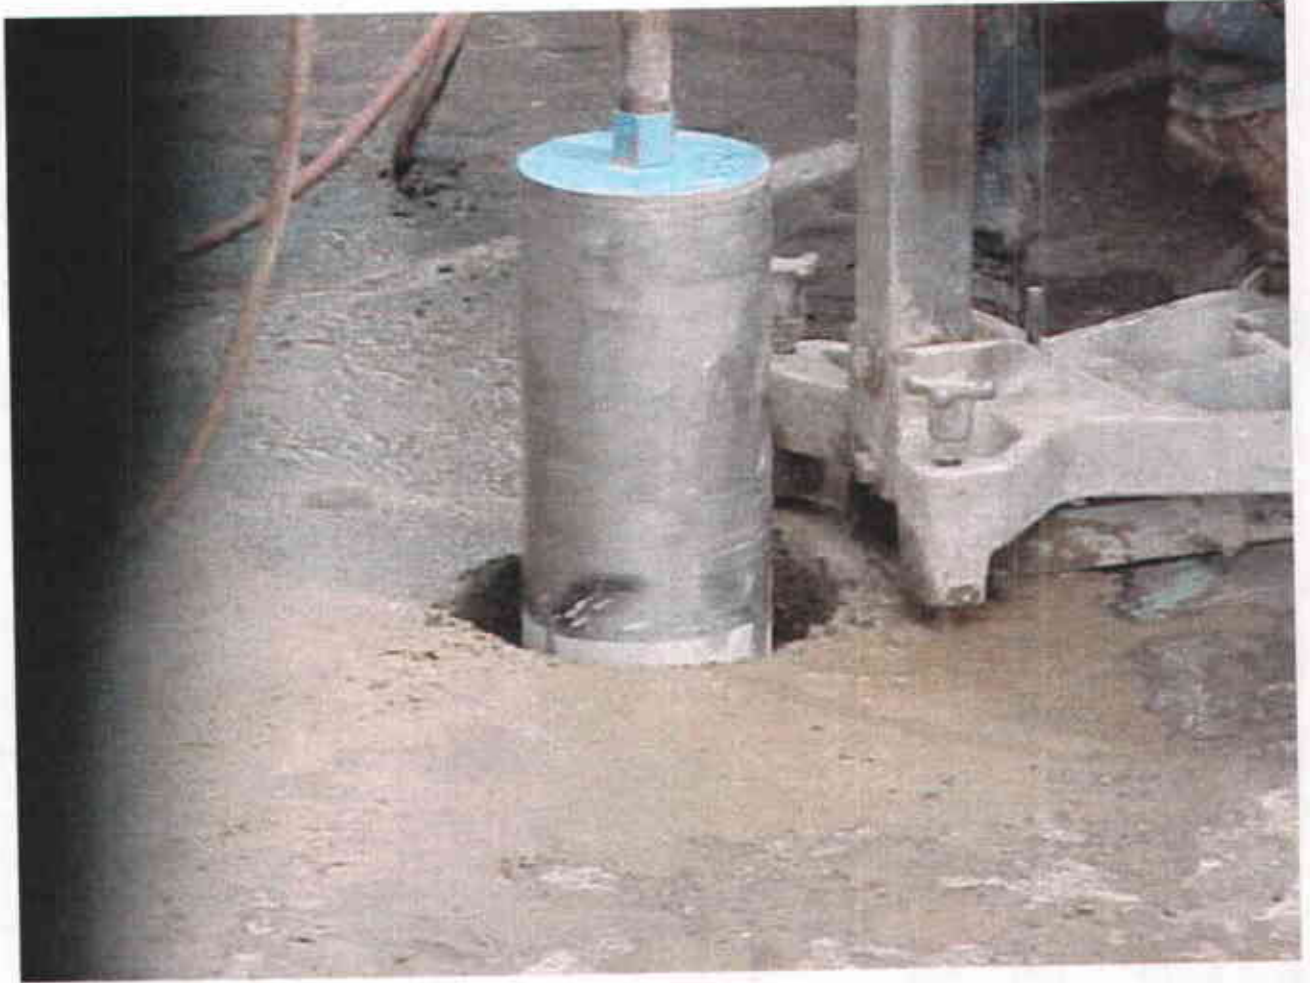
Figure B-1 Concrete Cutting Operation

To delineate the horizontal extent of PCB-impacted soils, SOMA hired Jamco Concrete Cutting, Inc. of Redwood City, California to cut asphalt and concrete and Geo Environmental Services of San Jose, California to drill soil borings. During the recent excavation and construction activities at the Property, multiple layers of asphalt and concrete pads to an approximate depth of 1 to 2 feet below ground surface were encountered. Figure-3 shows the approximate extent of concrete pad beneath the Property.

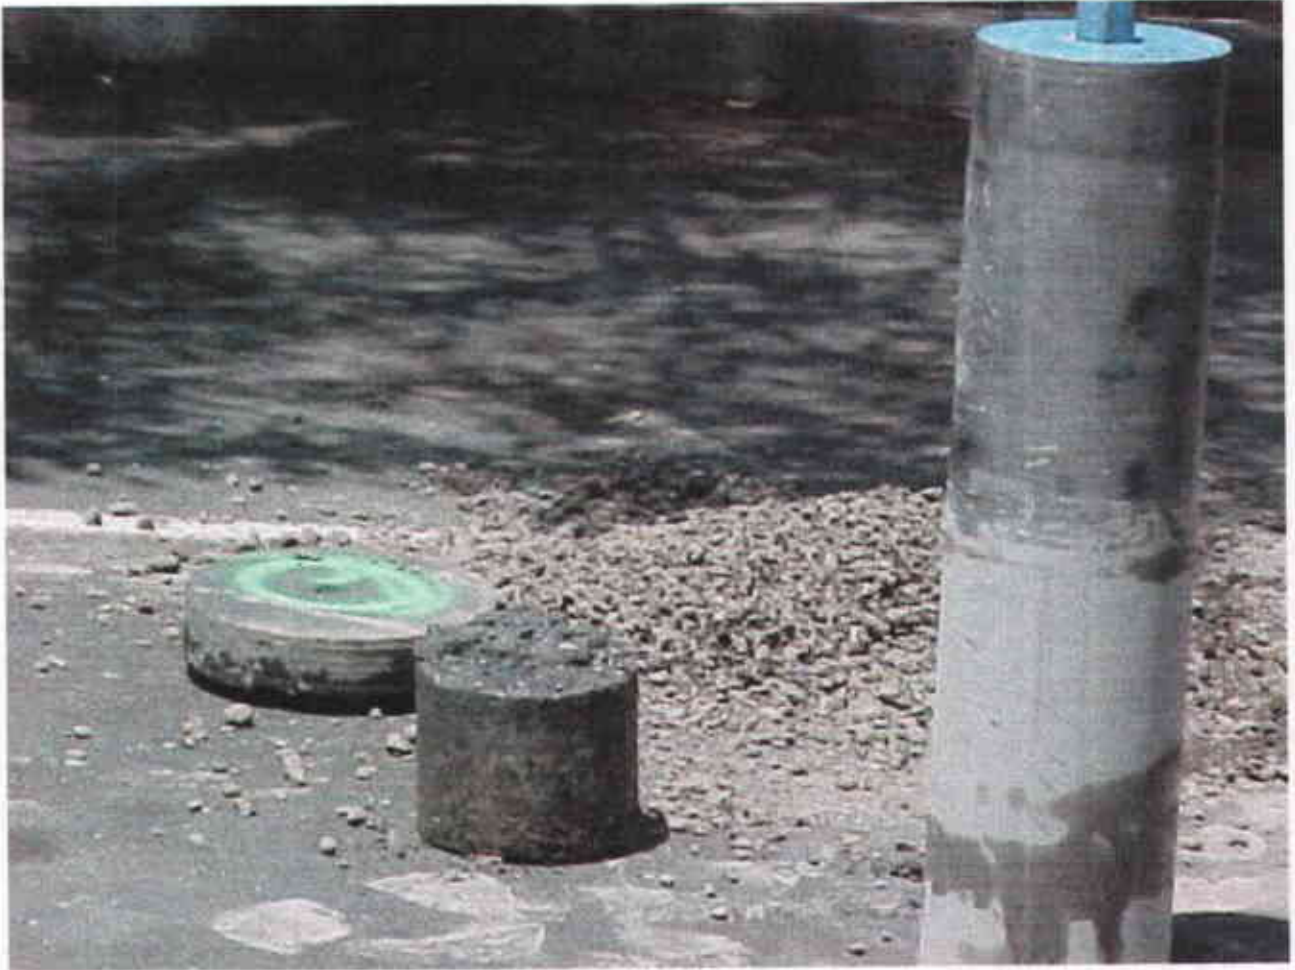
Figure B-2 12-Inch Diameter Asphalt and 8-inch Diameter Concrete Cores

Prior to drilling the soil borings, a 12-inch diameter asphalt core was cut using a concrete cutter. The approximate thickness of the asphalt core at different locations ranged between 4 and 5 inches. Following the cutting the asphalt core, a soil sample was collected beneath the asphalt pavement at a 6-inch depth. In soil boring locations where a concrete layer was present, after collecting a soil sample at a 6-inch depth, digging the borehole was continued by using a hand shovel. During this process the soil cuttings were completely removed from the borehole until the concrete layer at a 1 to 2 feet depth was exposed. At this time an 8-inch diameter core-bit was used to cut the concrete core and remove it out of the borehole. After removing the concrete core, drilling was continued using a hollow stem auger to an approximate depth of 3.5-feet. Pursuant to the approved workplan, a 6-inch long brass sampling tube was extended to the bottom of the borehole and pushed by using a hammer auger to a 4-foot depth and a soil sample was collected. At locations where the concrete layer was missing, after removing the top asphalt layer and collecting a soil sample at a 6-inch depth, drilling was continued using a hollow stem auger to an approximate depth of 3.5-feet. As it was explained, using a hammer auger, a brass sampling tube was extended into the borehole and a sample at a 4-foot depth was collected.

Note: The materials under asphalt and concrete layer are mainly pea gravel
