# REVISED ADDITIONAL SITE CHARACTERIZATION REPORT

GATZKE / HOOSHI'S AUTO SERVICE  
1499 MACARTHUR BOULEVARD  
OAKLAND, CALIFORNIA 94602

AGENCY CASE NO.      RO0000516

**JANUARY 29, 2010**  
**REF. NO. 120741 (8)**

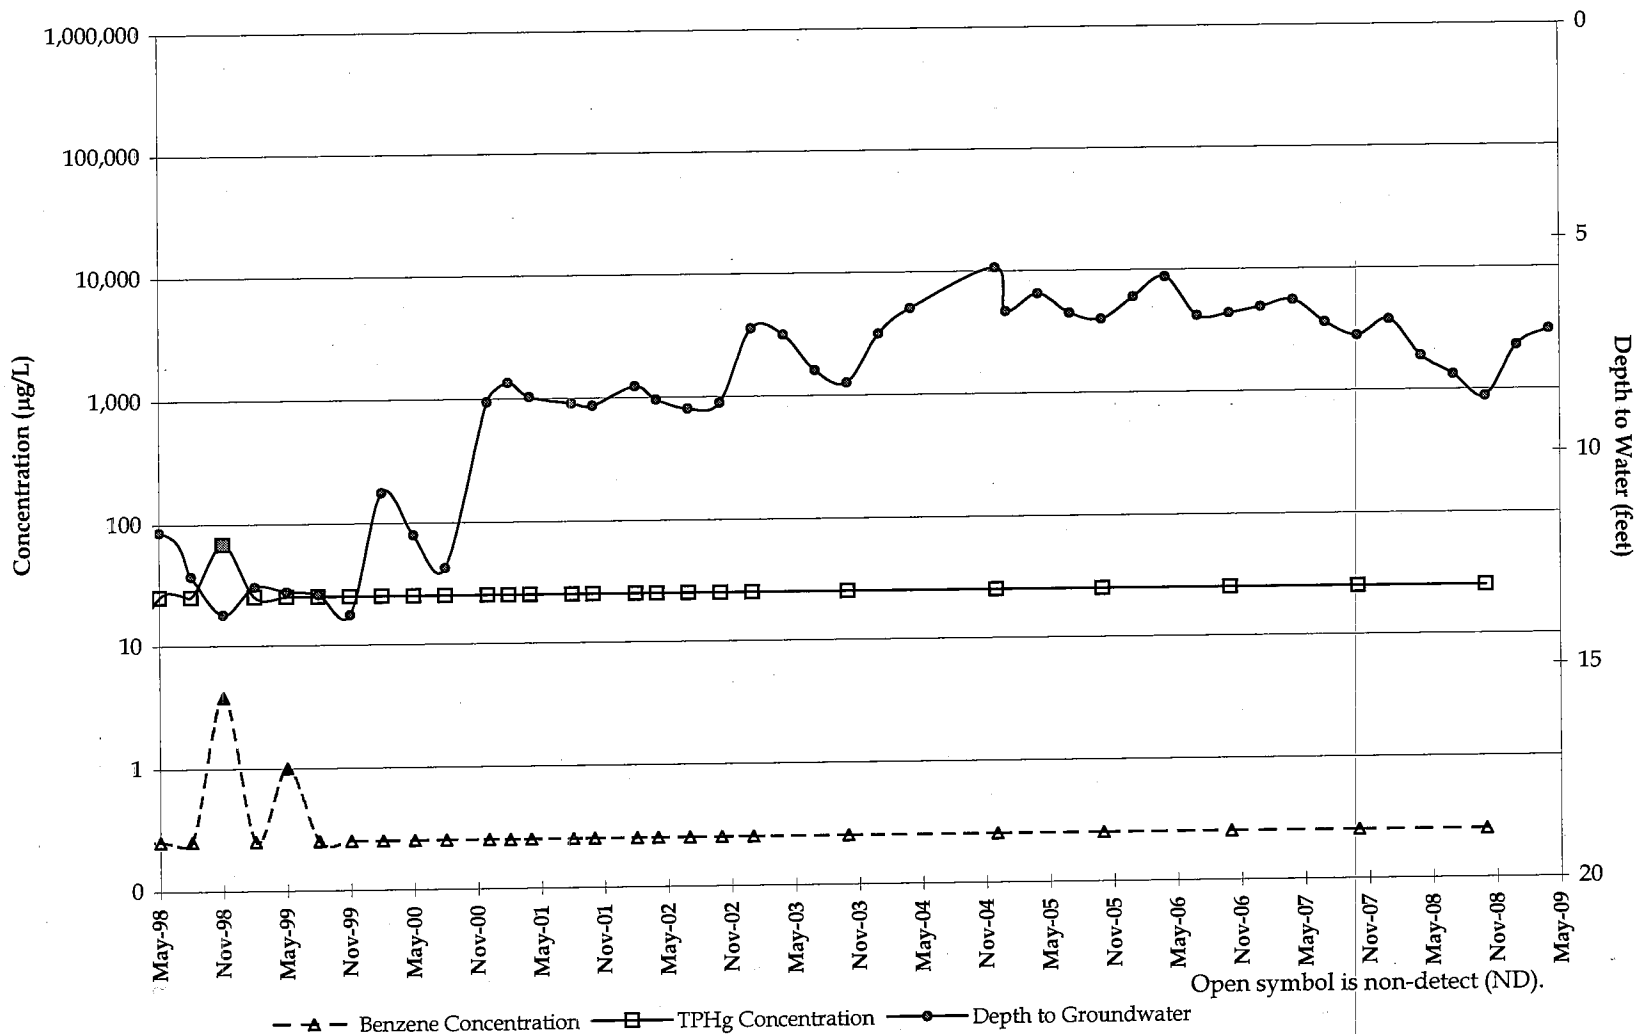
**Monitoring Well MW-6  
TPHg and Benzene Concentration Trend  
Hooshi's Auto Service, 1499 MacArthur Boulevard, Oakland, CA**
