**RE: Groundwater Monitoring Results, Second Semi-Annual 2016 Monitoring Period,
Cargill Salt – Alameda Facility, Alameda, California,
SLIC Case No. RO0002480**

**Groundwater Monitoring Results
Second Semi-Annual 2016 Monitoring Period
Cargill Salt – Alameda Facility
Alameda, California**

**Project No. CS1605
November 14, 2016**

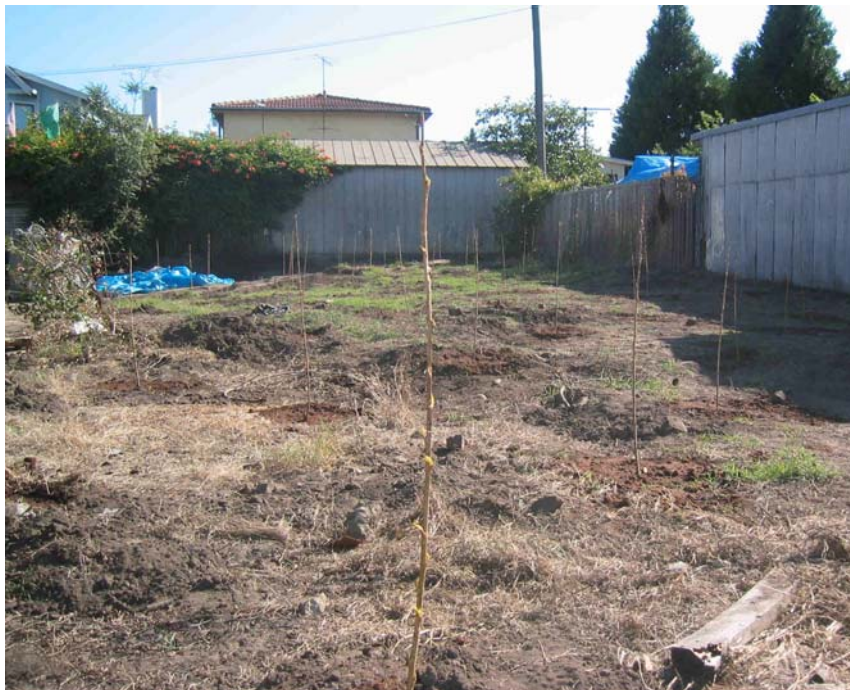
Bare-root trees planted in June 2005 - View towards rear of property

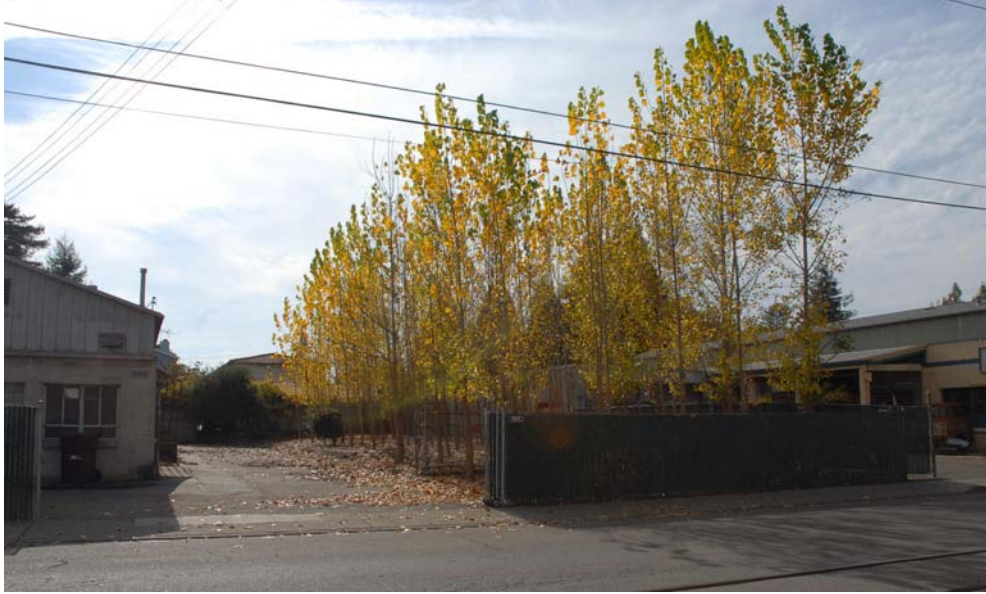
November 2010 – View from street towards driveway and rear of property
(compare tree height to photo on previous page)

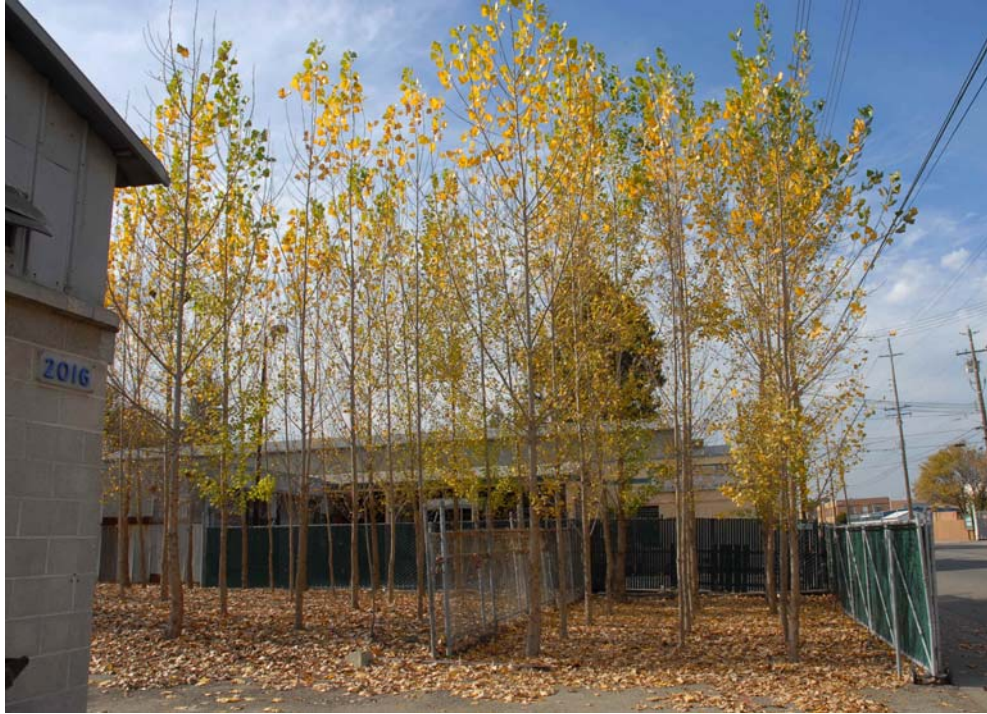
November 2010 – Trees dropping foliage. Also, branches on bottom 6 feet of trunks have been cleared for site visibility.

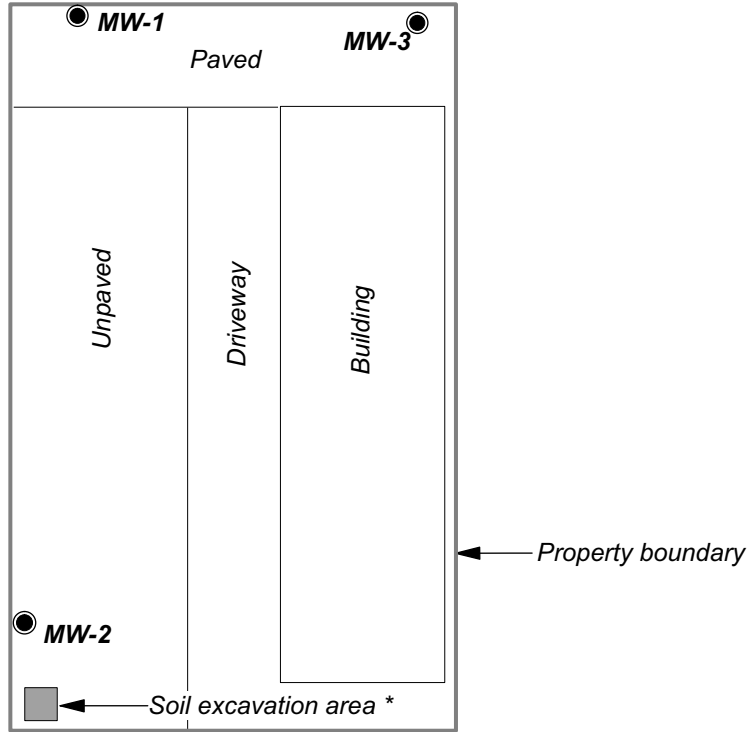
Project No. CS1605
 Cargill Salt Dispensing Systems Division
 2016 Clement Avenue, Alameda, California
Figure 2. Groundwater Monitoring Well Locations

After approval of the workplan by ACEHS, Cargill Salt conducted several phases of soil remediation and groundwater characterization. Surficial soils impacted by metals were excavated for disposal off site. Vadose-zone soils with the highest degree of impact by VOCs were also excavated for off-site disposal (see “Soil excavation area” on Figure 2).

A phytoremediation project was implemented at the Site in June 2005. The project involved planting 96 bare-root hybrid poplar trees in a grid of 24 rows. The rows are generally 6 feet apart with trees on 7-foot centers on each row. Selection of the phytoremediation approach and implementation of the project were described in the October 20, 2006 report, *Groundwater Monitoring Results, First through Fourth Quarter 2005, Cargill Salt – Alameda Facility, Alameda, California* prepared by Crawford Consulting, Inc. In April 2008, seven additional saplings were planted in the rear of the property near monitoring well MW-2.
