CO-1475

**Re: Response to Comments**  
July 25, 1997 Subsurface Investigation Report  
1300 Powell Street Emeryville, California 94608  
SLIC #322

Cambria Environmental Technology, Inc. (Cambria) is pleased to write this letter on behalf of Mr. Richard Becker in response to your October 1, 1997 letter regarding Cambria's July 25, 1997 Subsurface Investigation Report. Please find below responses to the concerns presented in your letter.

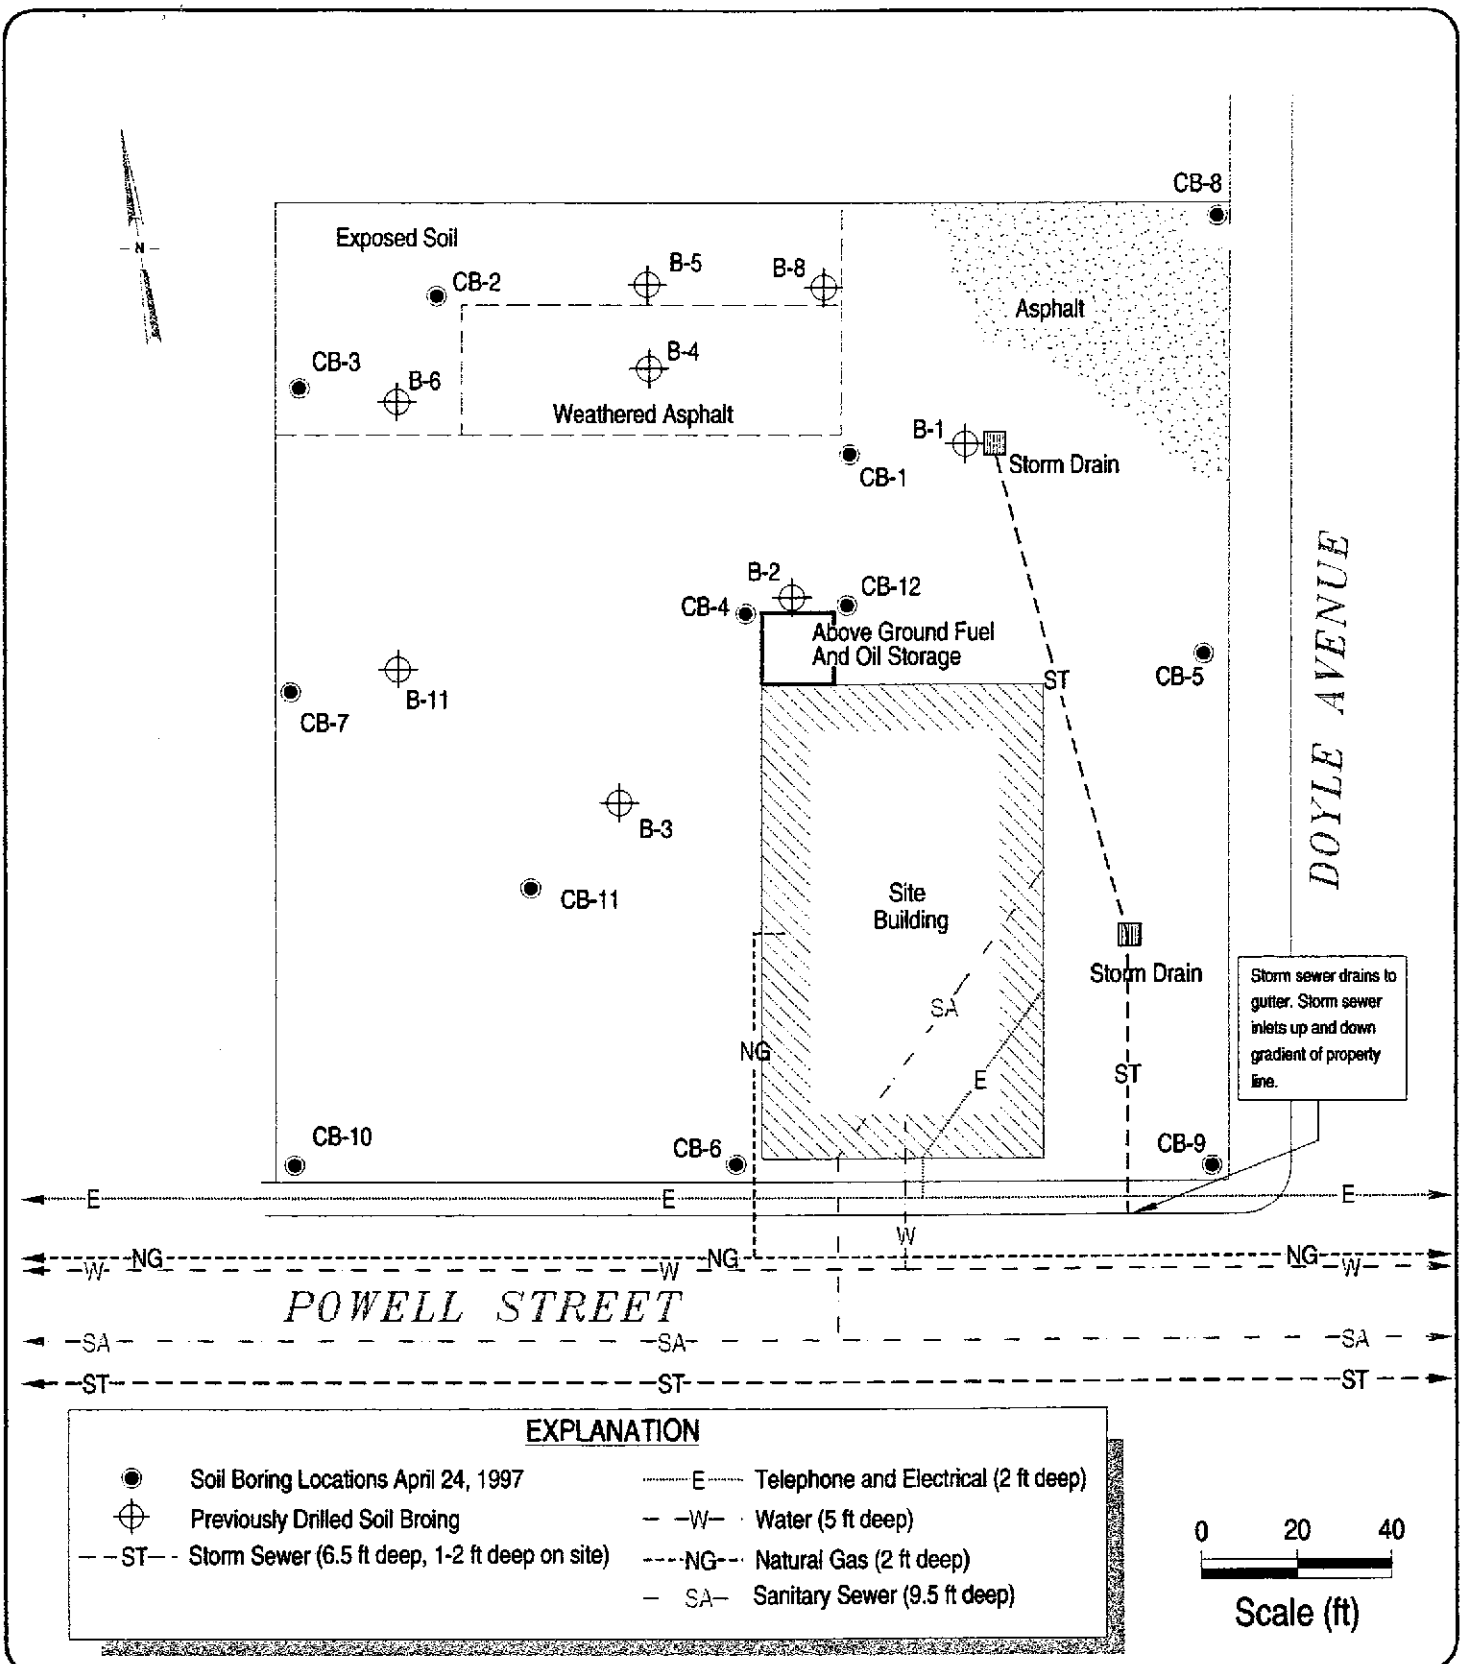
<p><b>CAMBRIA</b> Environmental Technology, Inc.</p>	<p>Construction Services Facility 1300 Powell Street Emeryville, CA</p> <p>F:\PROJECT\CONSERV\FIGURES\PREFPATH.DWG</p>	<p>Subsurface Utility Location Map</p>	<p>FIGURE <b>1</b></p>
--	--	--	----------------------------

Subsurface utilities beneath the site exist solely on the eastern upgradient portion of the site and are shown on Figure 1.<sup>1</sup> Because none of these potential conduits are located beneath or downgradient of the areas with elevated hydrocarbon concentrations in soil, it is unlikely that preferential migration is transporting the low mobility diesel or petroleum oil and grease (POG) downgradient of the site.

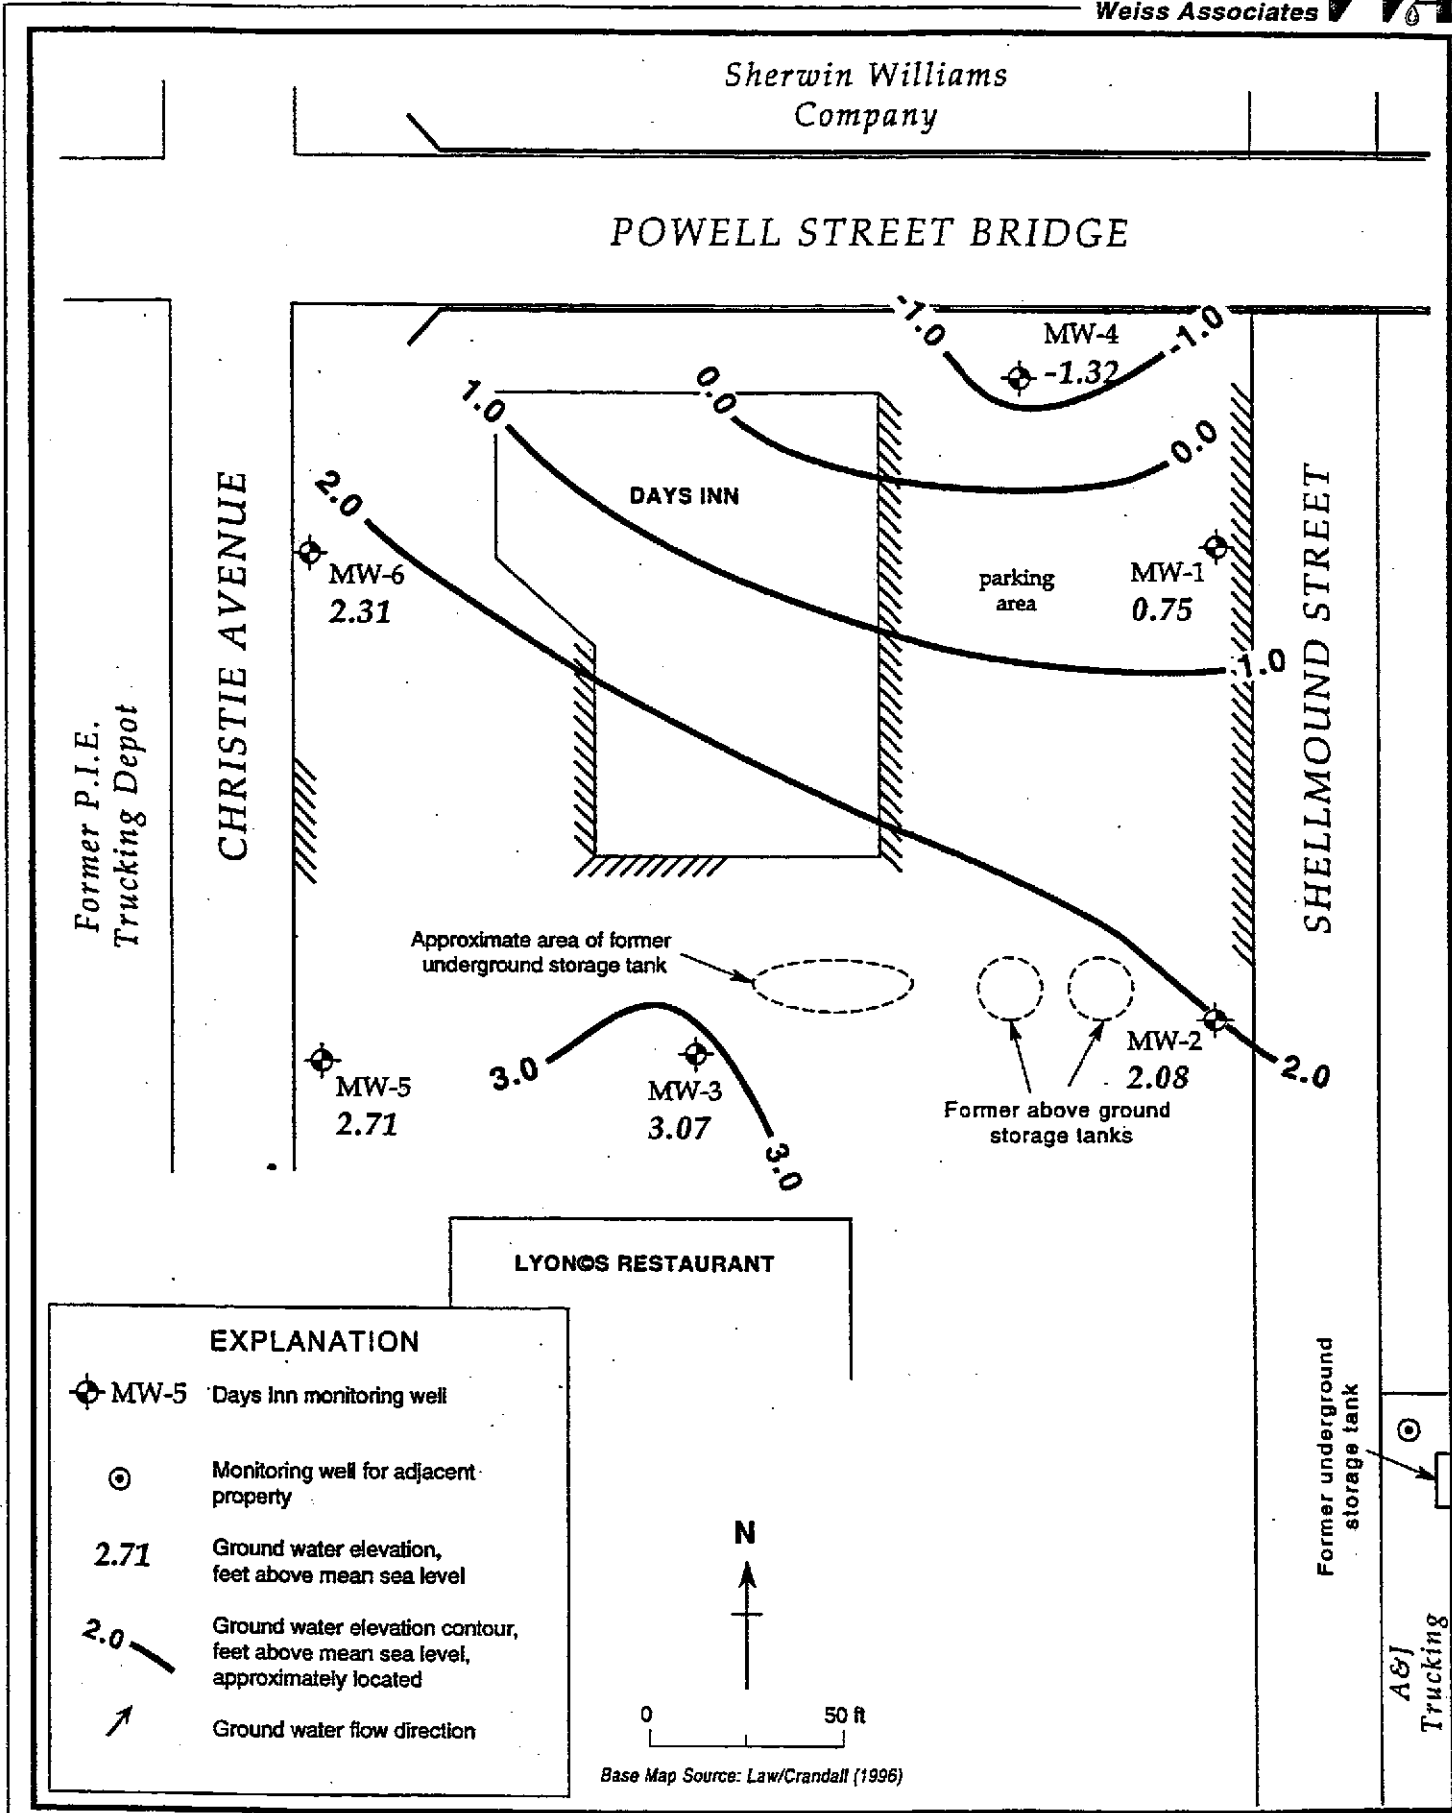
EXPLANATION	
	MW-5 Days Inn monitoring well
	Monitoring well for adjacent property
2.71	Ground water elevation, feet above mean sea level
2.0	Ground water elevation contour, feet above mean sea level, approximately located
	Ground water flow direction
