**Reference: Earthgrains Baking Companies, Inc.
955 Kennedy Street
Oakland, California 94606**

**Subject: First Semi-Annual Groundwater Monitoring Report for 2012
(January 2012)**

**Reference: Earthgrains Baking Companies, Inc.
955 Kennedy Street
Oakland, California 94606
RO #0002569**

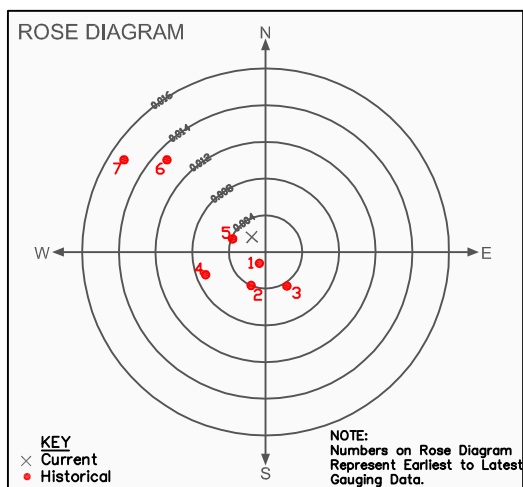
PROJECT NO.: 62402797
EARTHGRAINS
OAKLAND, CALIFORNIA
FIGURE 3

Groundwater Elevation – Wells MW-101 through MW-104 were measured and groundwater elevations were calculated to range from 4.95 to 2.88 feet above mean sea level (MSL). Free product was not observed in any of these wells during this or previous groundwater monitoring events. Groundwater levels in wells MW-101, MW-103, and MW-104 were 0.02 to 0.12 feet higher for this event compared to the previous monitoring event in July 2011. The groundwater levels for this event in these wells were 0.29 to 0.54 feet lower than the first semi-annual monitoring in February 2011. The water levels in MW-102 were 1.76 and 1.94 feet lower for this event compared to July 2011 and February 2011 respectively. Groundwater elevation measurements at the Site are presented on Table 2. Precipitation in the Oakland area for the July 2011 to January 2012 period (5.24 inches) was approximately 50 % compared with the same period the previous year (10.84 inches) and less than 50% of the normal precipitation (11.38 inches).

Groundwater Flow Direction and Gradient – Based on historic groundwater measurements, groundwater generally flows to the west. Groundwater flow for the January 6, 2012 event was toward the northwest. The approximate gradient of 0.04 foot-per-foot is an order of magnitude higher compared to historical gradients, which have been approximately 0.001 foot-per-foot. This gradient is also considered to be the result of the low precipitation and anomalous compared to historical groundwater monitoring events.

MW-102
2.88

MW-103
4.95

MW-104
4.93

MW-101
4.80

4.65 GROUNDWATER ELEVATION 01/06/12
