Date	May 13, 1997
Time	2:50 PM
From	Mark Knox
Project No.	3042.95.008

SHERWIN-WILLIAMS
Soil Sample Locations and Results
in Horton Street

Outlying Surface/Soil Boring Locations

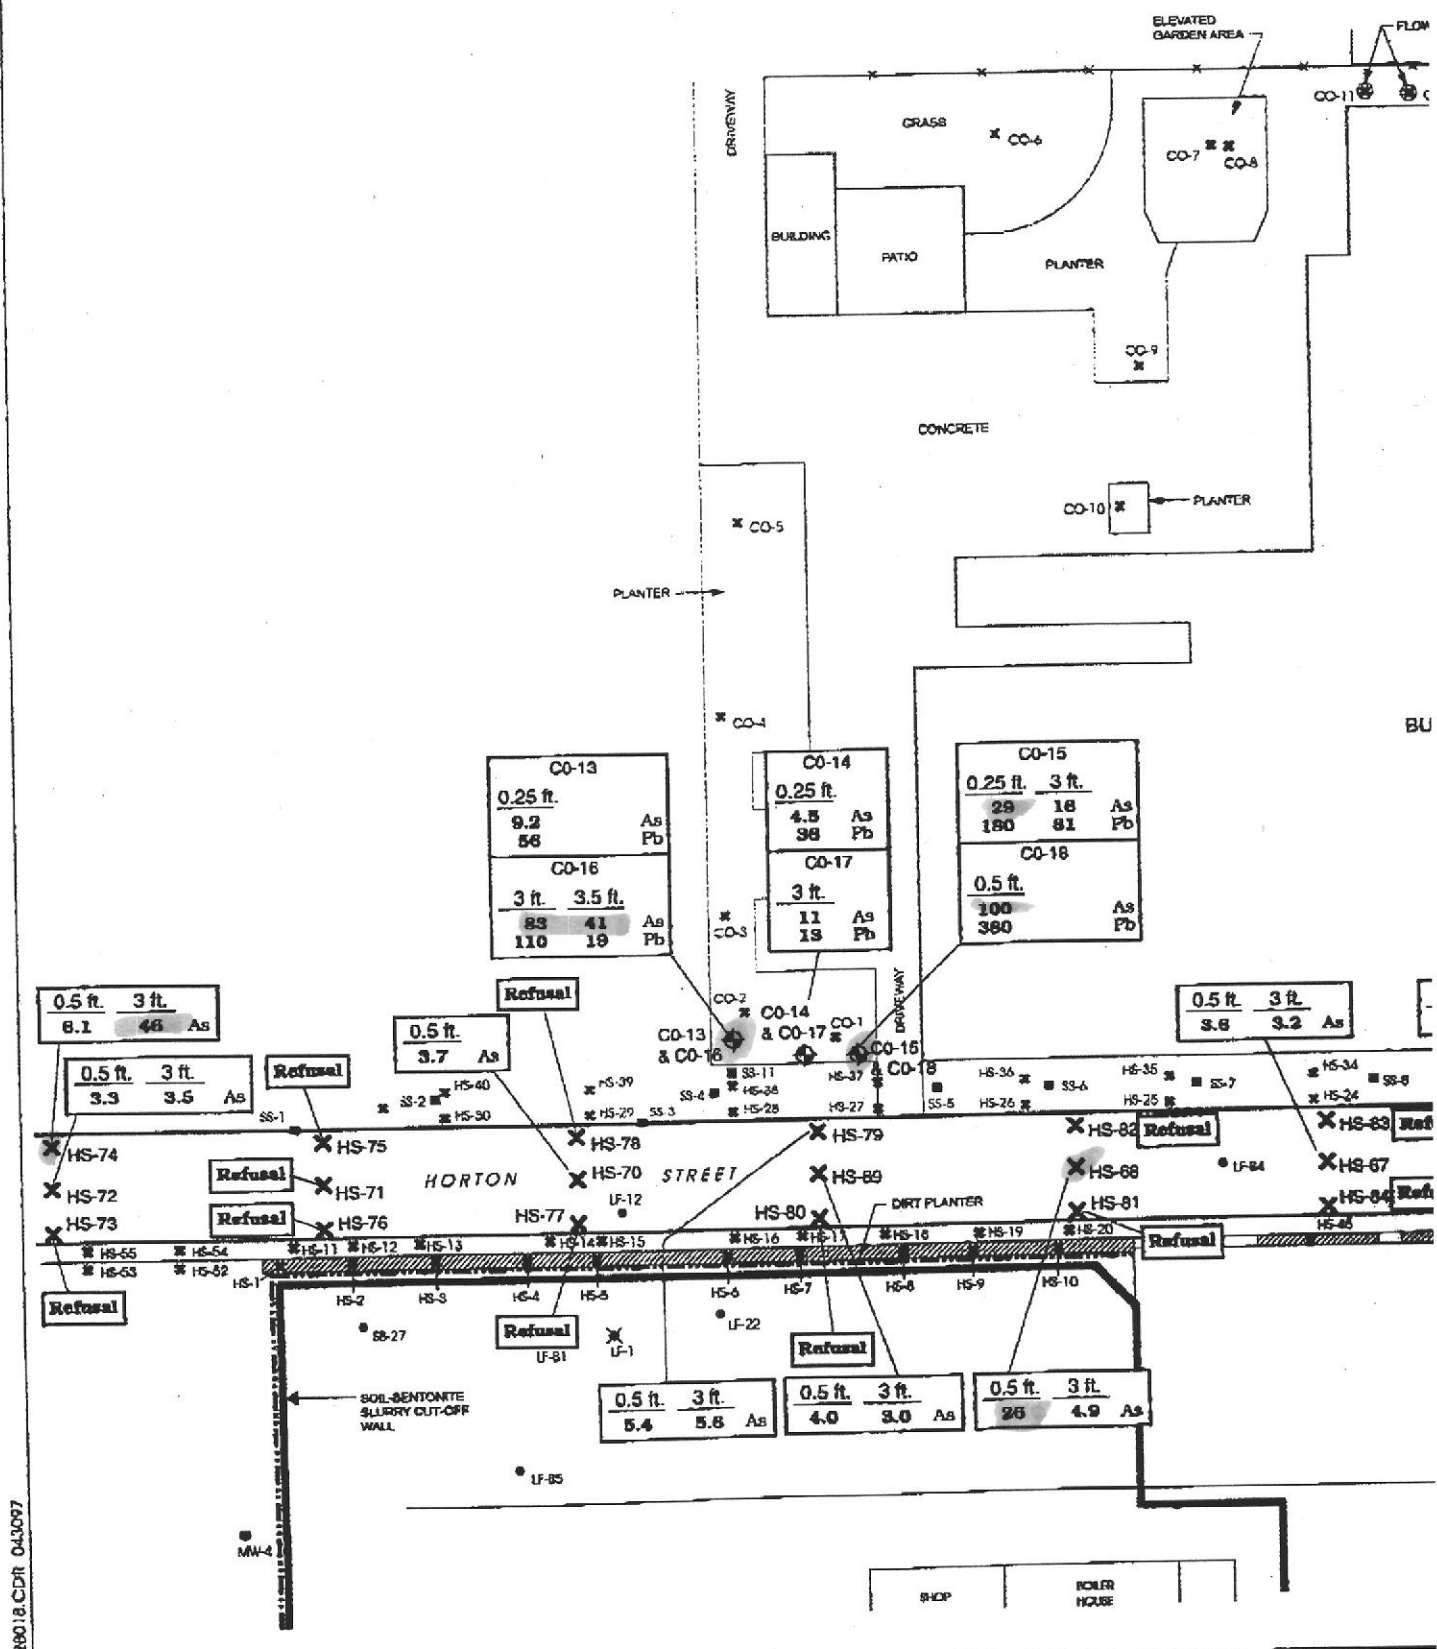
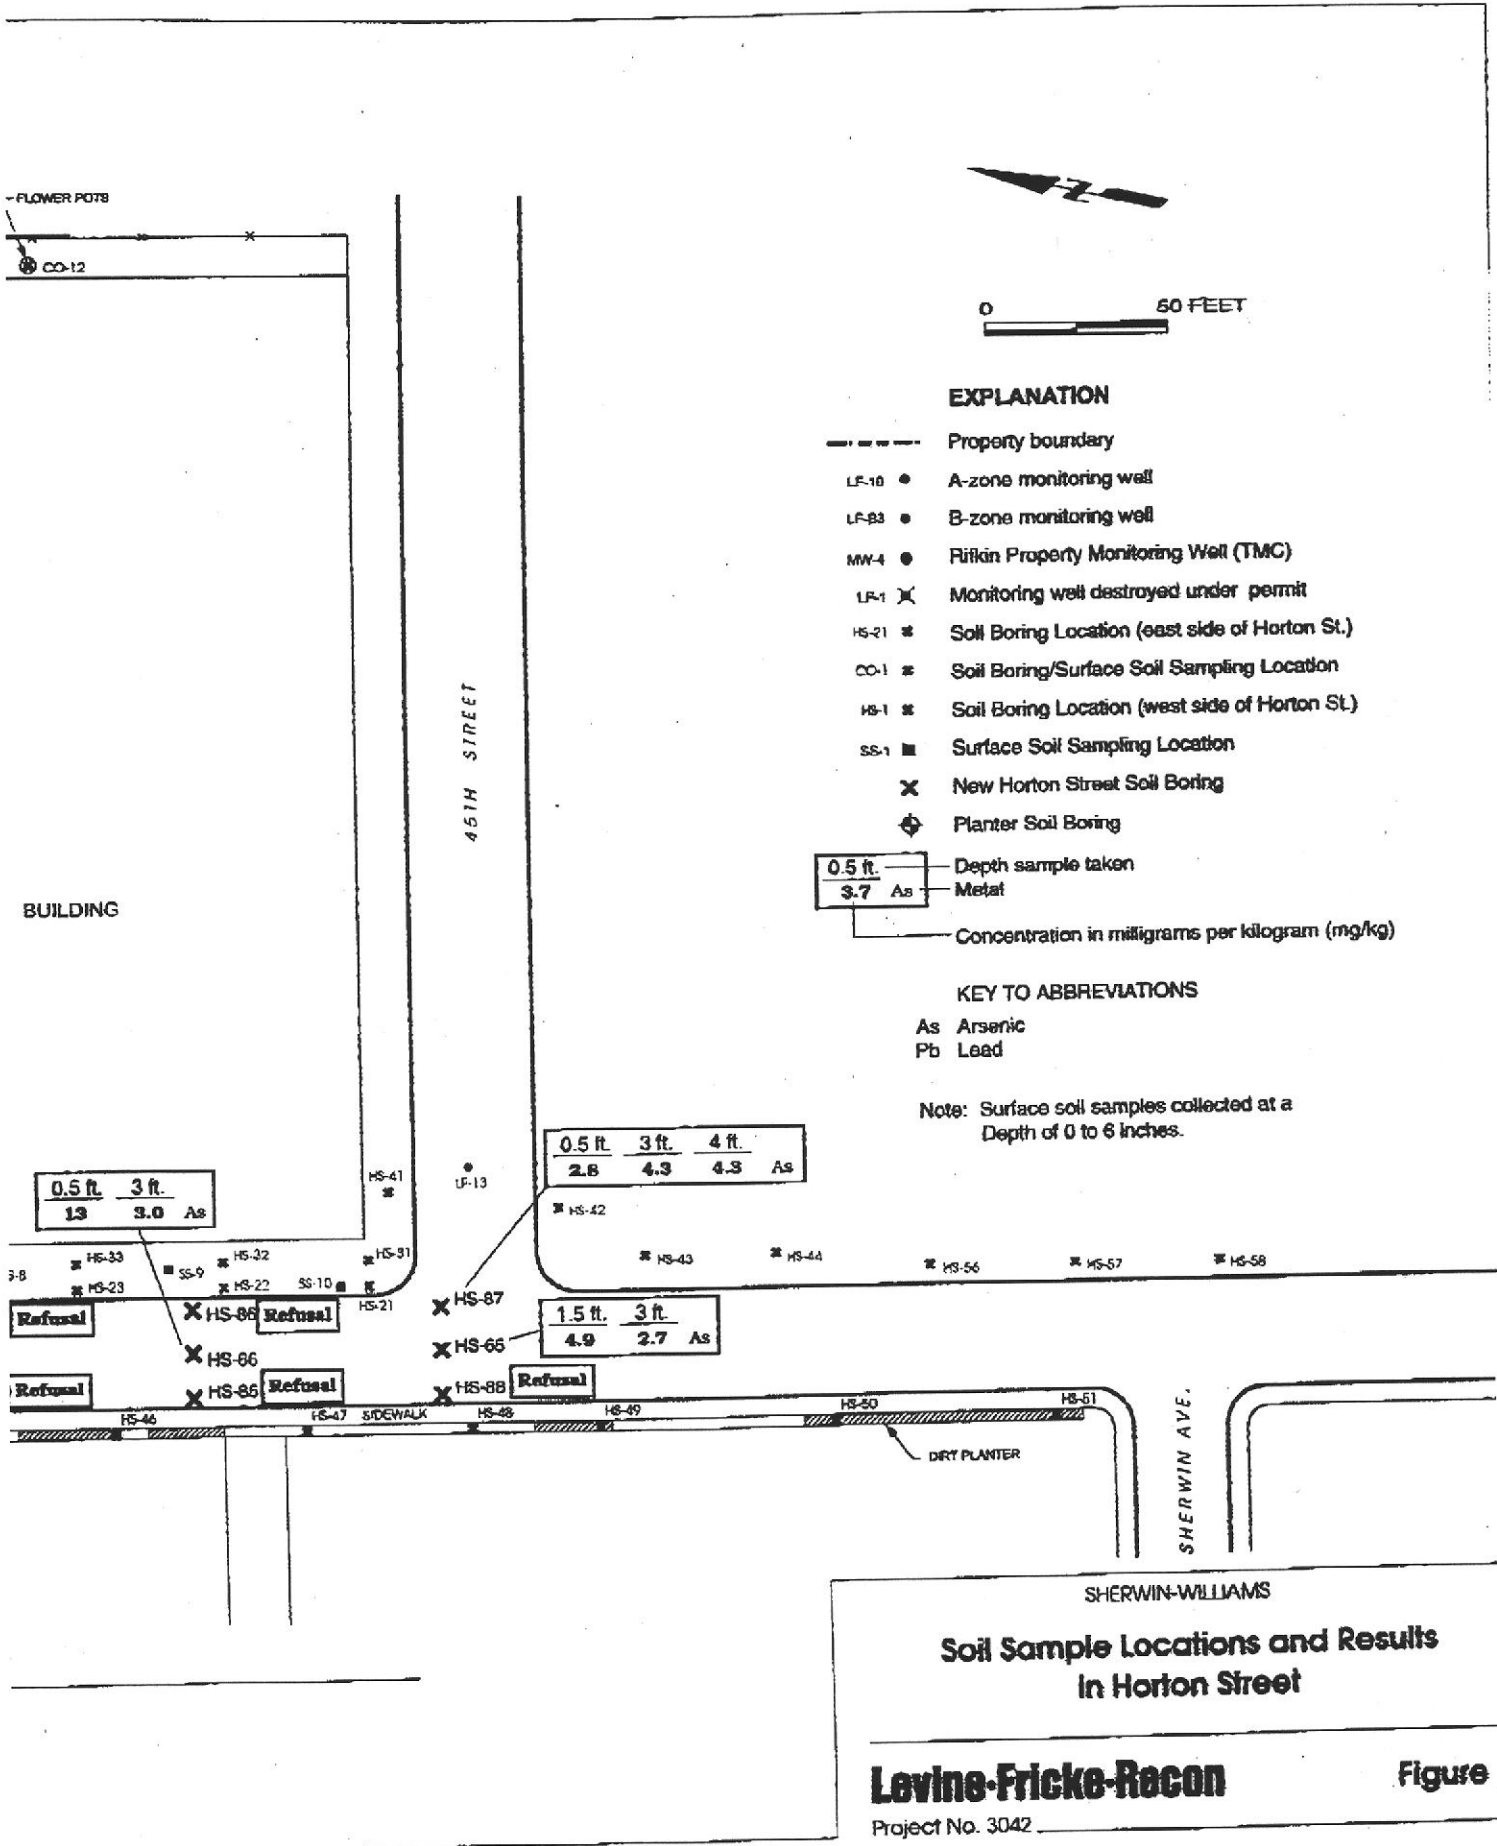
Figure 1a

- 2) SOIL SAMPLE LOCATIONS AND RESULTS HORTON STREET FIGURE 1A This figure presents the results of shallow soil sampling in Horton Street. Please note that we had a lot of sample locations where we had refusal due to the very tight compaction in the street. We also attempted to take a strata of samples at several locations (as requested by EKI) but either encountered refusal or had poor sample recovery.

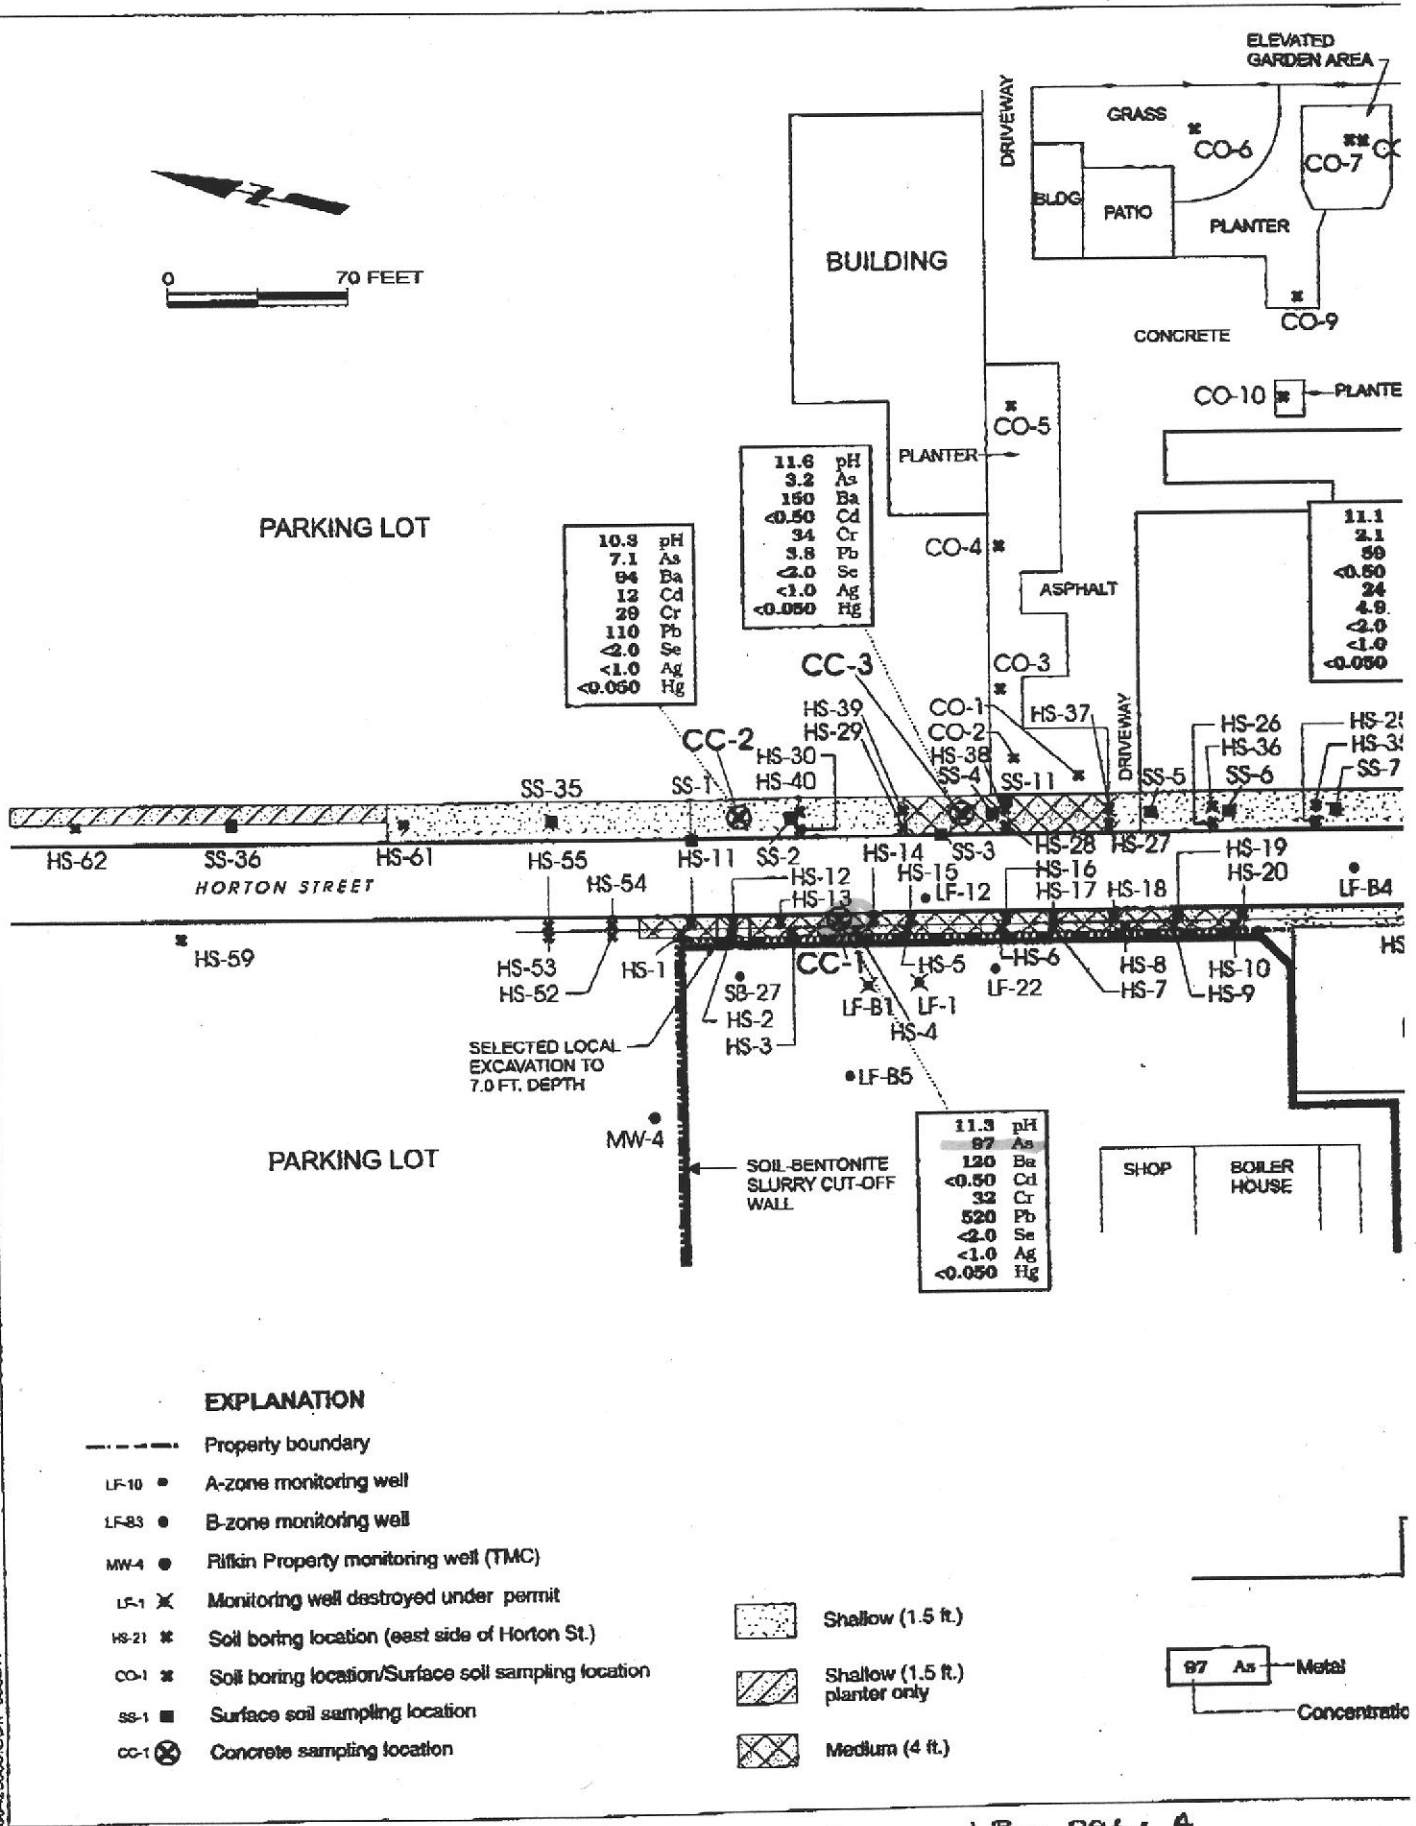
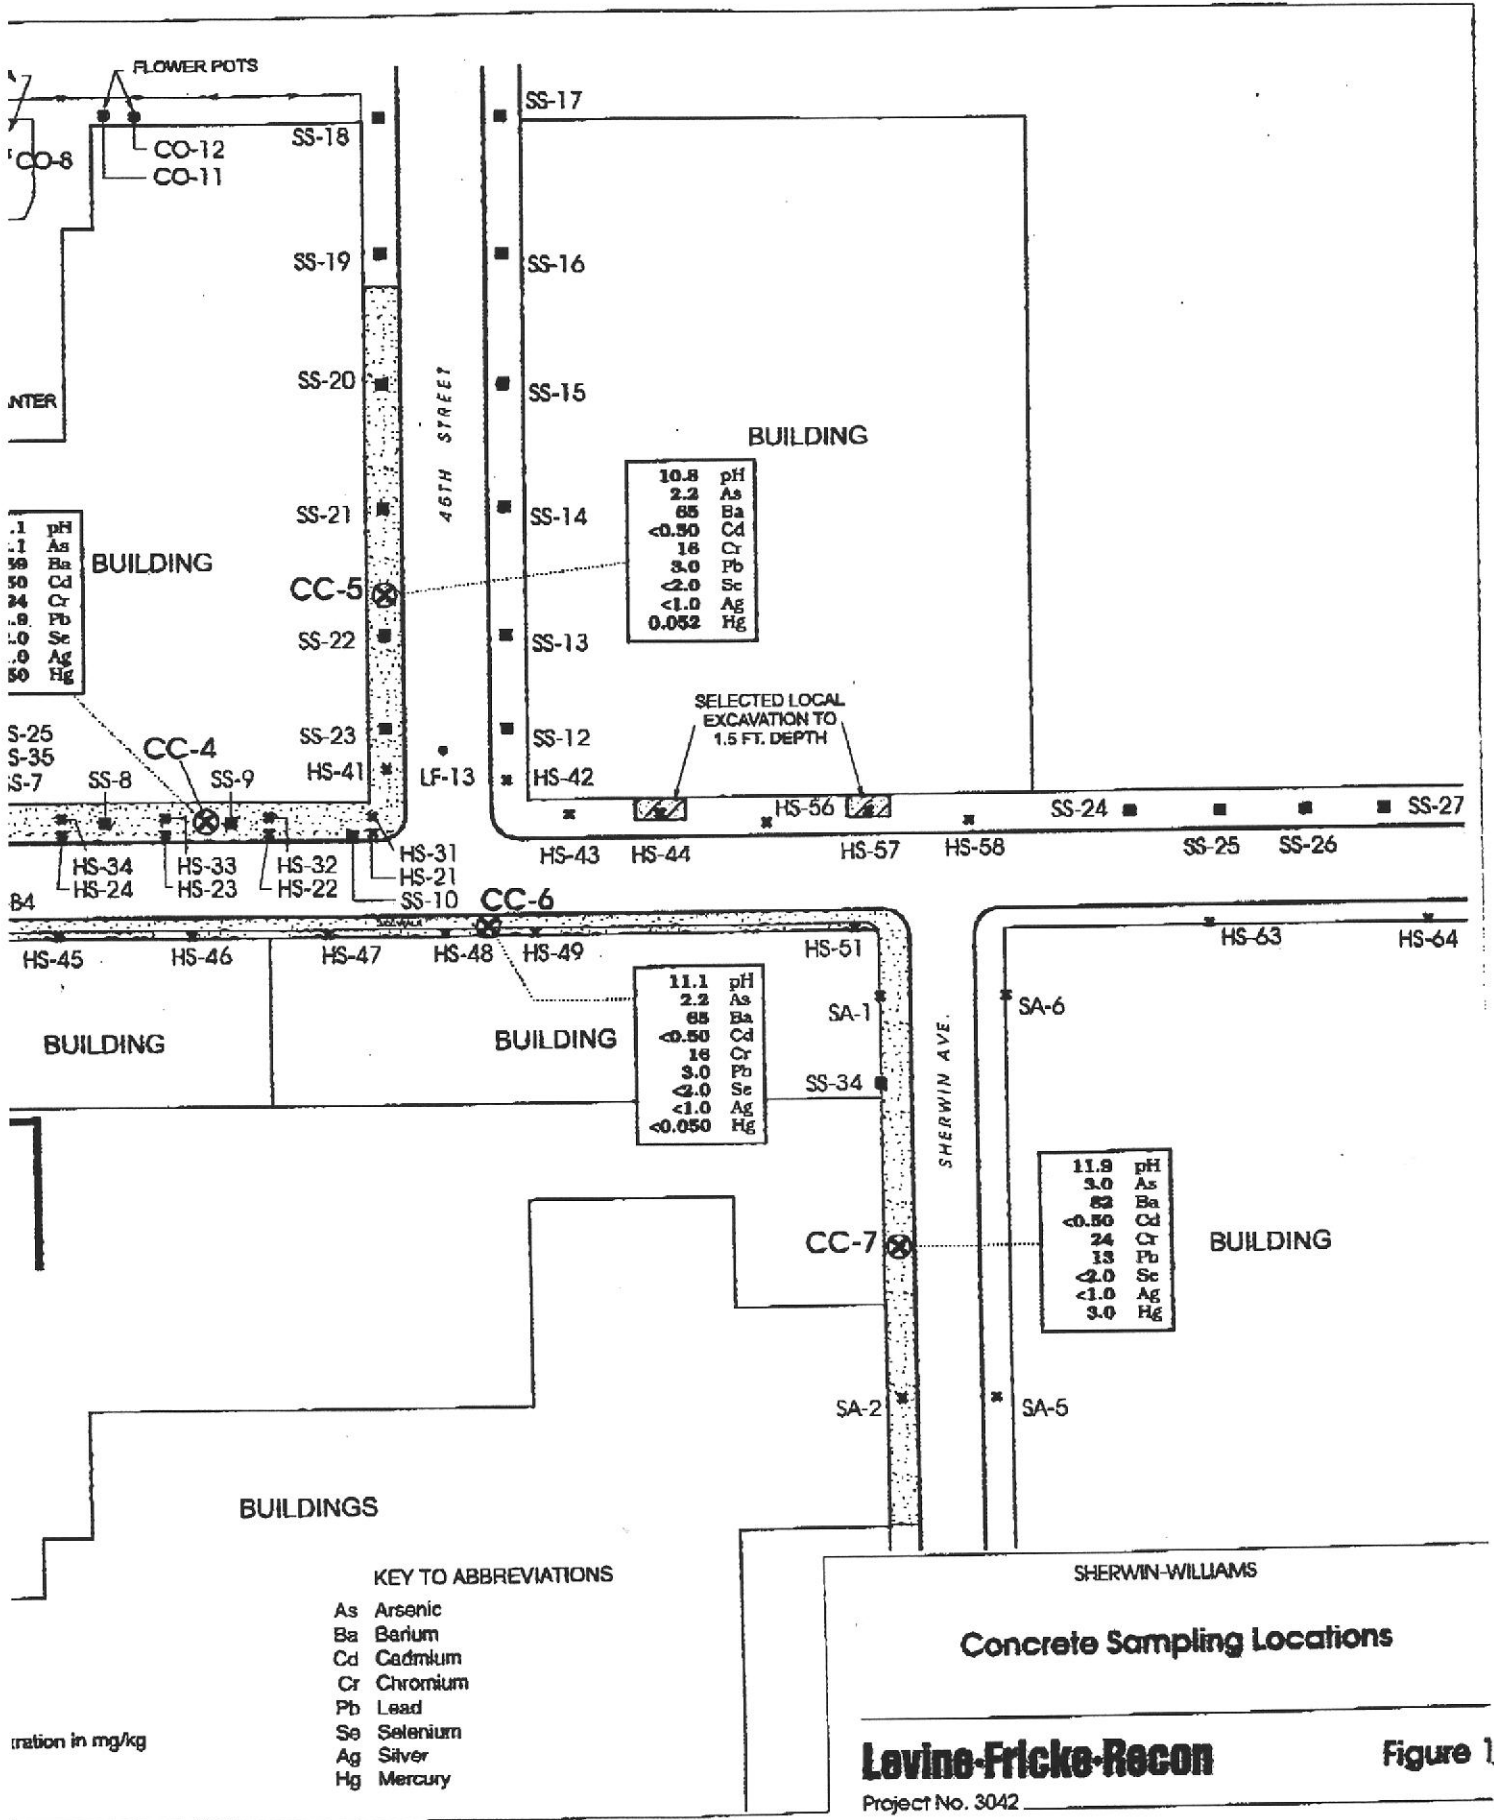
Figure 1B - page A

- 1) CONCRETE SAMPLING LOCATIONS FIGURE 1B This figure shows the results of sampling the concrete sidewalk for purposes of waste characterization for disposal.

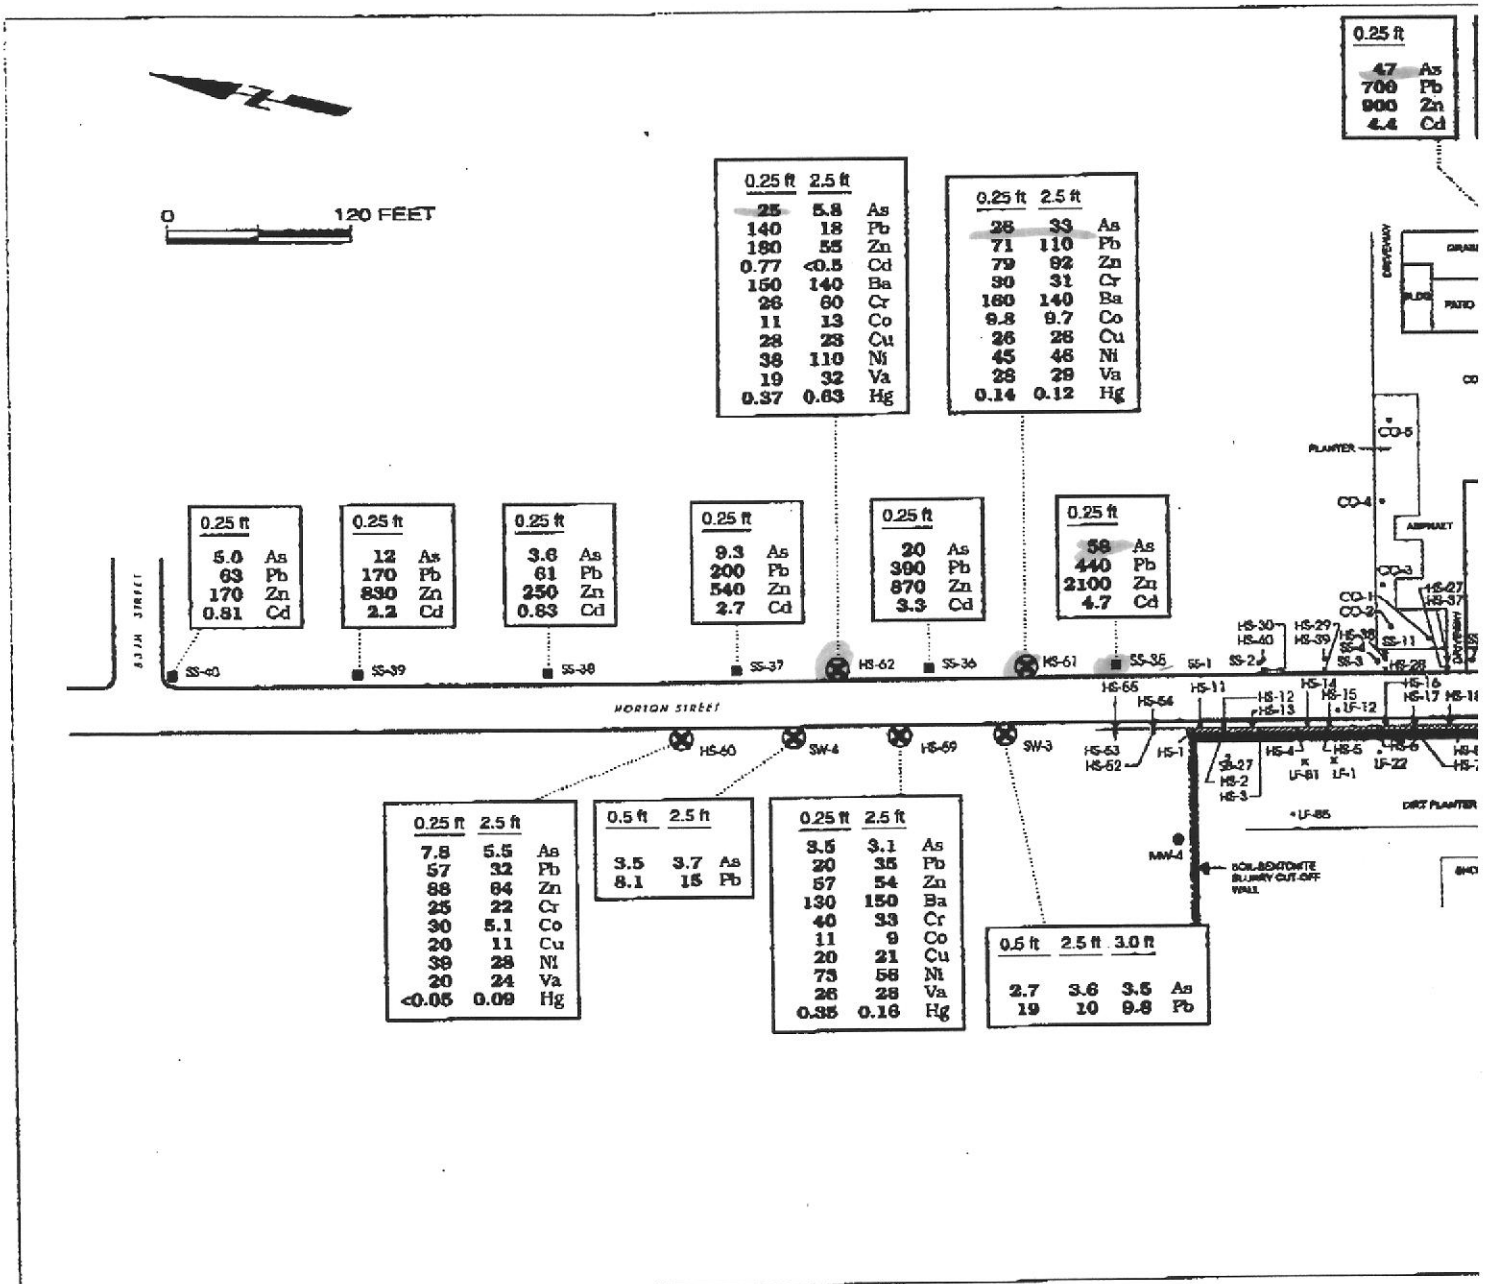
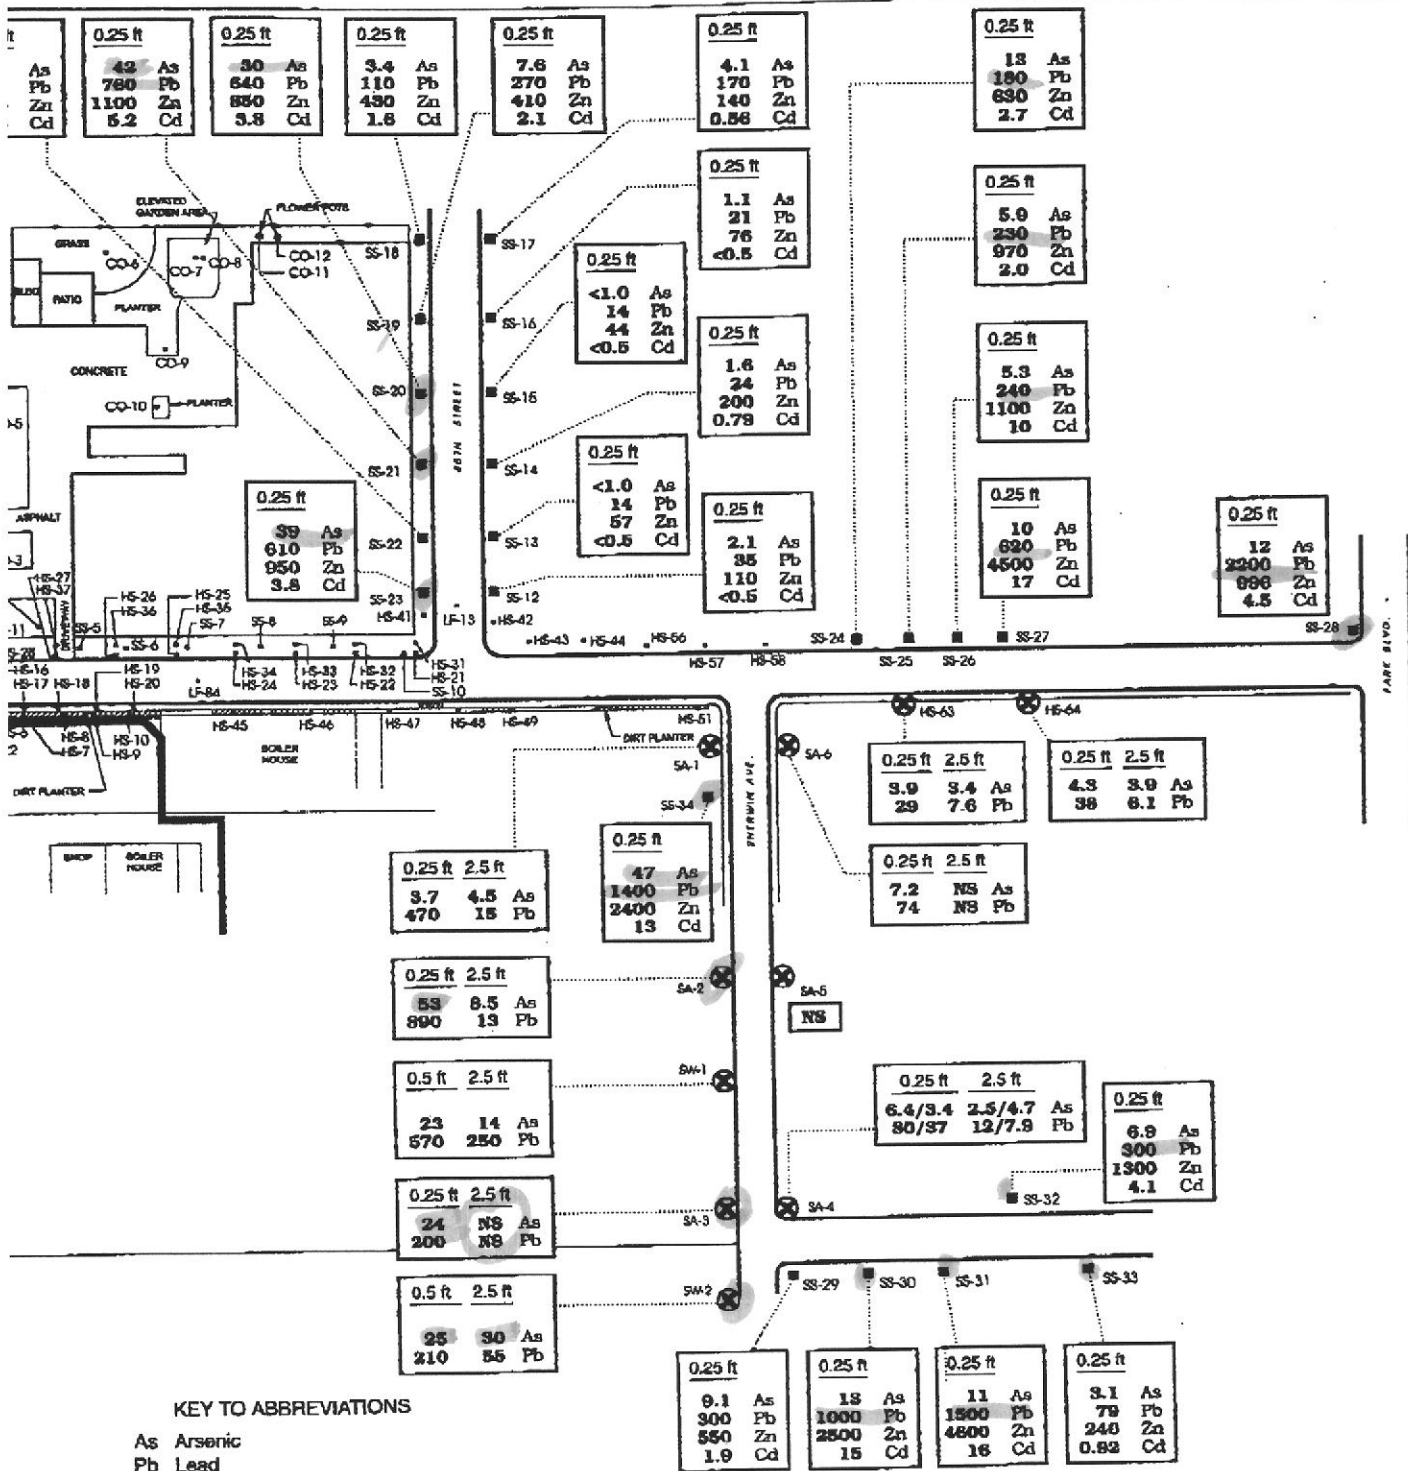
Levine-Fricke-Recon Figure 3

- 3) OUTLYING SURFACE/SOIL BORING LOCATIONS FIGURE 3 - This figure is the same as previously submitted with the addition of 4 samples in the sidewalk. The new samples are SW-1 and SW-2 along the north side of Sherwin Ave. and SW-3 and SW-4 along the west side of Horton St. north of Sherwin-Williams. These additional samples were requested by the RWQCB.
