## **REVISED DRAFT FEASIBILITY STUDY AND CORRECTIVE ACTION PLAN**

Crown Chevrolet Cadillac Isuzu  
7544 Dublin Boulevard and 6707 Golden Gate Drive  
Dublin, California

**AMEC Environment & Infrastructure, Inc.**  
2101 Webster Street, 12th Floor  
Oakland, California 94612

March 2013

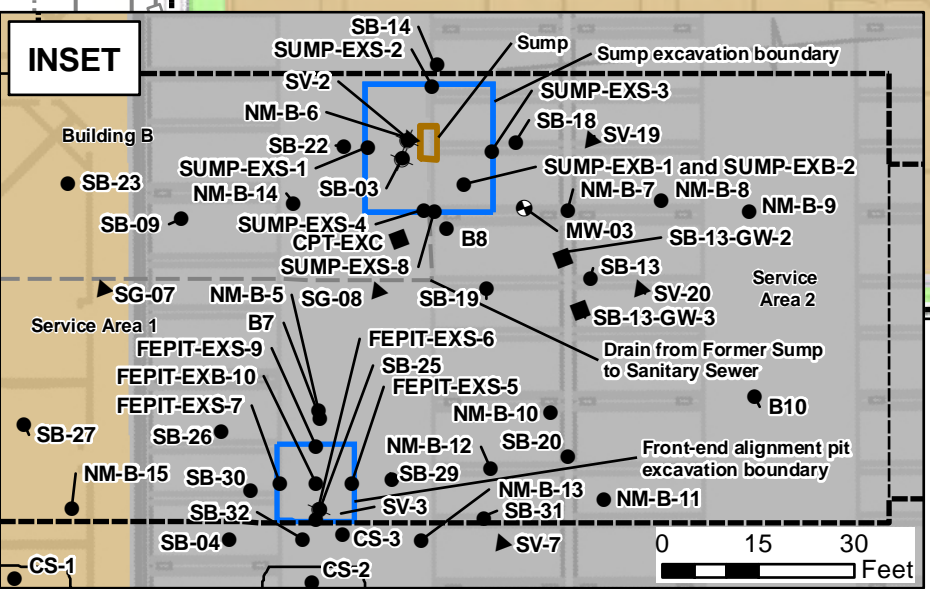
Figure 2b

PROPOSED DEVELOPMENT AND SAMPLE LOCATIONS  
 Crown Chevrolet Cadillac Isuzu  
 7544 Dublin Boulevard and 6707 Golden Gate Drive  
 Dublin, California

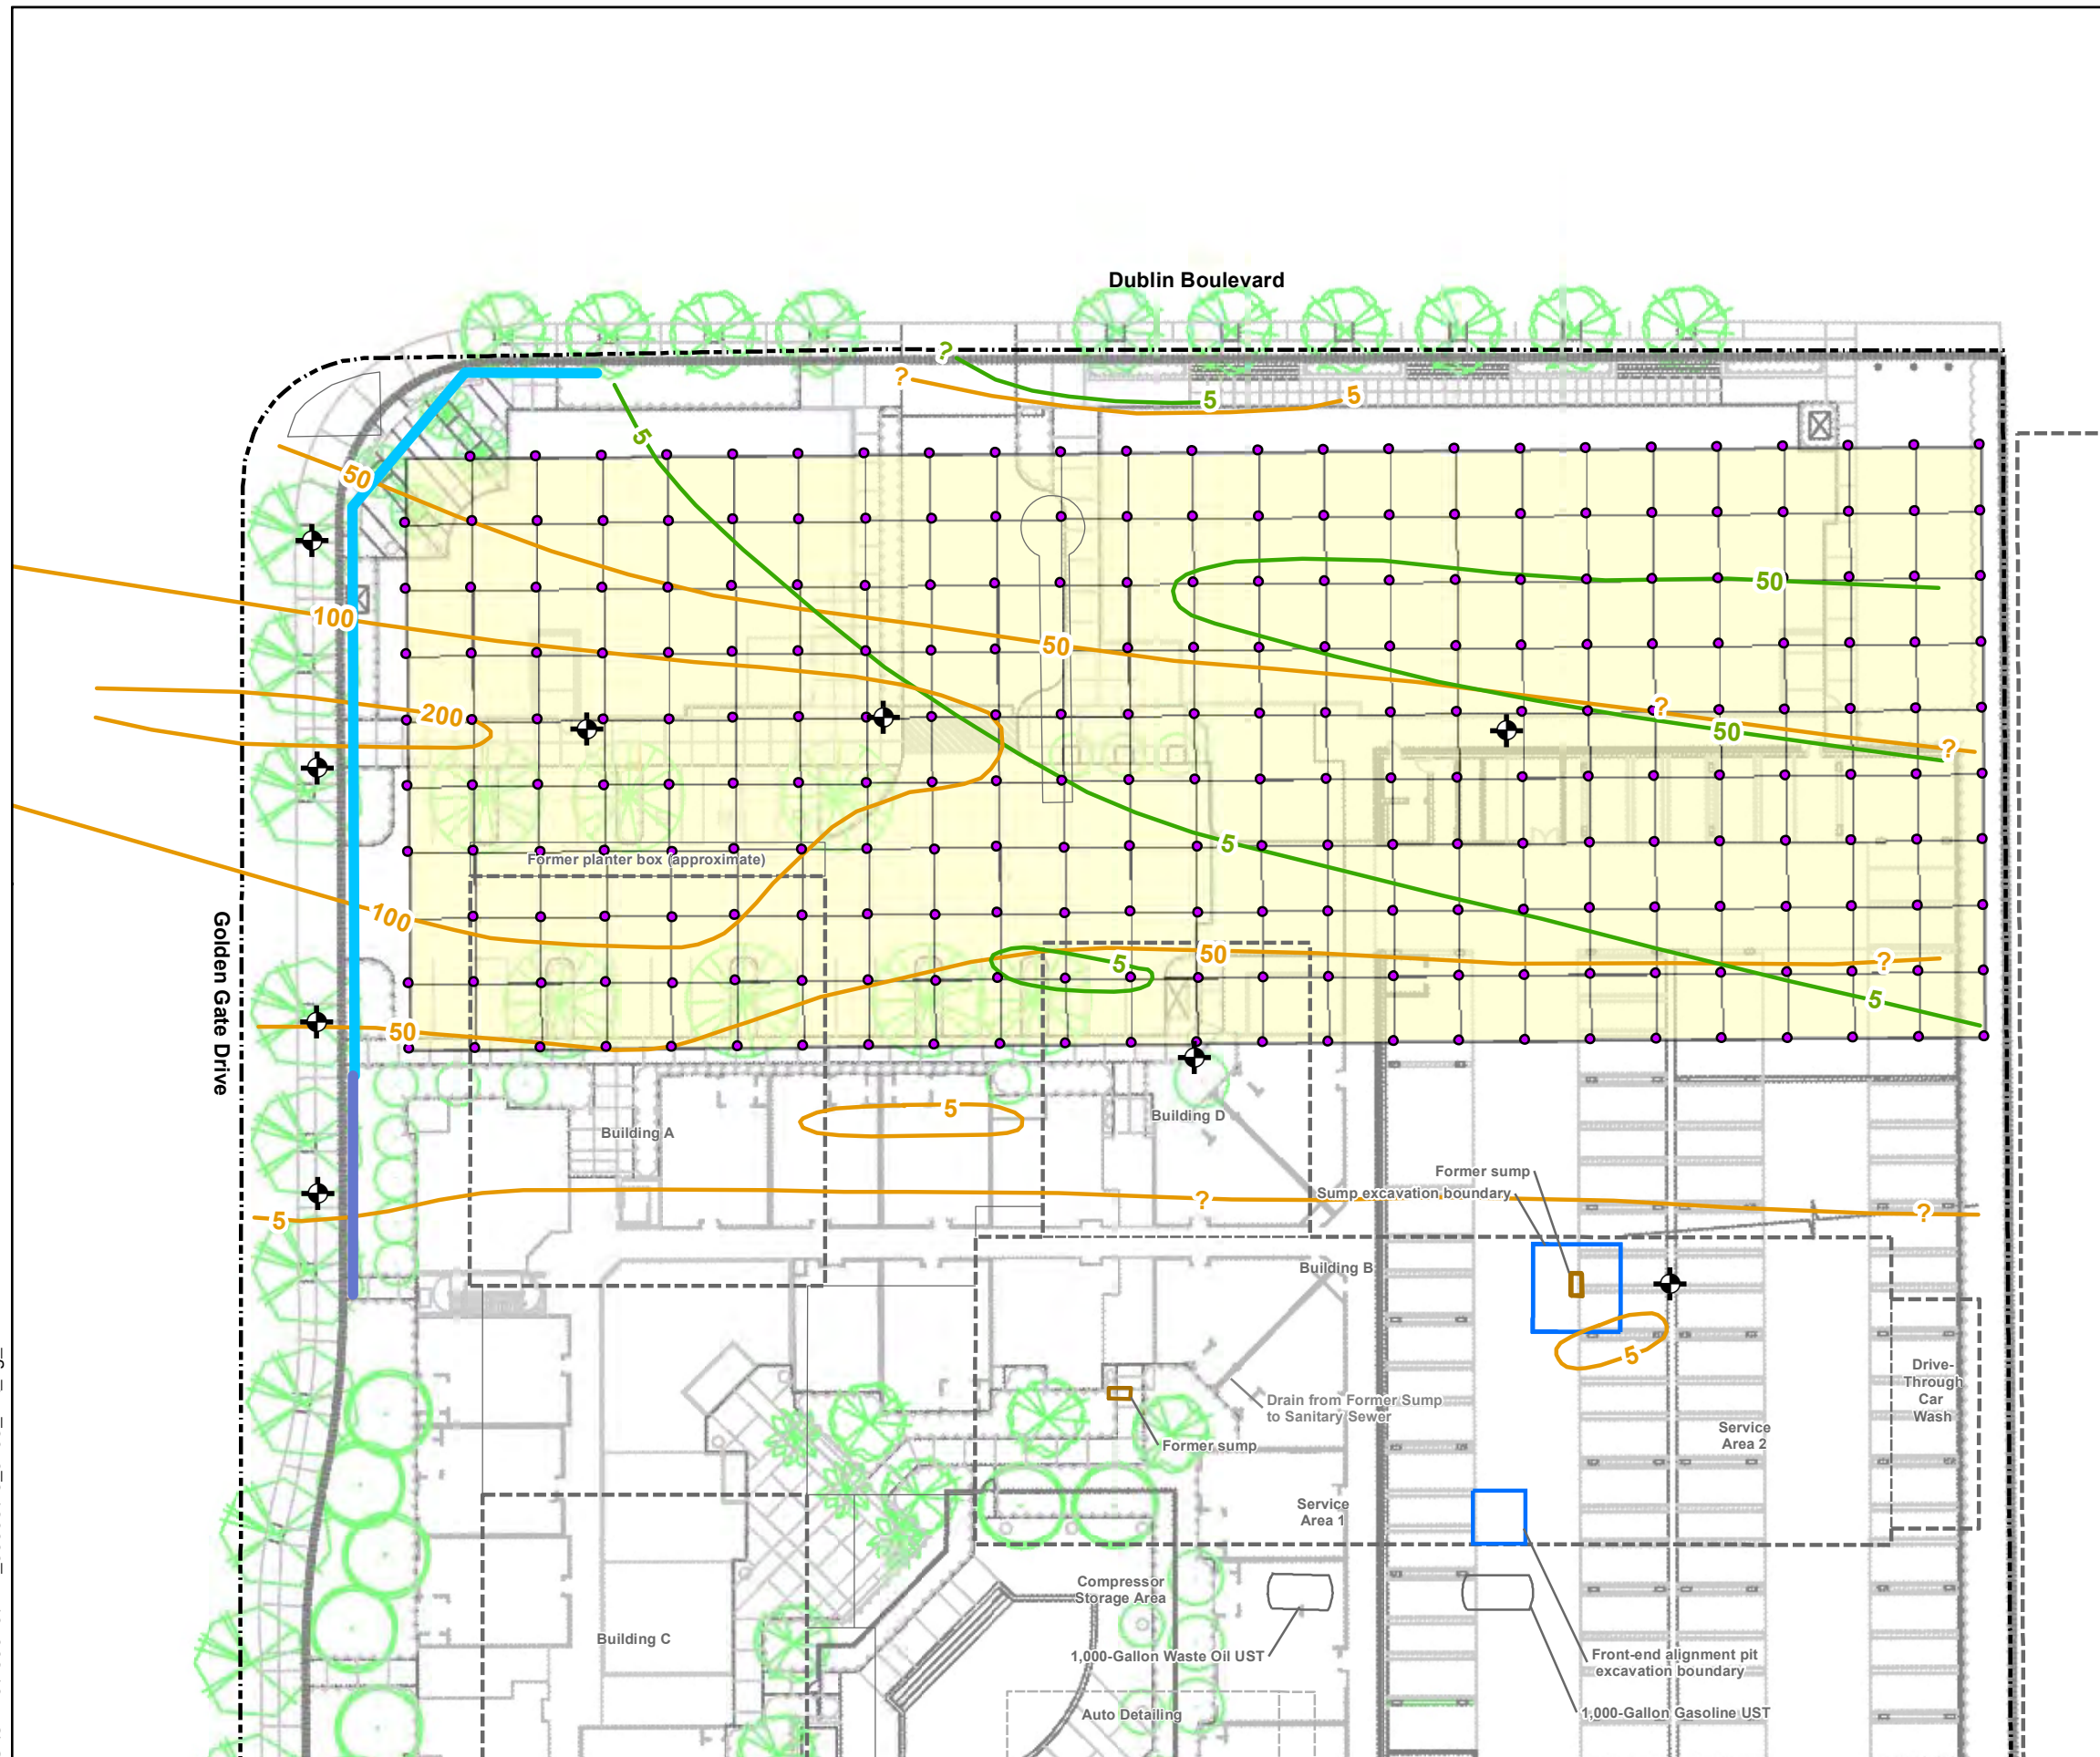
- Proposed bioremediation injection location
- ⊕ Proposed shallow groundwater monitoring well location
- Proposed location of permeable reactive barrier
- Proposed contingency location of permeable reactive barrier
- 50— Approximate line of equal PCE concentration
- 50— Approximate line of equal TCE concentration
- Approximate excavation boundary (October 2011)
- - - - - Approximate property line
- Approximate sump location
- ⊔ Existing buildings

The carbon substrate would be emplaced using direct-push drilling technology at each location indicated on Figure 14. For three to six months following the injection, the carbon substrate would be allowed to disperse, break down, and create an anaerobic environment. Upon sampling to determine that favorable conditions had been achieved (typically by an indication of iron or sulfate reducing conditions) for *Dhc* bacteria to reduce CVOCs; the *Dhc* culture would be injected into the impacted area. However, the fine-grained nature of the subsurface lithology limits the possibility of successfully targeting and delivering bacteria and nutrients.
