**SITE: SLIC CASE R00003079; GEOTRACKER GLOBAL ID T10000003401
BYRON POWER COMPANY
4901 BRUNS ROAD
BYRON, CALIFORNIA 94514**

RE: SURFACE SPILL INTERIM REMEDIAL ACTION REPORT

SURFACE SPILL INTERIM REMEDIAL ACTION REPORT

**BYRON POWER COMPANY
4901 BRUNS ROAD
BYRON, CALIFORNIA 94514**

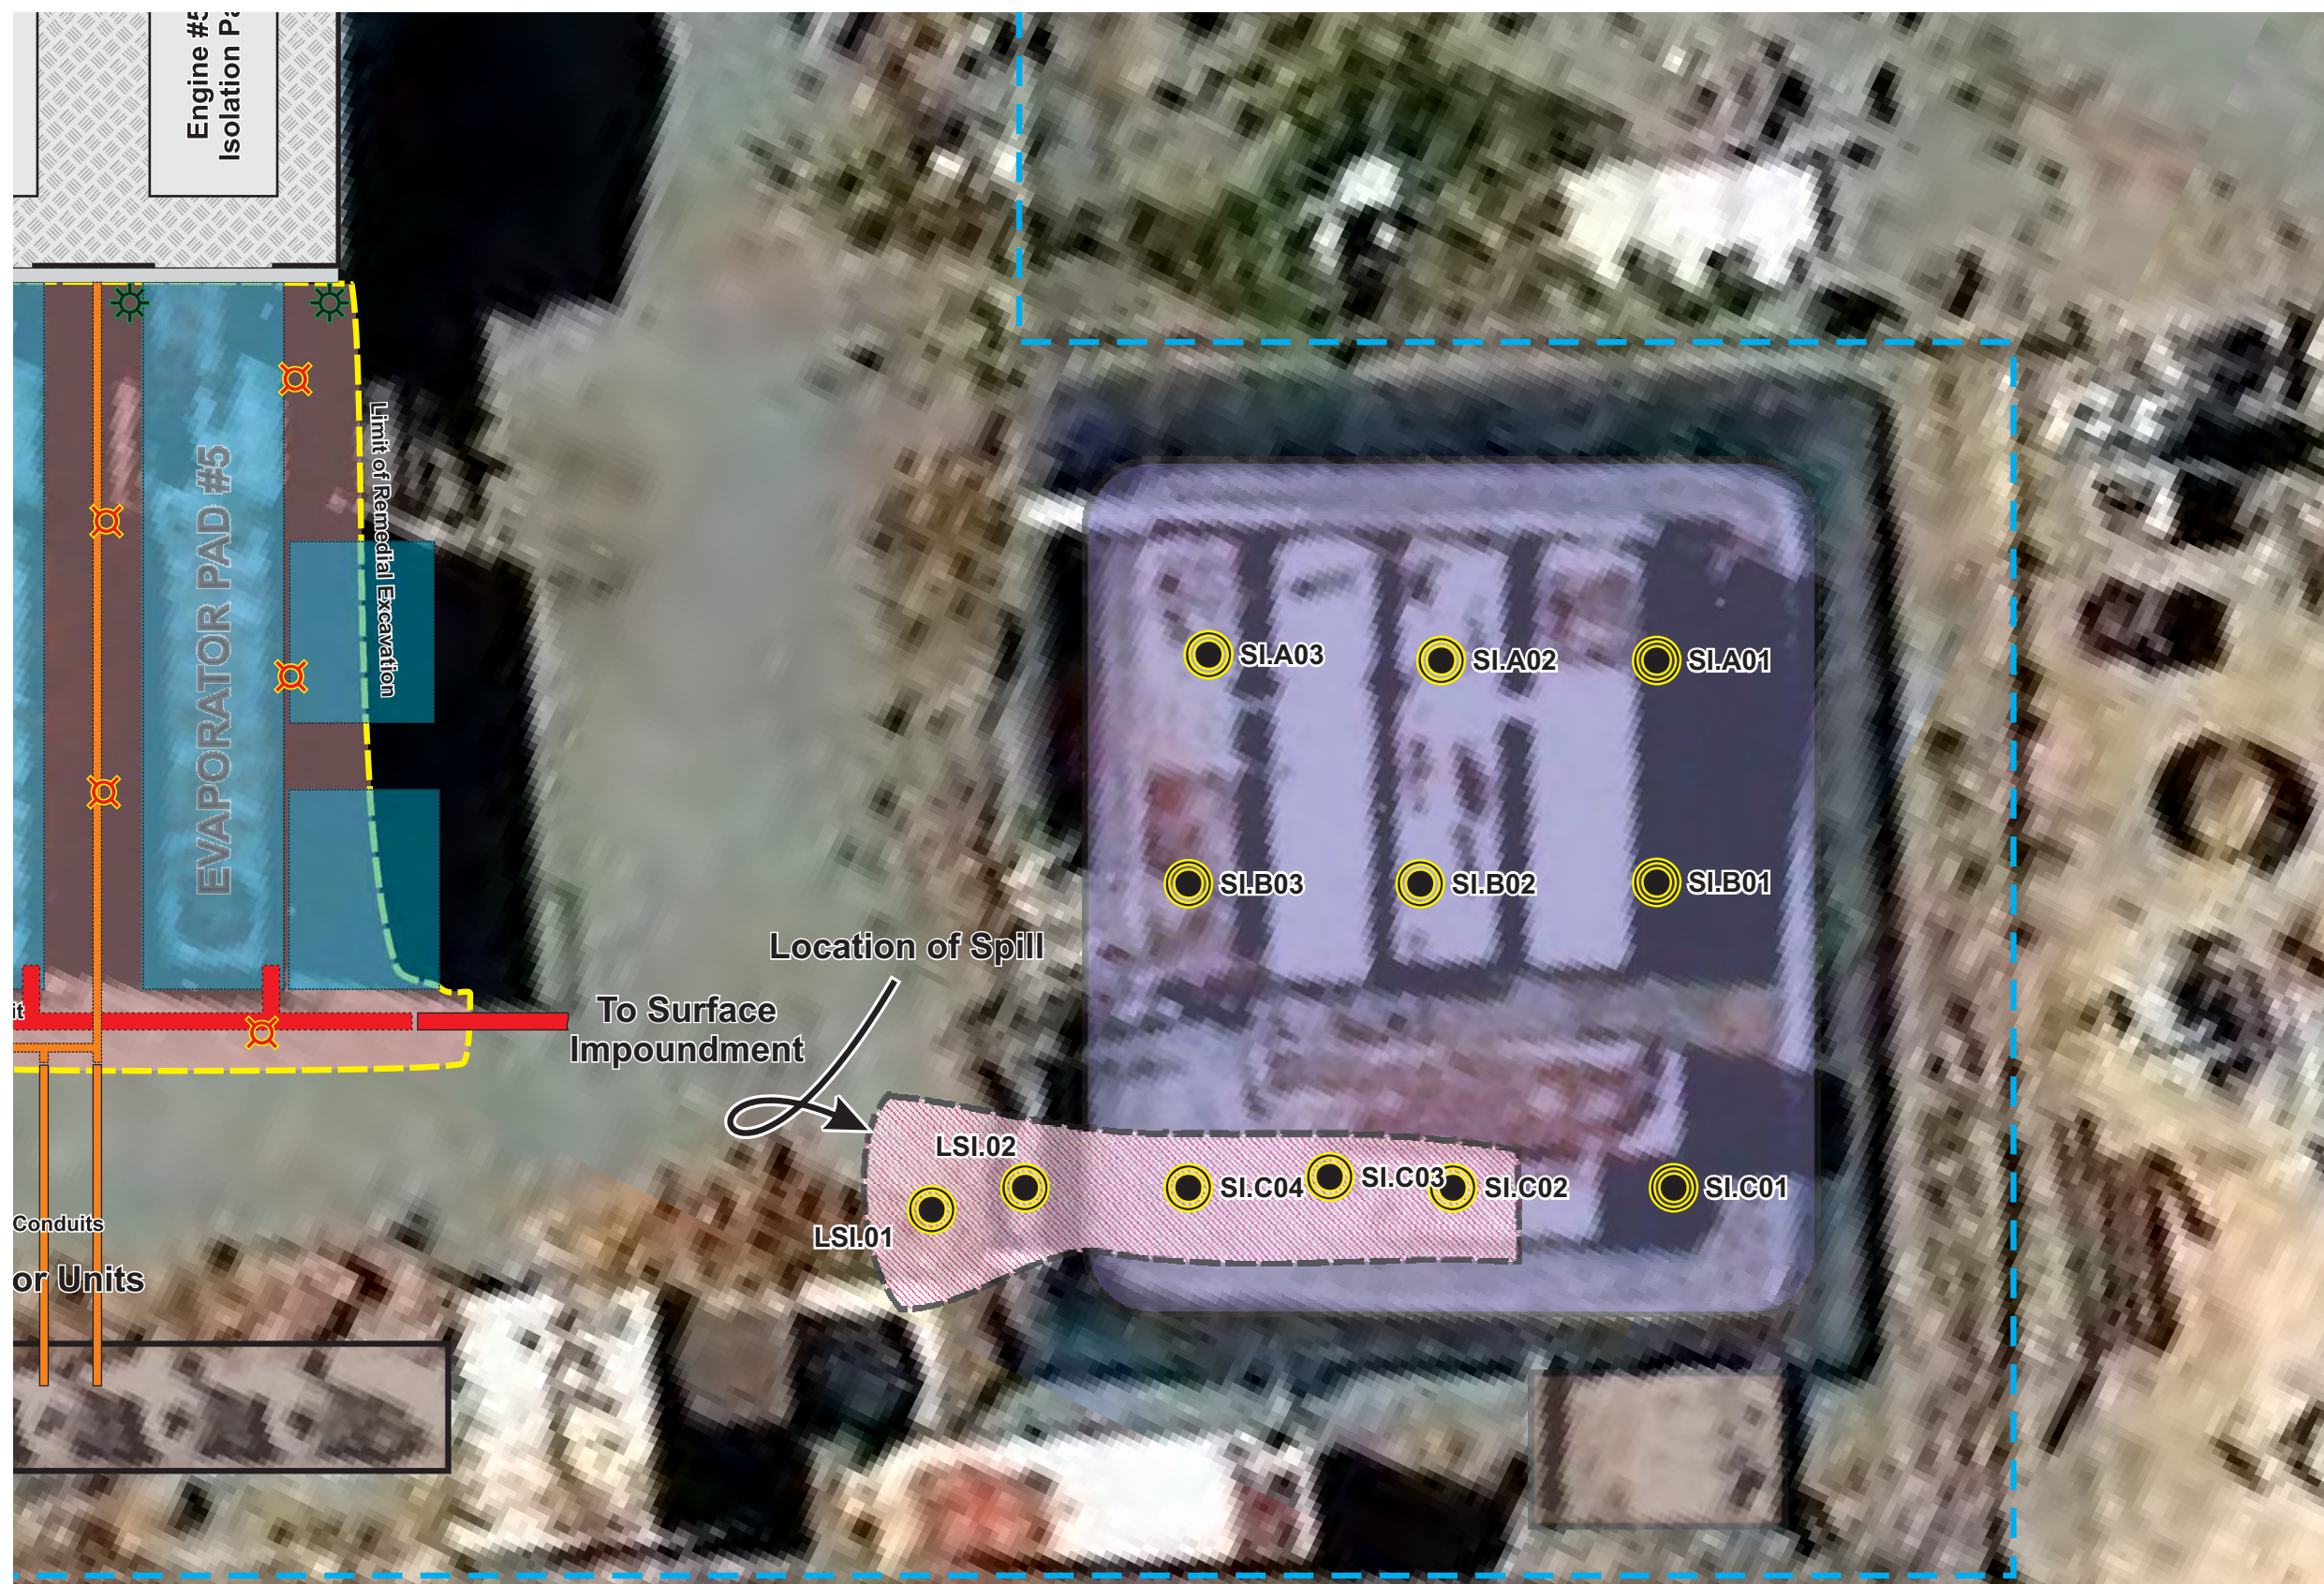
FIGURE 2
SITE MAP DEPICTING
SURFACE IMPOUNDMENT
SPILL SAMPLE LOCATIONS

- Surface Impoundment Sample Locations
SI.A01
- Remedial Excavation Soil Sample Locations

On December 12, 2012, two (2) soil samples were collected from locations adjacent to the former surface impoundment at the Site (Figure 2). The samples were collected by hand augering a hole to the sample depth (approximately 6 inches below grade, into native soil). Then a clean stainless-steel tube was driven 6 inches into the soil with an impact sampler to retain a discrete sample at each sample location. Once each sample was collected, each sleeve was sealed with tight-fitting plastic caps. The soil samples were collected, labeled, and transported under appropriate chain-of-custody. Soil samples collected for chemical characterization were transported to MAI for chemical analysis.

On August 8, 2013, soil samples were collected from ten (10) locations within the former surface impoundment at the Site (Figure 2). The samples were collected by hand augering a hole to the sample depth (approximately 6 inches below grade, into native soil). Then a clean stainless-steel tube was driven 6 inches into the soil with an impact sampler to retain a discrete sample at each sample location. Once each sample was collected, each sleeve was sealed with tight-fitting plastic caps. The soil samples were collected, labeled, and transported under appropriate chain-of-custody. Soil samples collected for chemical characterization were transported to MAI for chemical analysis.

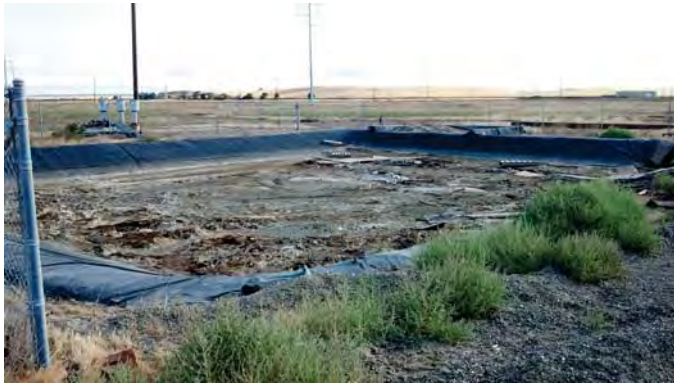
Photograph 1: Surface Impoundment Prior to Remedial Excavation Activities (View to the northeast).

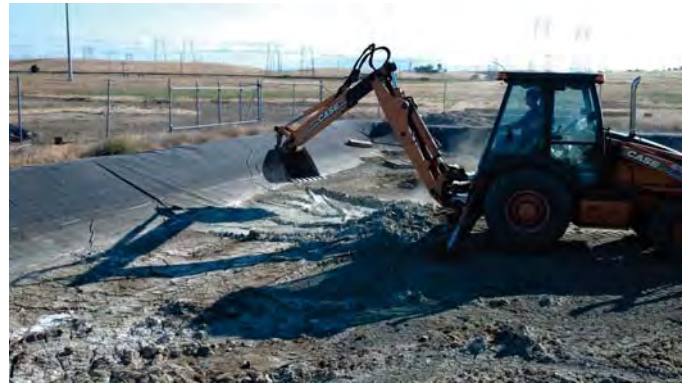
Photograph 2: Removal of Dry Sludge Above Primary Liner (View to the northeast).

From August 7 and 8, 2013, Vaca Valley Excavation and Trucking, Inc. of Vacaville, California completed the excavation and off-haul of general debris, dry sludge, and excavated soil under manifest to an appropriate disposal facility (Figure 3). A total of approximately xx yd³ of general debris, dry sludge, soil were transported under Non-Hazardous Special Waste & Asbestos Manifest to Republic Services Vasco Road Landfill in Livermore, California. Copies of the waste manifests are presented in Appendix A. During remedial excavation activities, in place soils at the base of the excavation were field screened, for odor, unusual staining, and a headspace analysis was conducted using a PID to detect the presence of VOC's. Soil excavation continued until screening evidence indicated that PHC impacted soil had been removed from the base of the excavation.

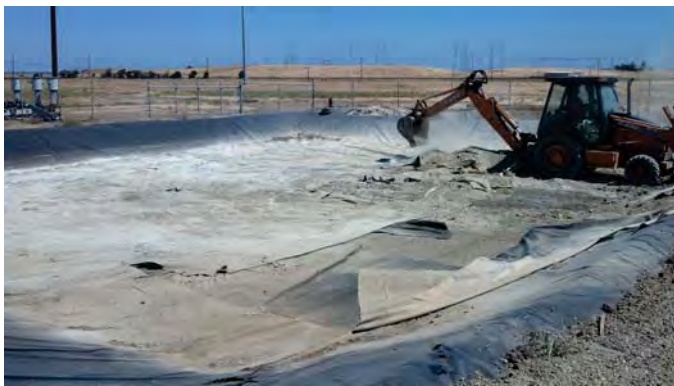
Photograph 3: Removal of Dry Sludge Above Primary Liner (View to the northeast).

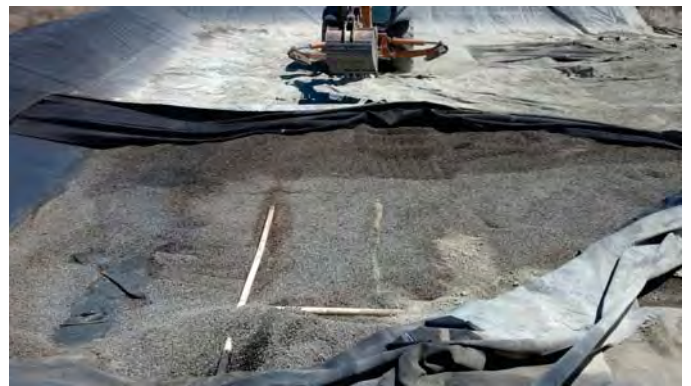
Photograph 4: Exposing Lysimeter in Base Gravel Separating Primary and Secondary Liners (View to the North).

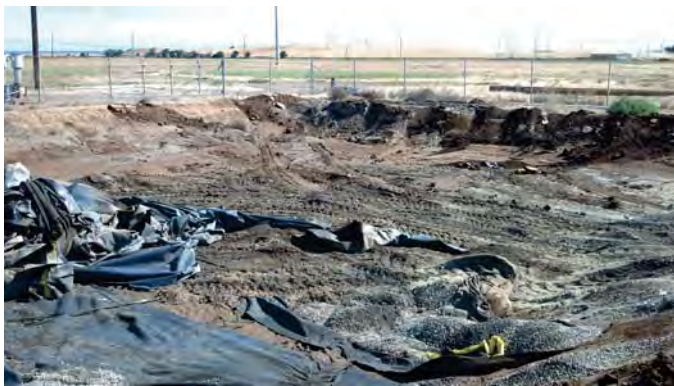
Photograph 5: Exposed Native Soil Beneath Secondary Liner (View to the northeast).

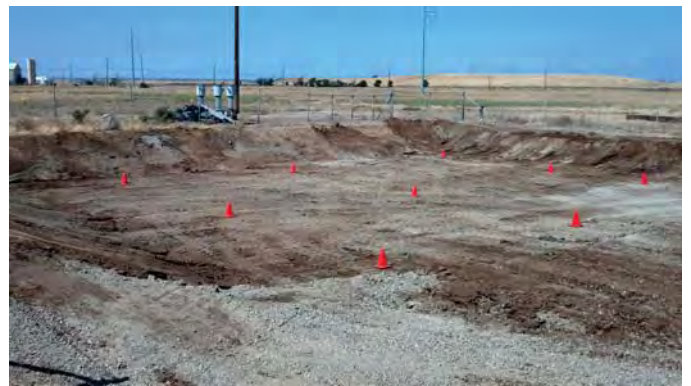
Photograph 6: Surface Impoundment Removed Exposing Native Soil. Cones Denote Soil Sample Locations (View to the northeast).

Arsenic was the only analyte found to exceed the commercial/industrial land use ESL for water that is considered or is a potential source of drinking water, but did not exceed published regional background concentrations. No PHC's were identified in the clearance soil samples analyzed. Based on a review of the analytical results and the Site conditions encountered, no further impacts in the area of the surface impoundment exist. Therefore, No Further Action appears warranted.
