From:	Nowell, Keith, Env. Health
Sent:	Friday, October 02, 2015 2:54 PM
То:	'Forrest Cook'
Cc:	Mona Hsieh; Roe, Dilan, Env. Health
Subject:	RE: Updated Site Map and Photos - 3101 35th Ave., Oakland, CA

From: Forrest Cook [mailto:cook.forrest@gmail.com]
Sent: Friday, October 02, 2015 1:52 PM
To: Nowell, Keith, Env. Health <Keith.Nowell@acgov.org>
Subject: Updated Site Map and Photos - 3101 35th Ave., Oakland, CA

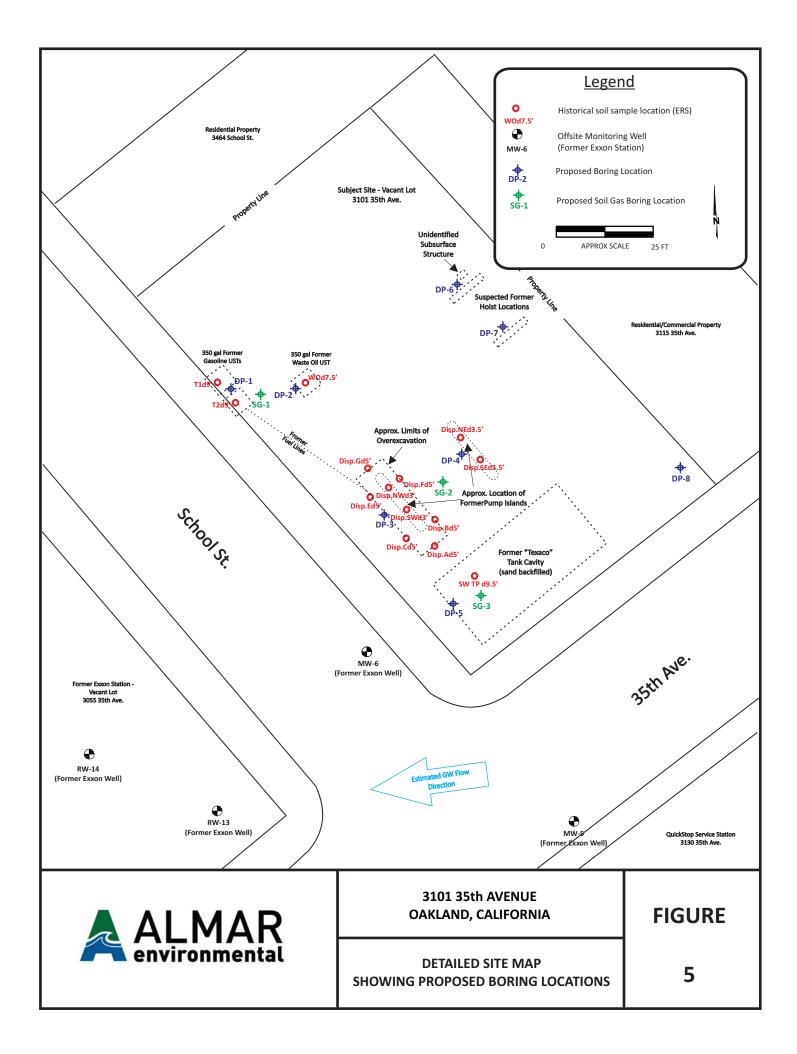
Regardless, at your request, we will do three additional borings in the locations shown on the new revised map (attached Figure 5).

Good work. Your revised boring locations are acceptable to ACEH. Please proceed with the investigation.

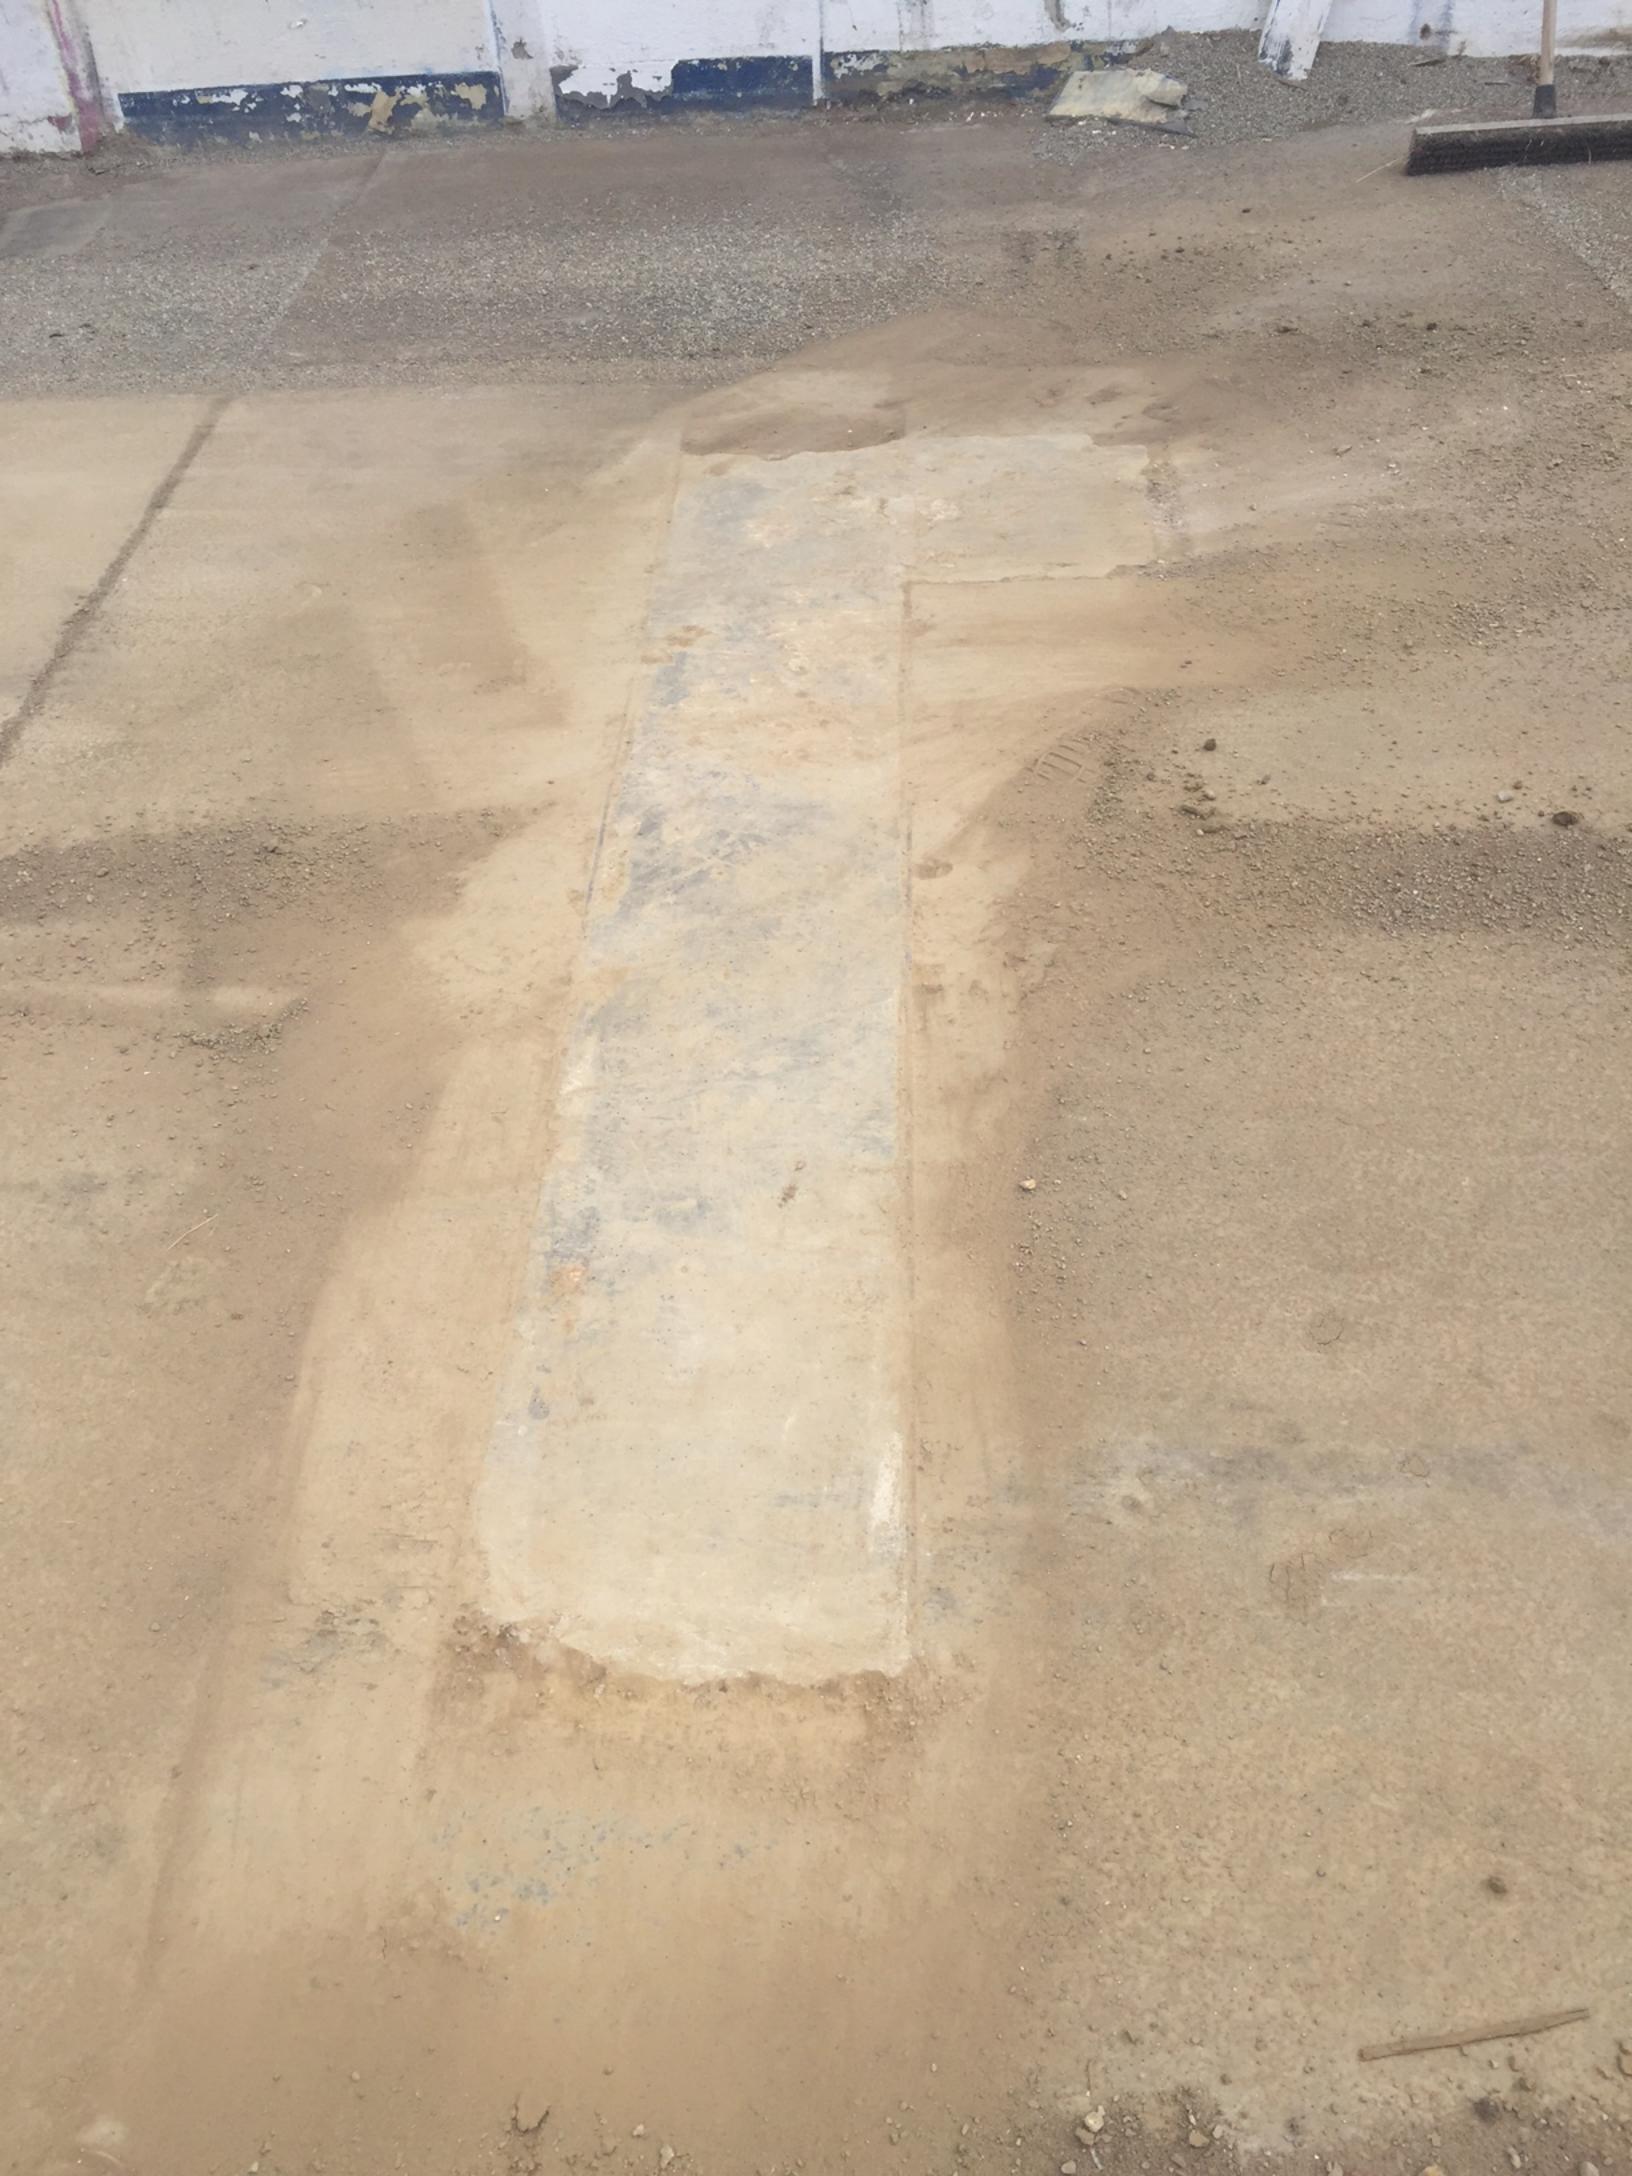
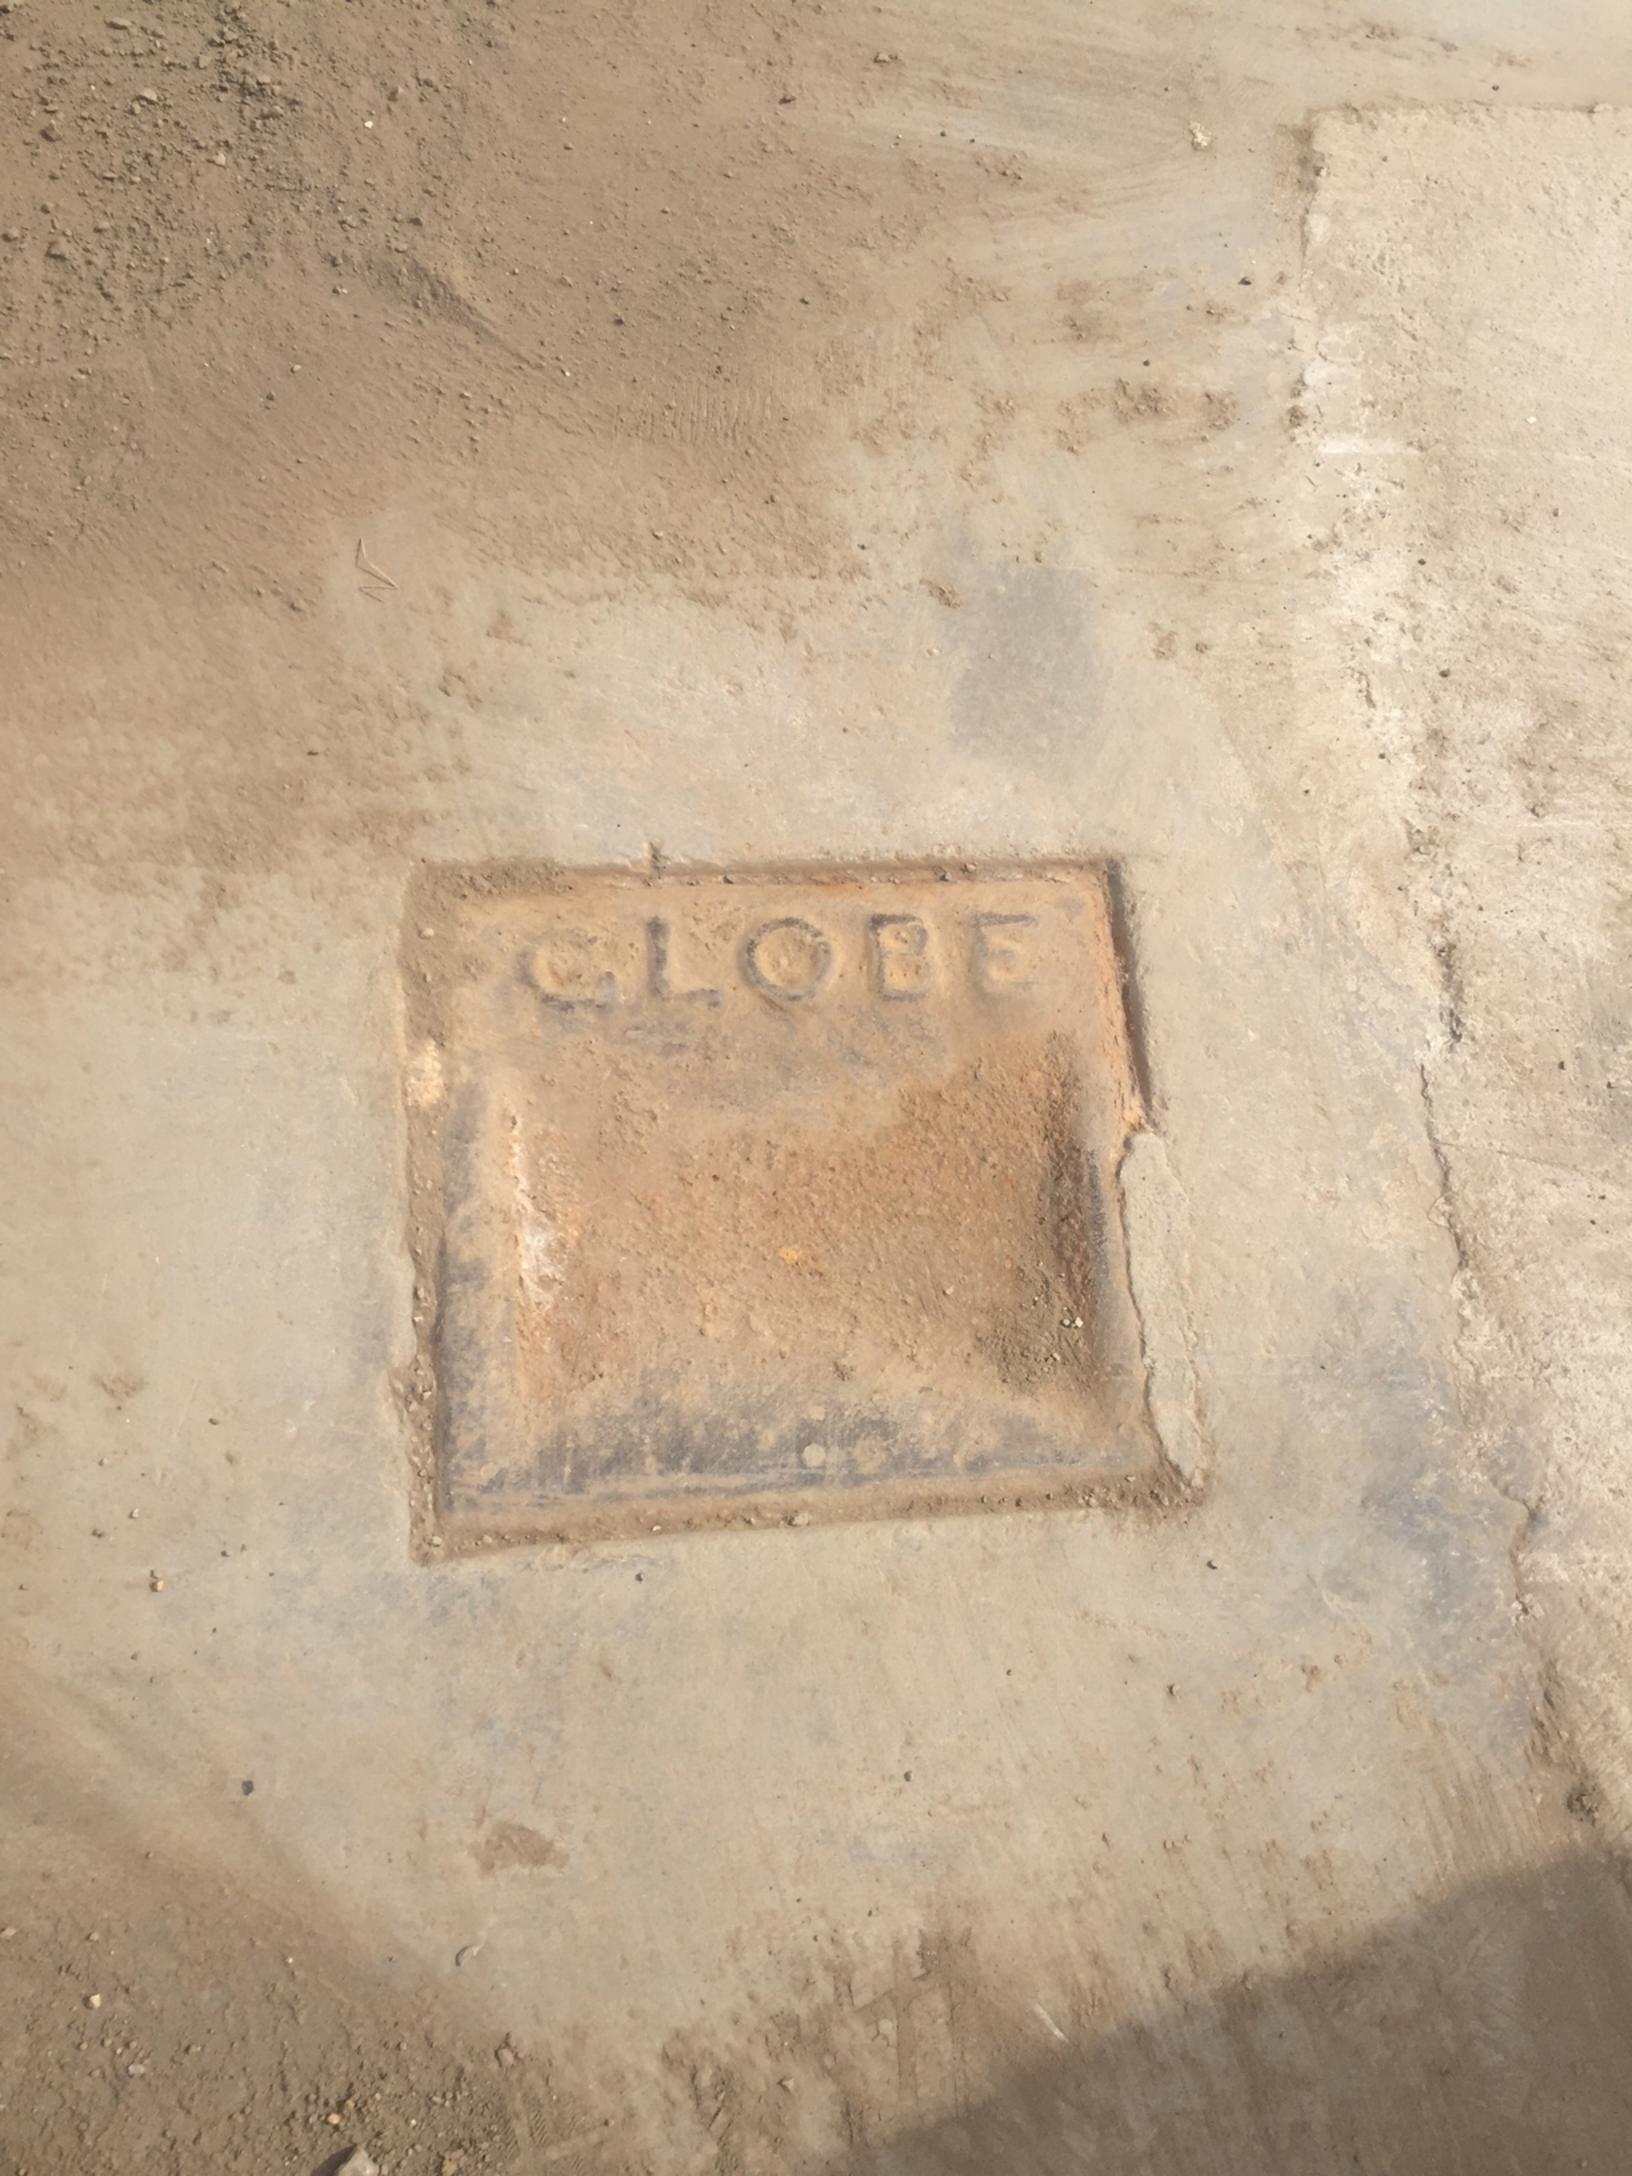
I have no idea what the plate is covering. It may be a sump drain cover. Our resident service station expert is out of the office today. I'll try to get his feedback. Please pop the cover on you next site visit for a look-see and get back to me. Due to its location adjacent to one of the potential hoists, boring location DP-6 should also evaluate the any impacts associated with the covered structure.

We were finally able to clear of the area of this site where a suspected hoist was formerly identified as part of a Phase I. I found two patches of concrete which, almost with out a doubt, were former hoists. Additionally, adjacent to one of the hoists was a strange metal lid of some sort set into the concrete (see the attached pictures). I honestly, have never encountered something like this before. Any ideas what it might be?
