THIRD QUARTER GROUND WATER MONITORING

Harcros Pigments Plant 4650 Shellmound Street Emeryville, California

December 2, 1993

ROUX ASSOCIATES, INC.

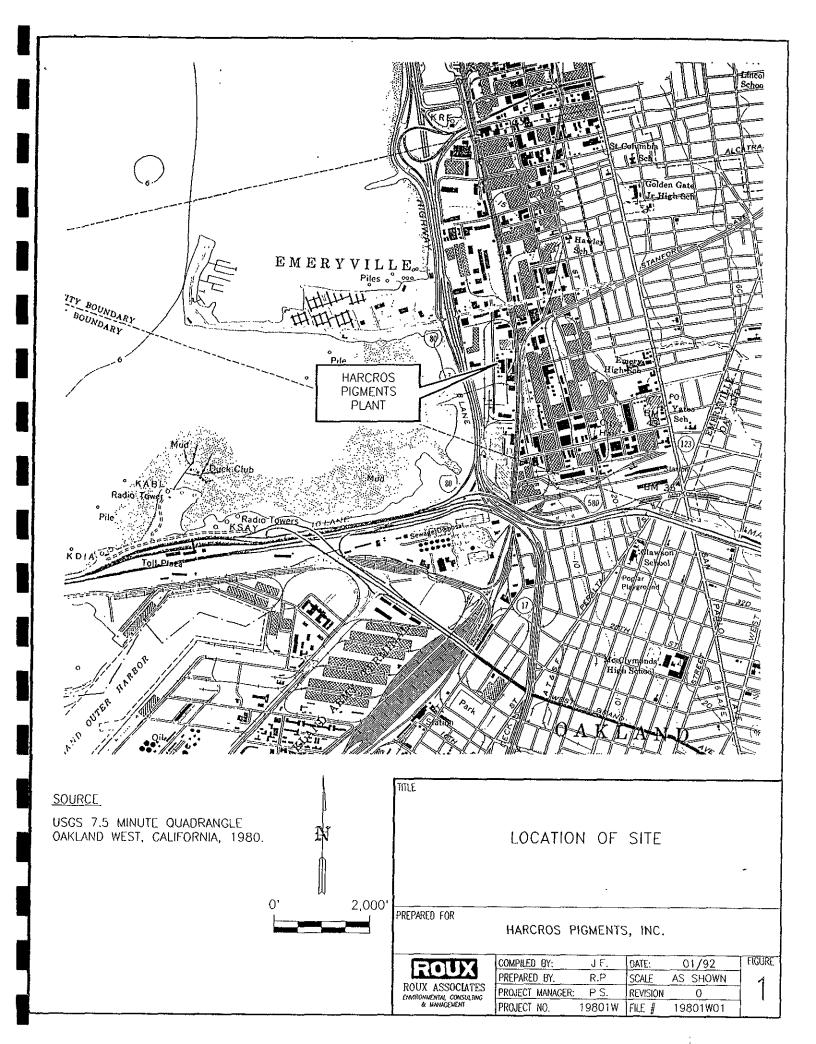
The Harcros Pigments Plant, formerly Pfizer Pigments Plant, is located in a predominantly industrial area of Emeryville, California (Figure 1). The plant produces iron oxide pigments and has been in operation since 1925. The Site is on the east side of the San Francisco Bay at an elevation of about seven feet above mean sea level. The current bay shoreline is about 1,000 ft. west of the Harcros Pigments property (USGS, 1980). A 1936 aerial photograph of the plant shows the former shoreline located along the eastern edge of present day Shellmound Street. The Site is underlain by sandy clay and clay of low estimated permeability (Roux, 1990a). The regional direction of ground water flow is to the west, towards the San Francisco Bay (Roux, 1990a).

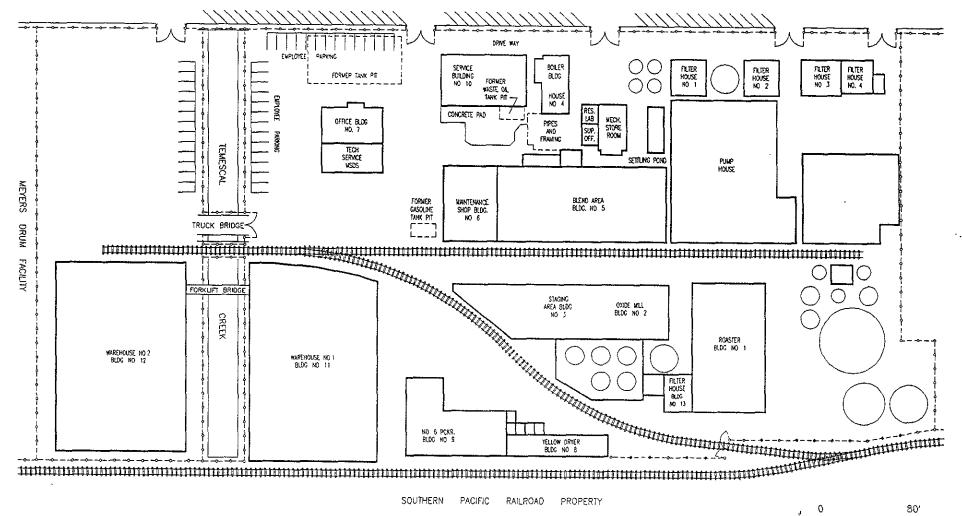
COMPILED BY P.S. PREPARED BY: D.D.	PREPARED FOR: HARCROS PIGMENTS INC. EMERYVILLE, CA	FIGURE
		TITLE:	_
S	DATE. 07/92 SCALE: AS SHOWN	SITE PLAN	2
	PROJECT NO 19801W01 FILE NAME 19801W2B	EMERYVILLE, CA	
	13001470

SOURCE NOTE:
MAP MODIFIED FROM EMERYVILLE PAINT MAP
PROVIDED BY HARCROS PIGMENTS, INC.

This report presents the findings of the September 1993 quarterly ground water monitoring activities conducted by Roux Associates, Inc., (Roux) at the Harcros Pigments Plant located at 4650 Shellmound Street in Emeryville, California (Site, Figures 1 and 2).

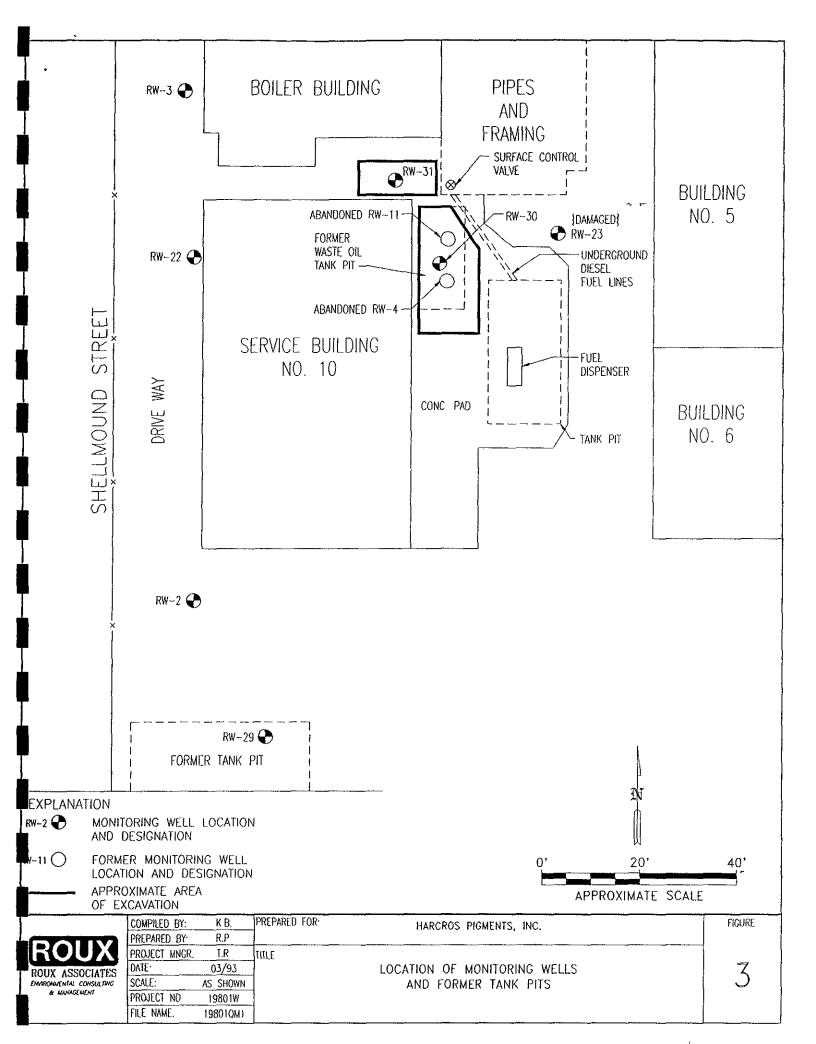
In January 1990, Roux staff discovered diesel fuel floating on top of the water column in monitoring wells RW-4 and RW-11 (Roux, 1990b). Wells RW-4 and RW-11 were located near the northeastern corner of Service Building No. 10 (Figure 3). The monitoring wells were within a former waste oil tank pit and were adjacent to the two recently installed USTs and their associated pipelines.
