**SITE INVESTIGATION WORKPLAN**

**Greyhound Lines Terminal  
2103 San Pablo Avenue  
Oakland, California 94608**

**Green Star Project No. 10-1379**

**July 16, 2010**

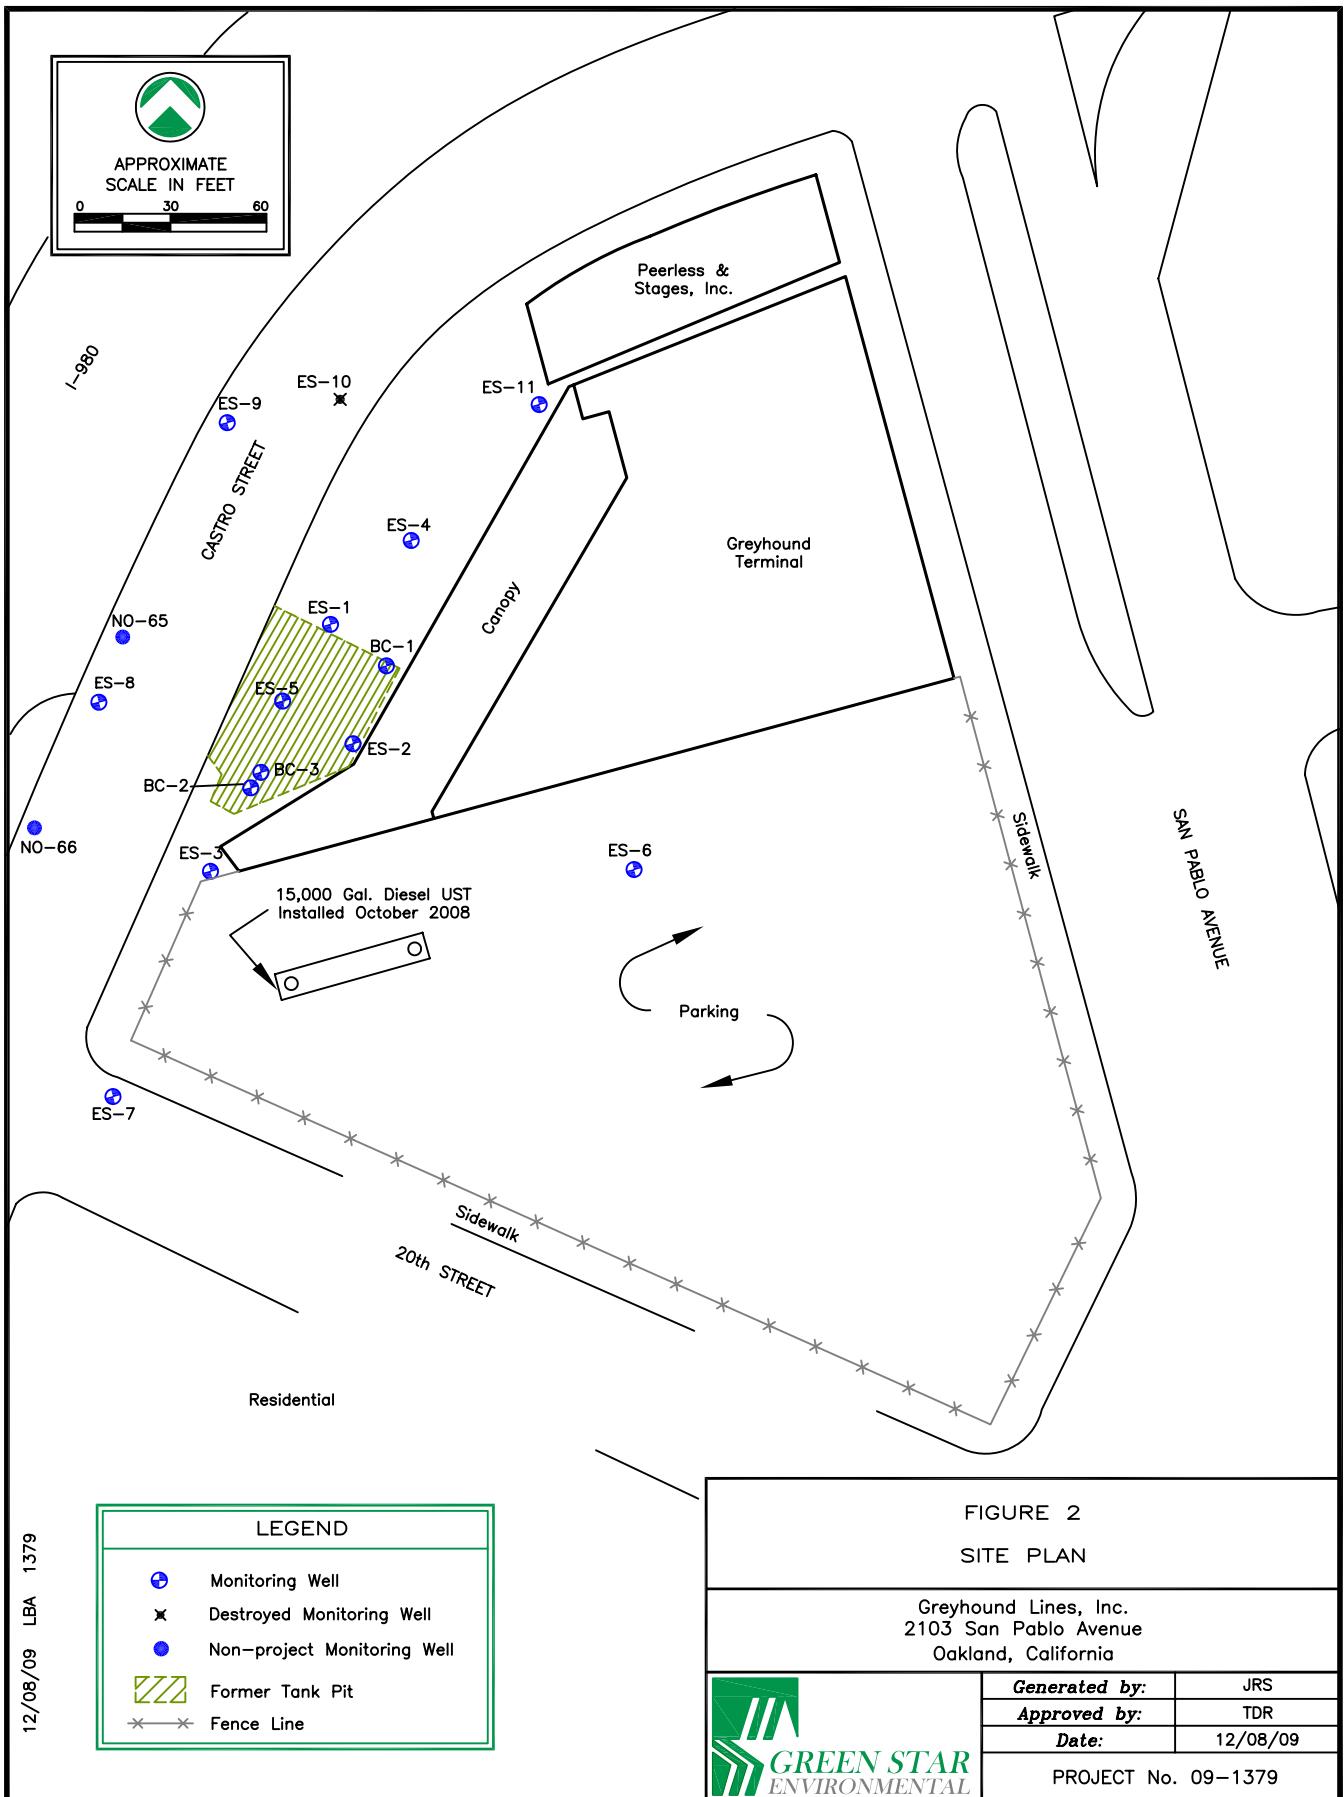
The Site is a Greyhound Lines, Inc. bus terminal located at 2103 San Pablo Avenue, Oakland, California. The facility is bordered to the north and west by Castro Street, to the south by 20th Street, to the southeast by Martin Luther King Way and to the east by San Pablo Avenue. A USGS Topographic/Site Location Map is attached as Figure 1. A Site Plan is attached as Figure 2.

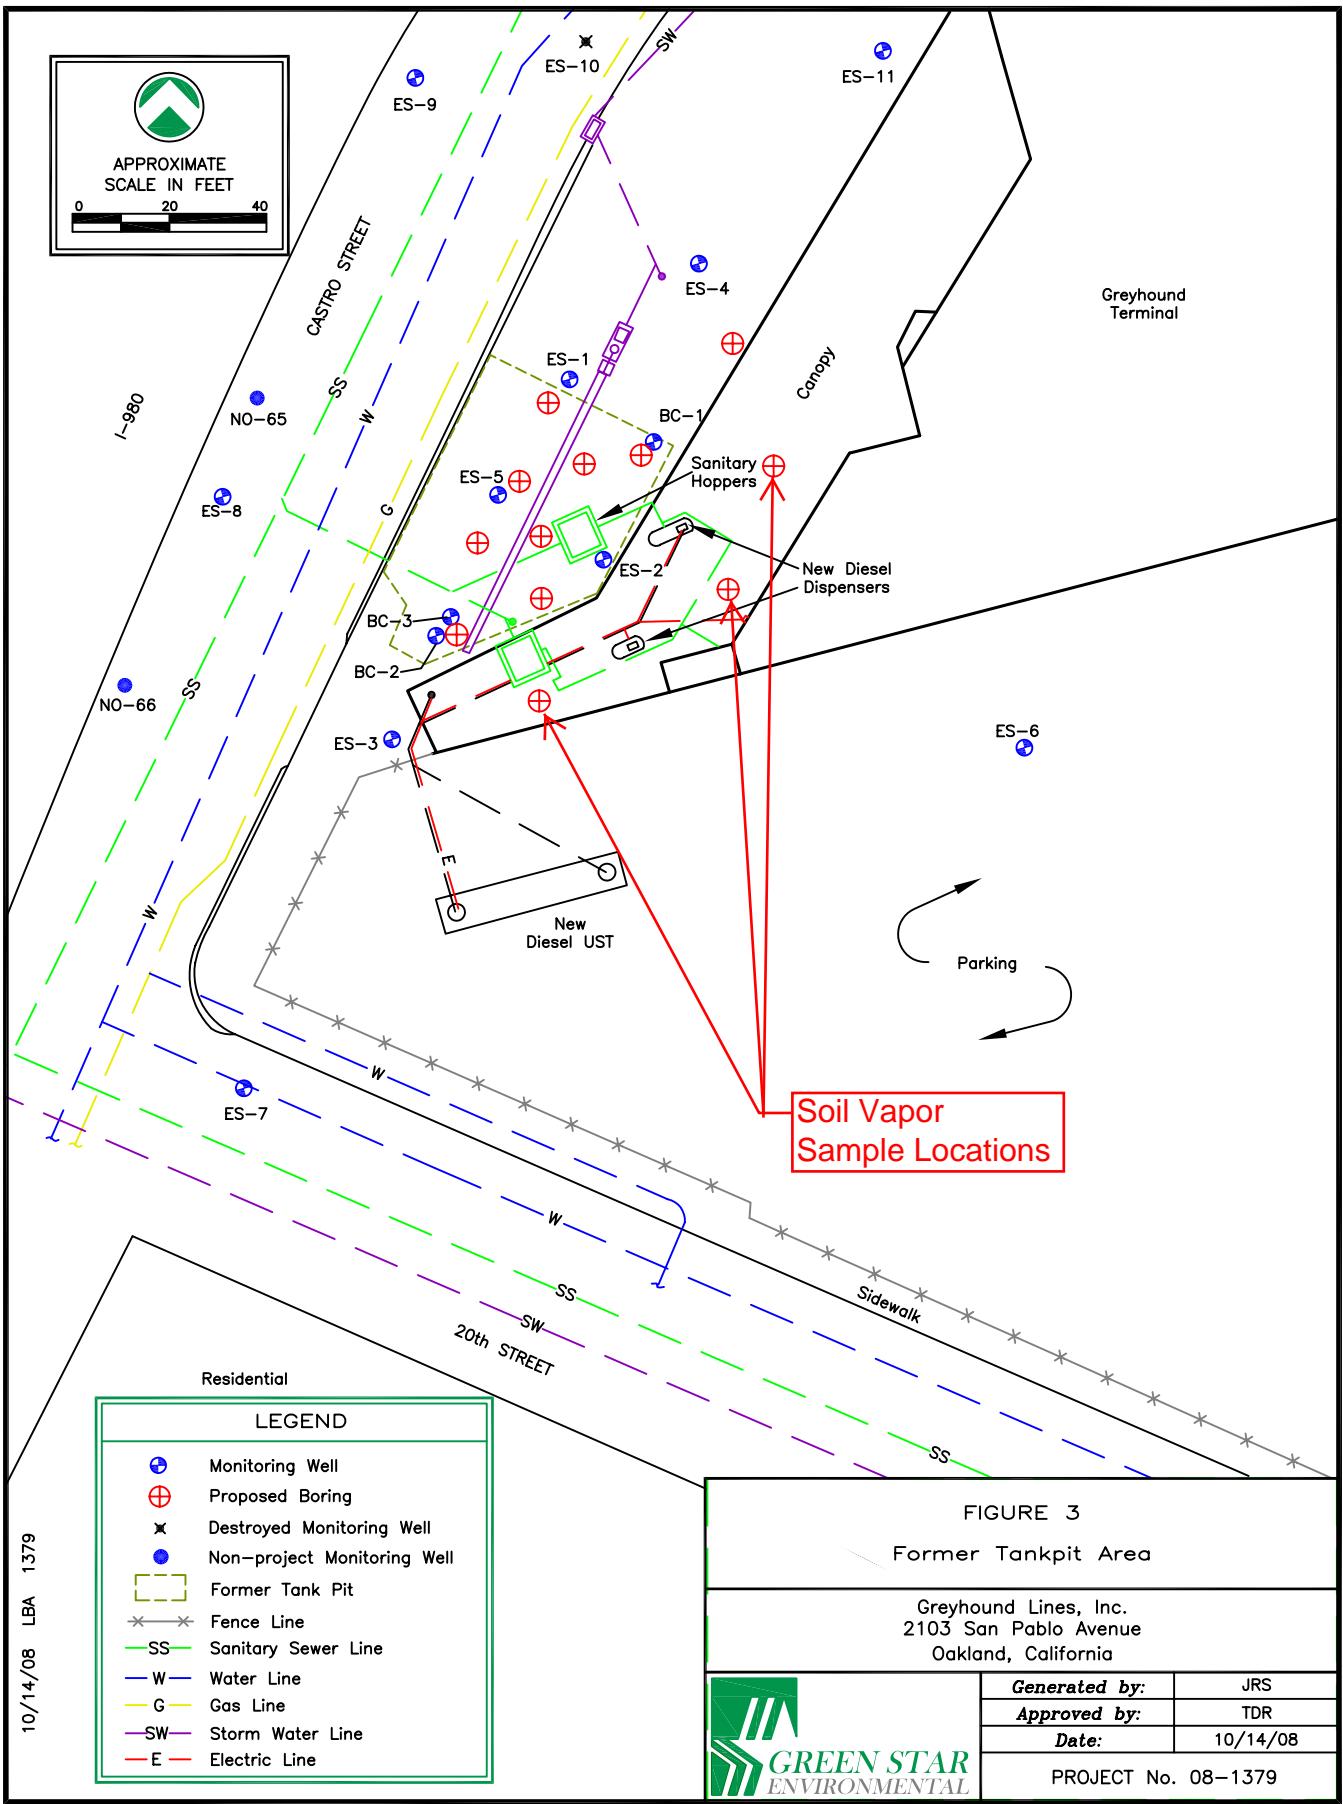
Approximately 12 soil borings will be installed in the vicinity of the former tankpit. Due to recent construction in the area, the exact locations of the borings will be determined in the field and may be limited by subsurface utilities, over head structures, or other improvements. Furthermore, Green Star has been unable to determine the exact locations of the former USTs due to mapping inconsistencies by previous consultants. Therefore, the borings will be advanced within the former tankpit and to the south, southeast and east of the tankpit to evaluate residual, unsaturated soil impacts. Borings will be advanced to a maximum depth of 20 feet below ground surface (bgs) or to the water table using a direct-push drill rig by a California-licensed well driller. Figure 3 illustrates the locations of the proposed borings.

advanced to approximately five feet bgs in order to collect the soil vapor samples (Figure 3). Vapor samples are proposed to be collected from each boring at approximately five feet bgs near the Terminal building to determine if vapors have migrated to shallow soils near the indoor space of the building. The samples will be collected using laboratory-provided Summa Canisters and will be analyzed for benzene, toluene, ethylbenzene, and xylenes (BTEX), naphthalene, total petroleum hydrocarbons gasoline range (TPH-g) and miscellaneous fuel oxygenates according to EPA Toxic Organic Method TO-15 or equivalent.
