Subject: December 2010 Report  
Subsurface Environmental Activities  
Western Forge and Flange, Albany

### **Executive Summary**

### Description of the Data Gaps identified by the county and the results of the implementation of the data gaps workplan.

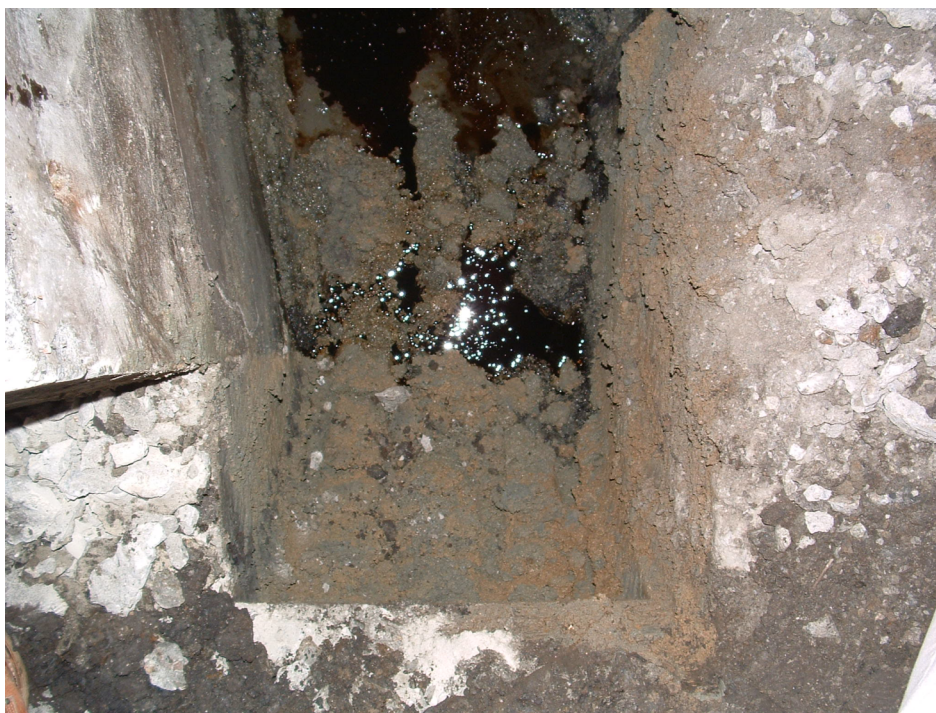
WFF decided to excavate the sediments surrounding three of the boreholes to a depth of three feet, and a depth of five feet at B-106. These depths were chosen to include excavation of the sediments that were above the ESLs. In January 2009, during the excavation around B-106, adjacent to the former ring roller, the excavator encountered a gravel zone surrounding the foundation and hydraulic fluid began to flow from the gravel into the excavation and accumulate on the surface of the water table that had been reached during the excavation. (Fig. 1)

Fig. 1. Photograph of the hydraulic fluid released from the gravel zone around the ring roller foundation.

Following the discovery of the hydraulic fluid seeps, the excavation was continued around two thirds of the ring roller foundation in search of the source of the fluid. The excavated sediments and gravel containing the hydraulic fluid were containerized and shipped for disposal as a

hazardous waste. The following day, ground water had risen in the excavation to 3.5 feet below the ground surface. Excavation continued to the edge of the ring roller foundation where the gravel backfill was discovered. Water and oil were pumped out of the excavation into fifty-five gallon drums for disposal.

Over the next few months, hydraulic fluid was skimmed from the surface of the standing water in the excavation using oil absorbent pads. CDMS also deployed a 5000-gallon vacuum truck that drew oil and water from the surface of the water contained in the excavation.

At the conclusion of these removal efforts a thin film of hydraulic fluid remained on the surface of the water. At that point, a chemical oxidation treatment was deployed using the product RegenOx. Reaction products were observed for several weeks, followed by the return of a thin layer of hydraulic fluid. Following the months of physical and chemical removal techniques, the bulk of the hydraulic fluid has been removed leaving only a small amount in the vicinity of the ring roller foundation.

The geology of the site is protective of the environment. The dense low permeability clays that underlie the site will contain any remaining hydraulic fluids in place. The efficacy of these clays as a containment feature was obvious when the interface between the clay and the backfill gravel was breached allowing the hydraulic fluid product to flow out of the gravels. (Fig. 1).

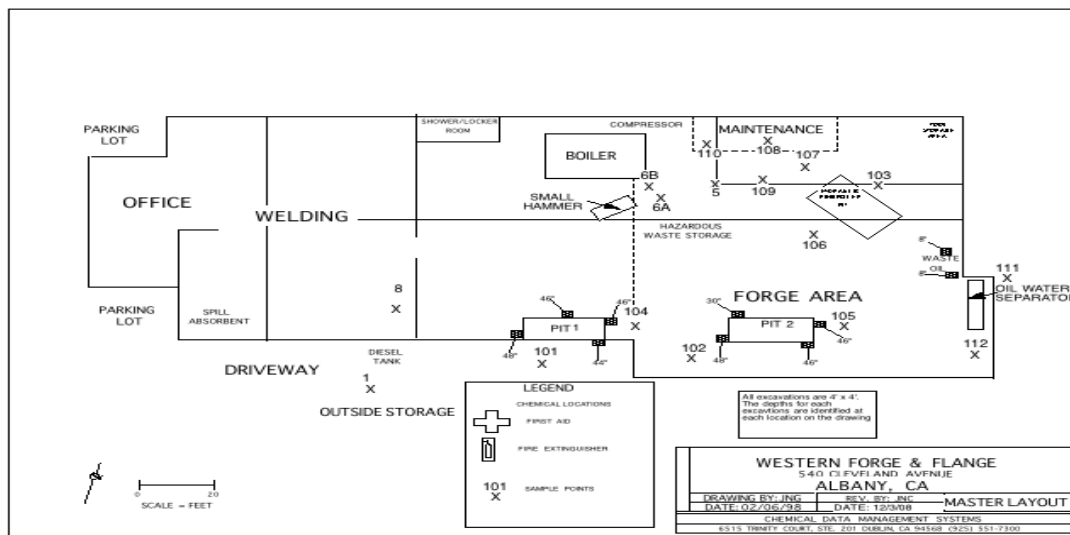
Fig. 2: Sample Location Map

The data from the subsurface investigations conducted at the site, including the data from the implementation of the data gap workplan in October 2010 is included as Appendix C. The sample locations are shown on Fig. 2.

The data indicate that the remaining hydraulic fluid released at the site of the former ring roller is confined to the immediate vicinity of the ring roller foundation. When SB-107 was drilled in December 2008, the sediment sample collected at 4.5 feet contained 15,000 mg/kg of hydraulic fluid. This boring location was used as the center of a four-foot by four-foot by three-foot deep excavation designed to remove any sediment contaminated with hydraulic fluid. When the walls and bottom of the SB-107 excavation, labeled SWEX, were sampled in October 2010, the data showed that the north wall nearest the ring roller foundation (eight feet away from the south wall of the ring roller foundation) remained above the ESL for total petroleum hydrocarbons (residual fuels) (TPH). The samples taken from the West and the South walls of this excavation decreased with distance away from the ring roller foundation. The East wall, furthest from the foundation was below the ESL, as was the sample from the bottom of the excavation. Samples from SB-108, SB-109, SB-110, and the excavations SCEX, and SEEX, all further away from the ring roller, were all below the ESL for TPH, or were not detected (ND) TPH.

Sediments from SB-106, located immediately to the east of the ring roller foundation, were ND at 2.5' and 7.5' bgs, but the sample from 4.5' contained 2800 mg/kg TPH. It was this sample that prompted the excavation at this location and uncovered the hydraulic fluid release.

Sediments from SB-108, located 22' southeast of the south edge of the ring roller foundation had a detection of 150 mg/kg TPH at 4.5' and was ND for TPH at 1.5' and 7.5' bgs. Ground water at this location was ND for TPH.

SB-103, located 9' west of the south edge of the ring roller foundation, had a detection of 110 mg/kg TPH at 7.5' bgs and was ND for TPH at 3.5', 11.5', and 15.5' bgs. Ground water sampled at this location was ND for TPH.

Sediments from SB-109, located 14' east of the south edge of the ring roller foundation, were ND for TPH at all depths. Ground water sampled at this location was also ND for TPH.

Sediments from SB-105, 33' north of the north corner of the ring roller foundation were ND for TPH at all depths. Ground water sampled at this location was also ND for TPH.

Sediments from B1001, located 44' southwest of the ring roller foundation in the down-gradient direction, had detections of TPH at 6'', 6', and 10' bgs. Samples taken from 2', 4', and 8' were ND for TPH. Ground water sampled at this location contained 1.7 mg/L TPH.

Sediments from B1002, located 27' southwest of the ring roller foundation in the down-gradient direction, had detections of TPH at 6'' bgs and ND for TPH at 2', 4' and 10' bgs. Ground water sampled at this location contained 2.0 mg/L TPH.
