GSA / BMD Incident Report

Equipment #: 11060-EG-0001

Location: (floor, room #, etc.) OES GENERATOR 1

Problem: LEAKING DIESEL FUEL

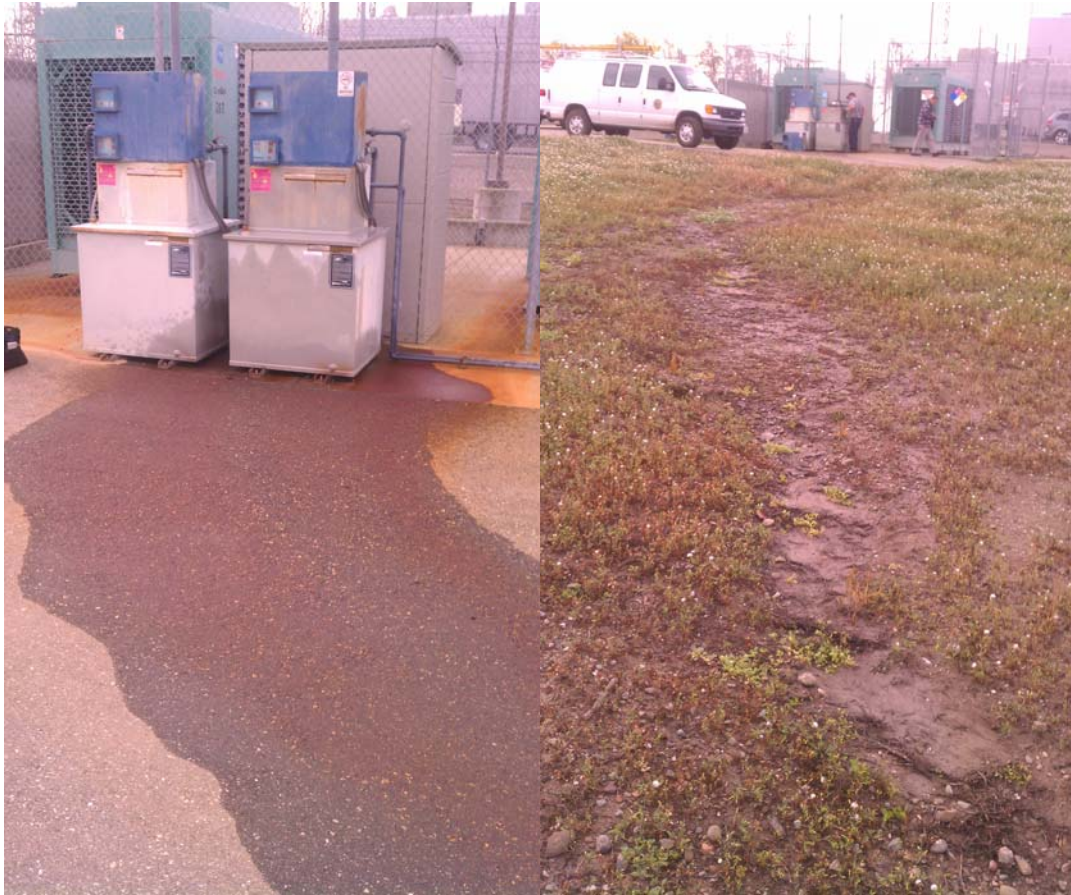
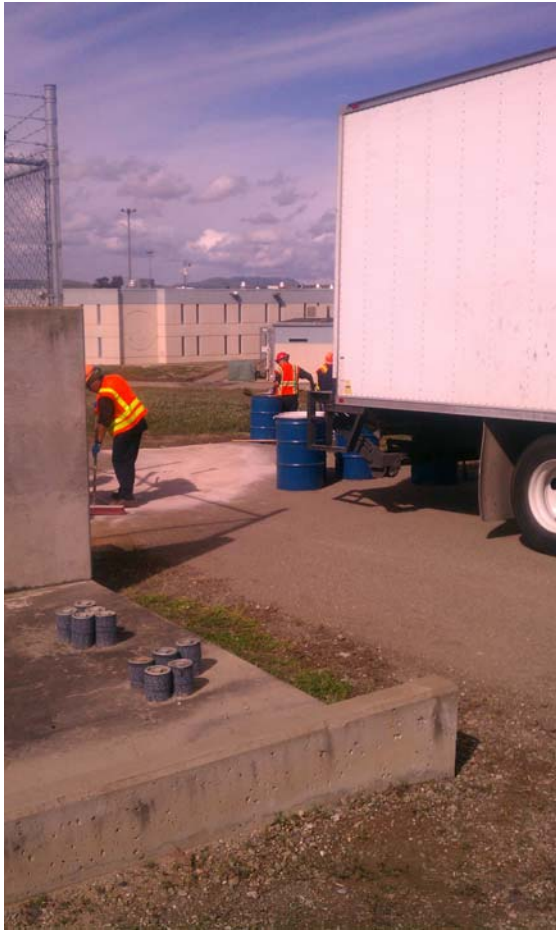
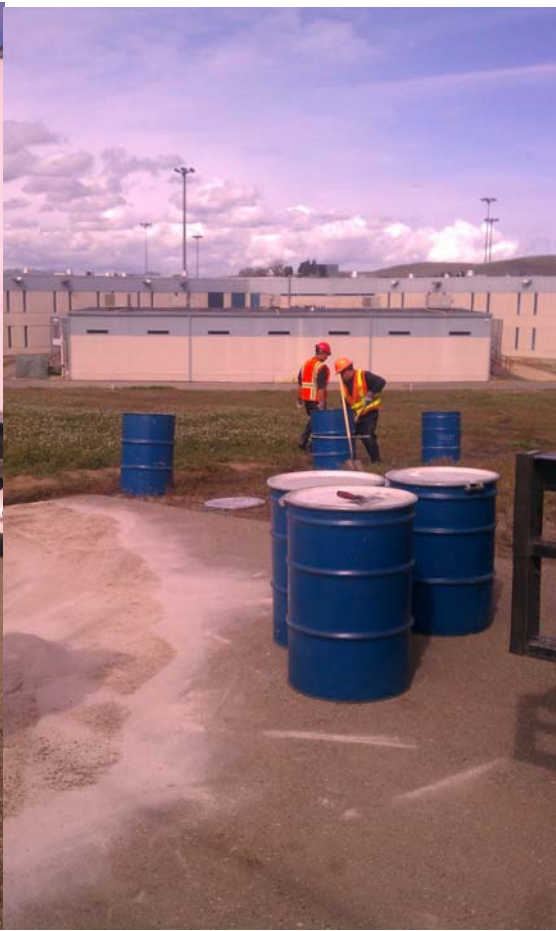
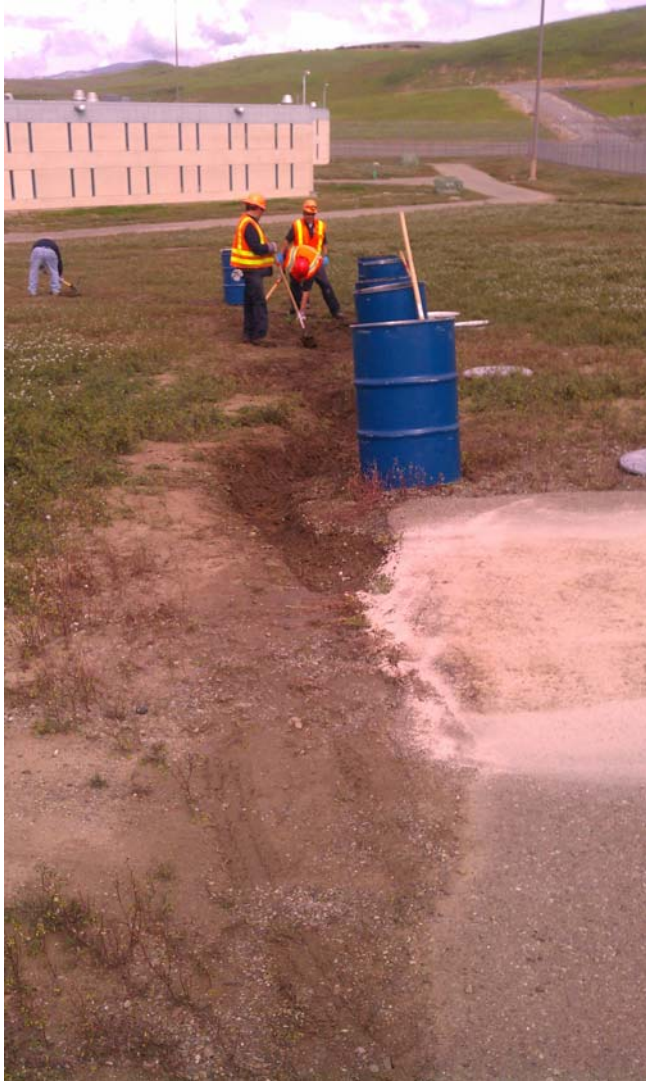
Resolution: Found pump seal is leaking. Found pump is in reverse. Pump motor may have been wired wrong. The underground tank might have a check valve preventing a back flow of fuel and when the day tank went low, the pump motor energized. Pressure may have built in the fuel line causing the pump seal to blow out. Diesel fuel leaked approximately 20 gallons downhill about 80 feet.

Assessment: The generators are tested biweekly and the area is inspected daily. The day tank might have been full when the pump motor was replaced in Nov 2012 and may not have had to refill since then. The diesel level in the underground storage tank is still at 2100 gallons. This indicates that when the pump float contacts closed, the pump pumped the diesel out of the day tank and because it could not go into the underground tank (pressure was created by the pump), it resulted in the pump seal being blown out of the pump.

Additional Info: Electrician Mike Henning rewired the pump for proper rotation. BMD will replace pump on day tank. Rosa Construction will give a bid to construct a 6" curb around the generators and day tanks in concrete to prevent a spillage from reaching the soil. Cummins West will give an estimate to replace the float assembly on day tank 1.
