Limited Subsurface Investigation (LSI)

Commercial Property 964 A Street, Hayward, CA 94541 Alameda County

7371

September 6, 2017

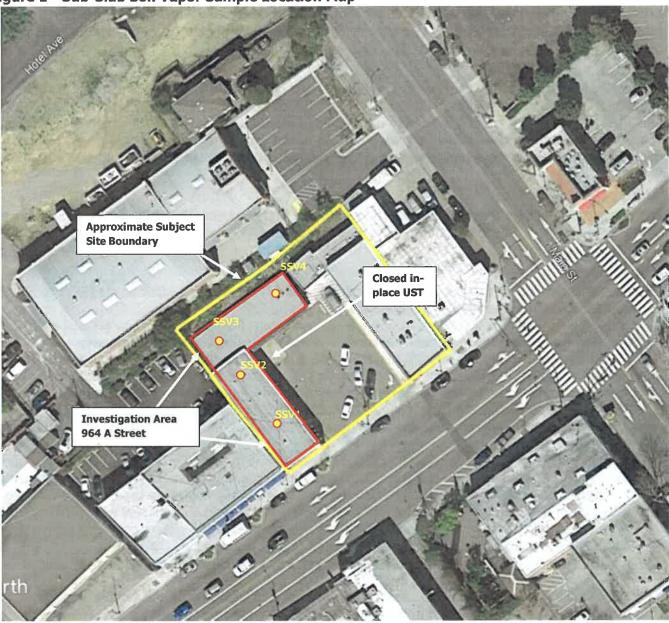
Figure 1 - Sub-Slab Soil Vapor Sample Location Map

- eScreenLogic mobilized to the subject site to install four (4) sub-slab soil vapor points (SSV1 to SSV4) beneath existing asphalt parking lot (Figure 1).

- SSV1 was located along the sanitary sewer alignment and representative of the display area in the
 western portion of the investigation area. SSV2 was located near the abandoned in-place UST as well
 as sewer alignment. SSV3 was located near a floor drain which ties into the main sewer alignment.
 SSV4 was located within the back room of the northeast portion of the investigation area. This back
 room had evidence of a wall vent, three ceiling vents, an 220volt ACV outlet and significant oil staining
 on the wall.

Note: Not to scale.

An additional subsurface investigation to determine the vertical and lateral extent of PCE in the vicinity of SSV4 is recommended. Additionally, groundwater in the vicinity of SSV4 is recommended to be sampled and analyzed to determine if an impact to shallow groundwater has occurred. The additional information will be incorporated into a site conceptual model which will allow a better understanding of the extent of the impact and if site remediation is necessary.
