**ENGINEERING-SCIENCE, INC.**

Re: Greyhound Terminal  
Location 8934  
Oakland, California

**WELL LOCATION MAP**

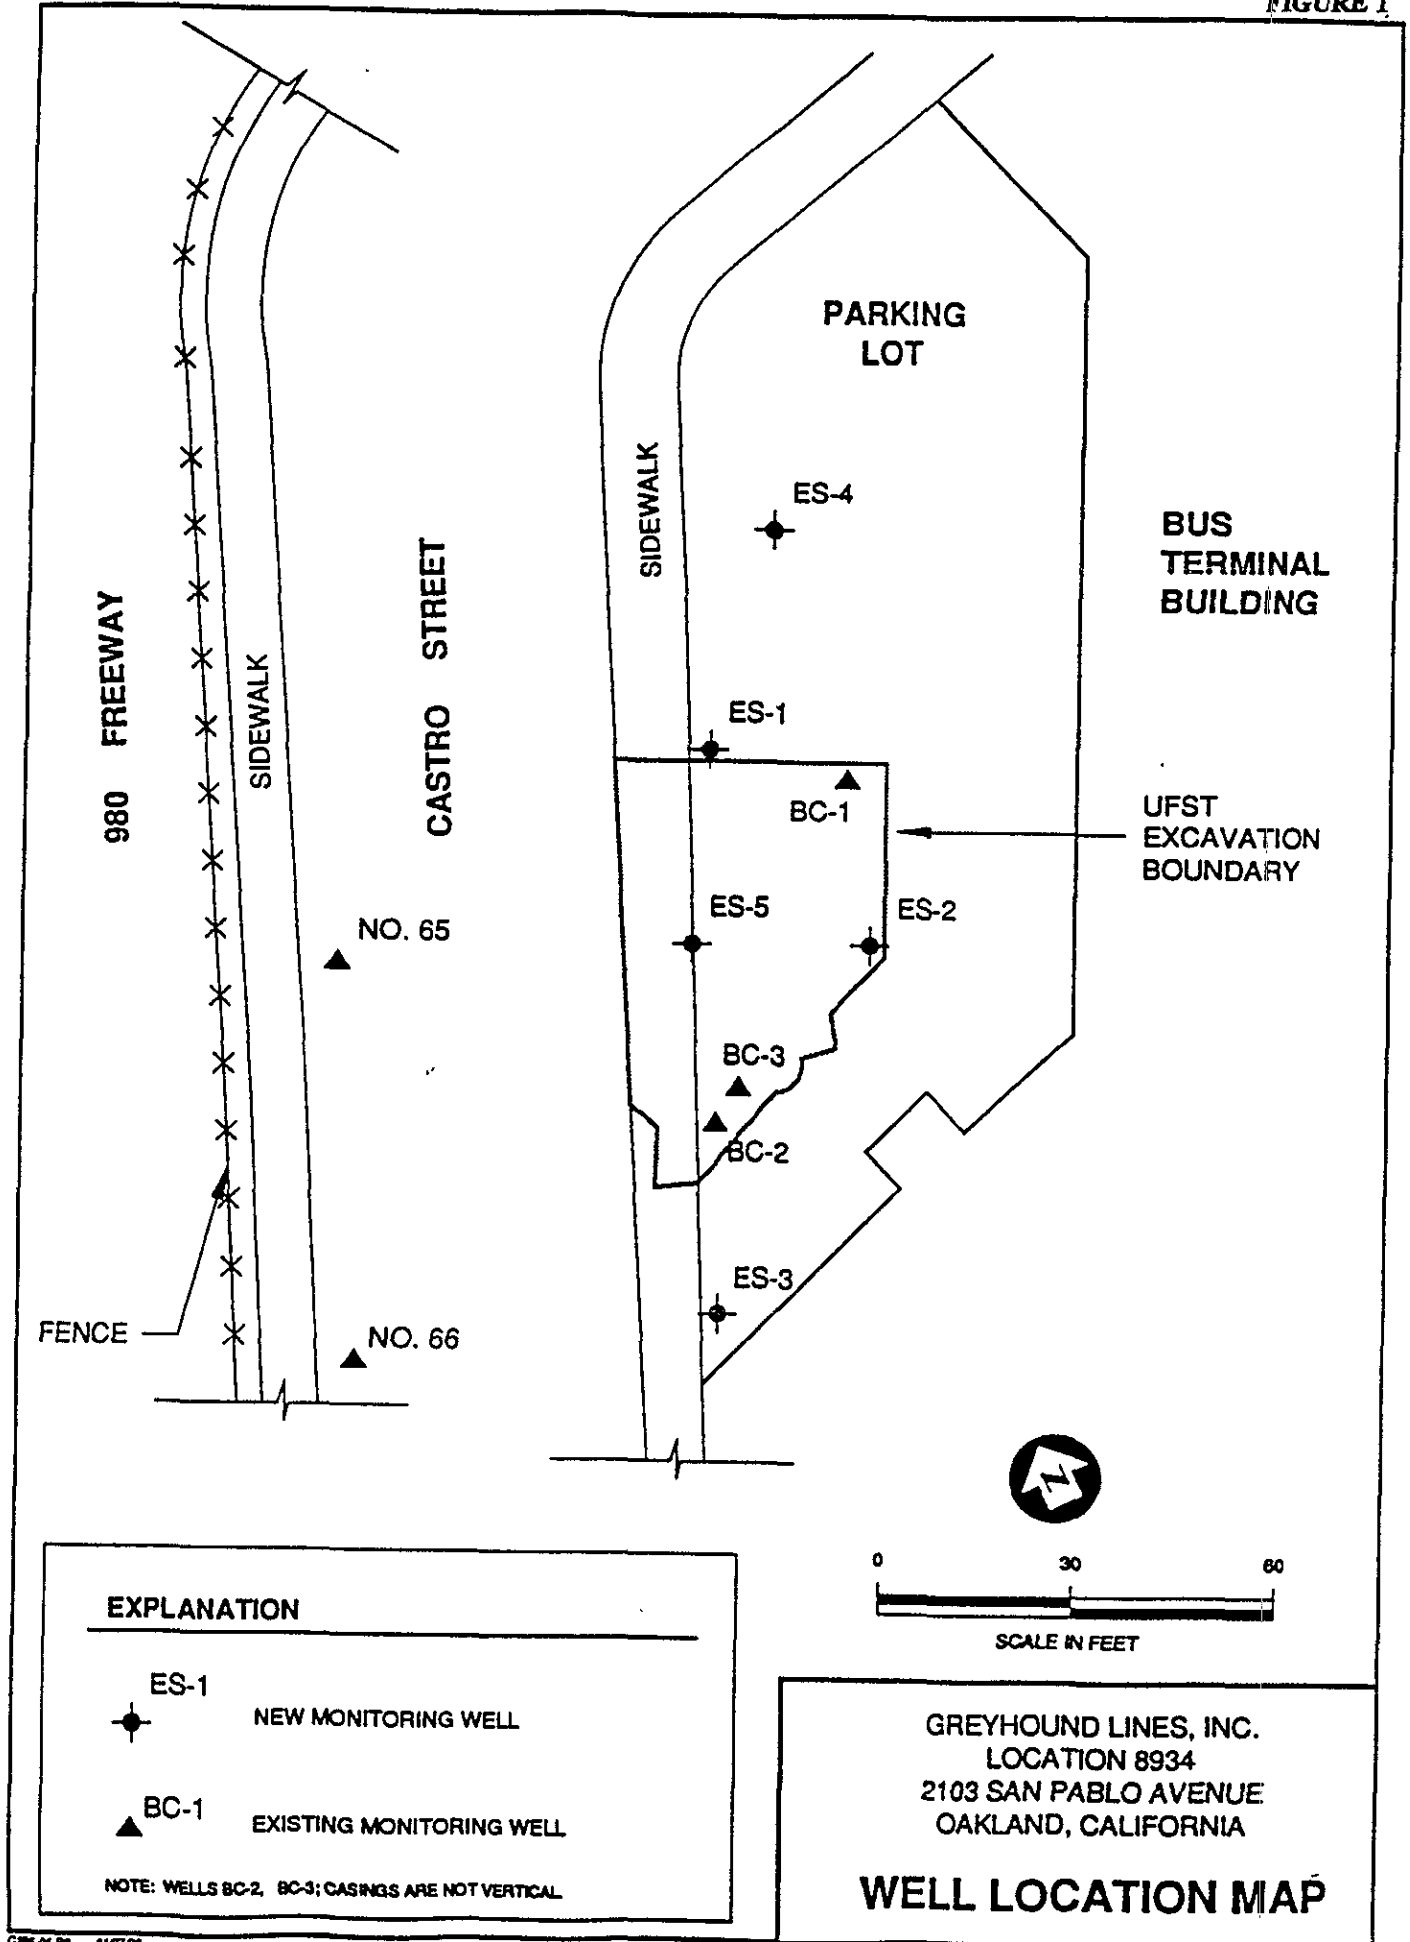
FIGURE 1

On behalf of Greyhound Lines, Inc., Engineering-Science, Inc. (ES) is pleased to submit the May 1993 monthly monitoring report for the Greyhound Terminal in Oakland. Attached you will find Table 1 which lists the measured water levels and free-product thicknesses from on-site wells monitored during our site visit. Figure 1 shows the locations of the monitoring wells.

NOTE: WELLS BC-2, BC-3; CASINGS ARE NOT VERTICAL
