Revised Groundwater Investigation Work Plan

5812 Hollis Street Emeryville, California

Fuel Leak Case Site RO0000201, Former Hydraulic Electro Service/Alder's Property

Subject: Revised Groundwater Investigation Work Plan

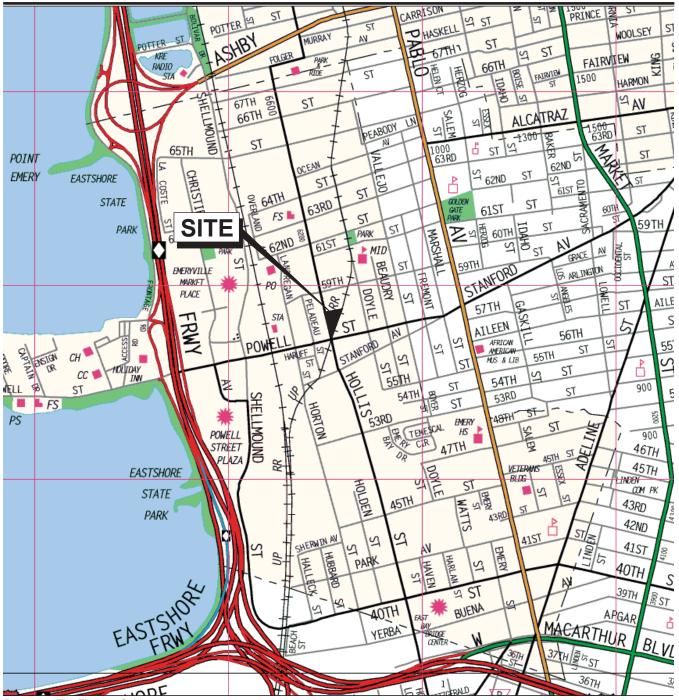
ALDERS PROPERTY 5812 HOLLIS STREET Emeryville, California		SIT	E LOCATIO	ON MAP	
Leong Environmental, Inc.	Date 9	9/23/08	Project No.	103.001	Figure 1

Base map: The Thomas Guide Alameda County 1999.

A Groundwater Investigation Work Plan was submitted to you on 2 September 2008 for the property located at 5812 Hollis Street, Emeryville, California (the "Site;" Figure 1) in accordance with your letter to Mrs. Wilma Alders dated 24 July 2008. Wareham Development purchased the property earlier this year and they have been working with the City of Emeryville regarding oversight of soil management and excavation dewatering for the proposed redevelopment activities at the property. Wareham Development met with Alameda County Environmental Health Services and the City of Emeryville on 6 November 2008 to provide information on these redevelopment activities and to discuss how to achieve Site closure from the County for the former underground storage tanks (USTs).
