**SECOND SEMIANNUAL 2011
GROUNDWATER MONITORING
AND ANNUAL SUMMARY REPORT**

**REDWOOD REGIONAL PARK
SERVICE YARD
OAKLAND, CALIFORNIA**

**EAST BAY REGIONAL PARK DISTRICT
OAKLAND, CALIFORNIA**

**STELLAR ENVIRONMENTAL SOLUTIONS, INC.
2198 SIXTH STREET
BERKELEY, CALIFORNIA 94710**

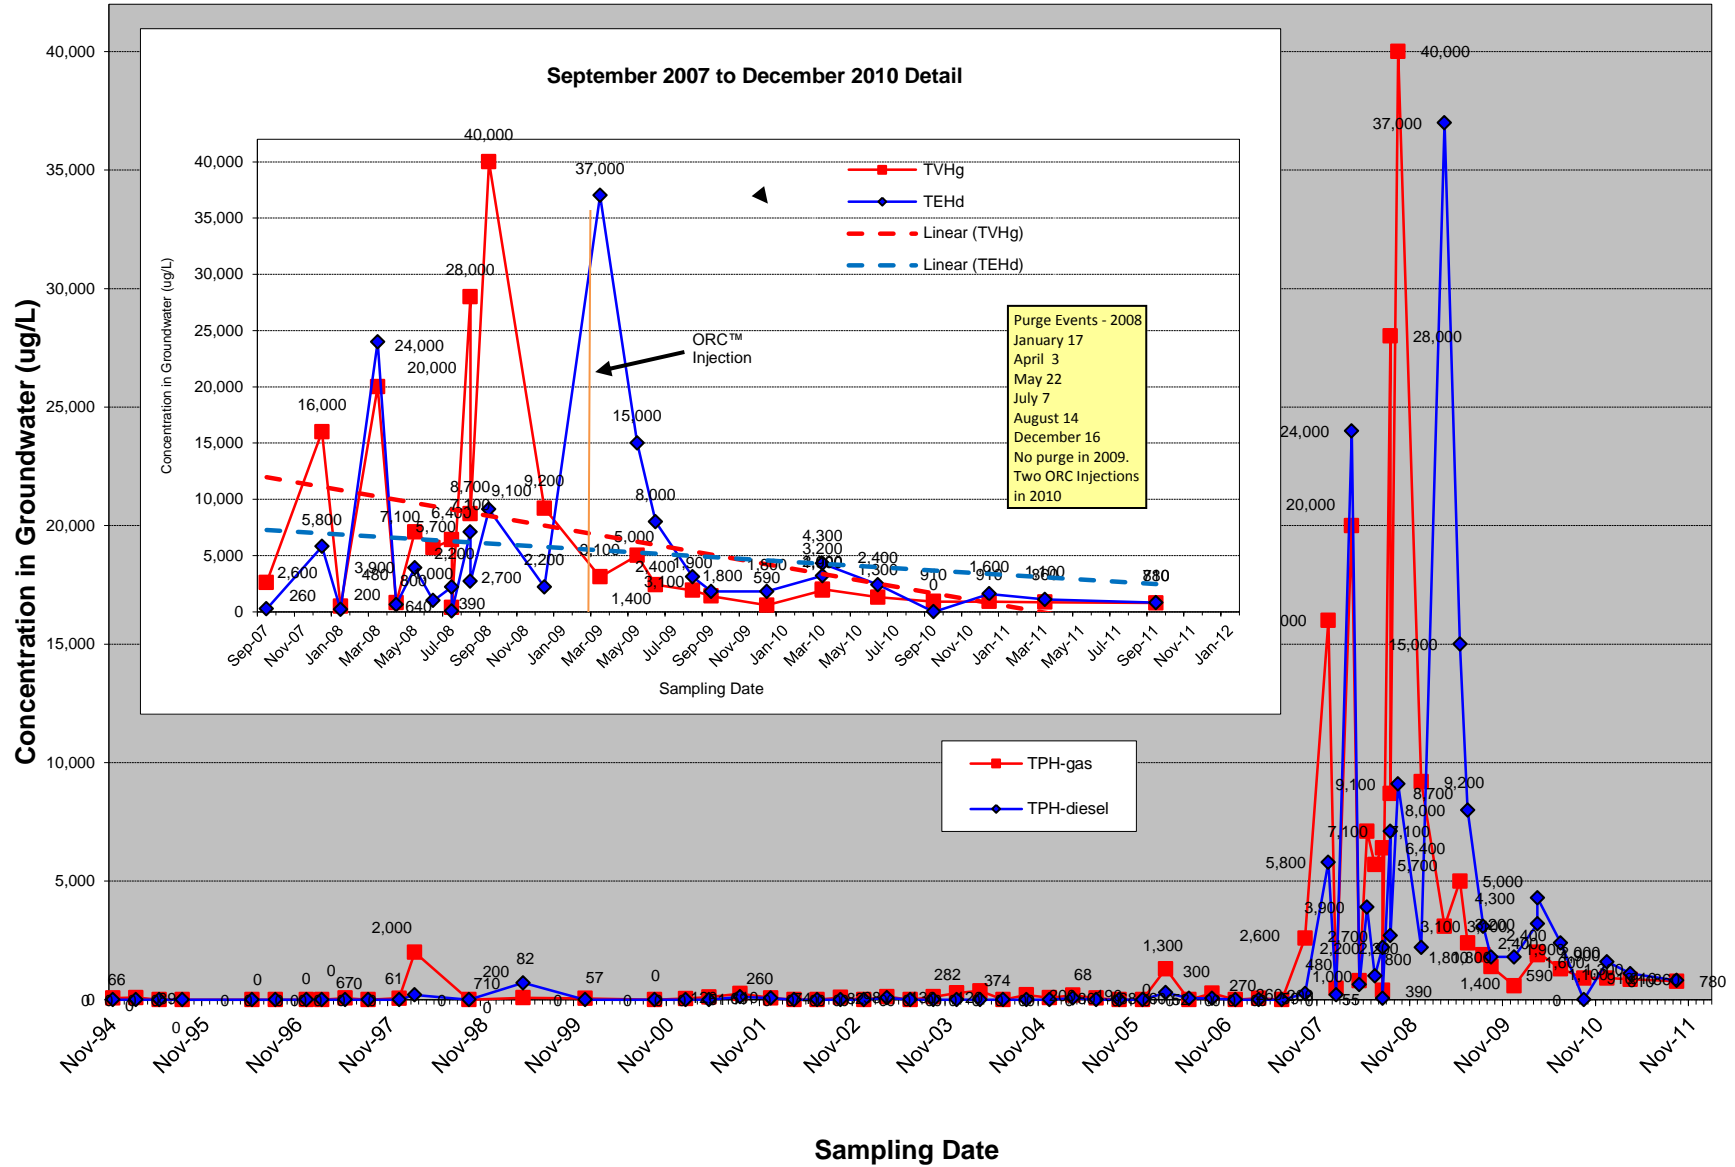
**Figure 9: Gasoline and Diesel Hydrochemical Trends: Well MW-2
Redwood Regional Park Service Yard, Oakland, California**

MW-2. As described in Section 4.0, this source area well historically has shown low to trace (sometimes non-detectable) contaminant levels. However, since September 2007, well MW-2 concentrations increased dramatically, suggesting desorption from the original upgradient source area as a result of the drought-induced drop in water levels. In September 2008, a new historic maximum of 40,000 µg/L of gasoline was observed in MW-2 and a new historic maximum of diesel at 37,000 µg/L was observed in March 2009. In March 2010, Stellar Environmental conducted a limited ORC™ injection, which has dramatically decreased concentrations of both gasoline and diesel over time. In this September 2011 event, the diesel concentration measured 810 µg/L and the gasoline concentration measured 780 µg/L. Figure 9 shows hydrochemical trends for gasoline and diesel in MW-2.
