QUANTITY	DESCRIPTION
1	ADDITIONAL OFFSITE INVESTIGATION, COMPREHENSIVE CONDUIT STUDY AND FIRST 2012 SEMI-ANNUAL GROUNDWATER MONITORING/SAMPLING REPORT

Fuel Leak Case No. **RO0000266**

**ADDITIONAL OFFSITE INVESTIGATION,
COMPREHENSIVE CONDUIT STUDY AND
FIRST 2012 SEMI-ANNUAL GROUNDWATER
MONITORING/SAMPLING REPORT**

**ALLRIGHT PARKING
1432 HARRISON STREET
OAKLAND, CALIFORNIA**

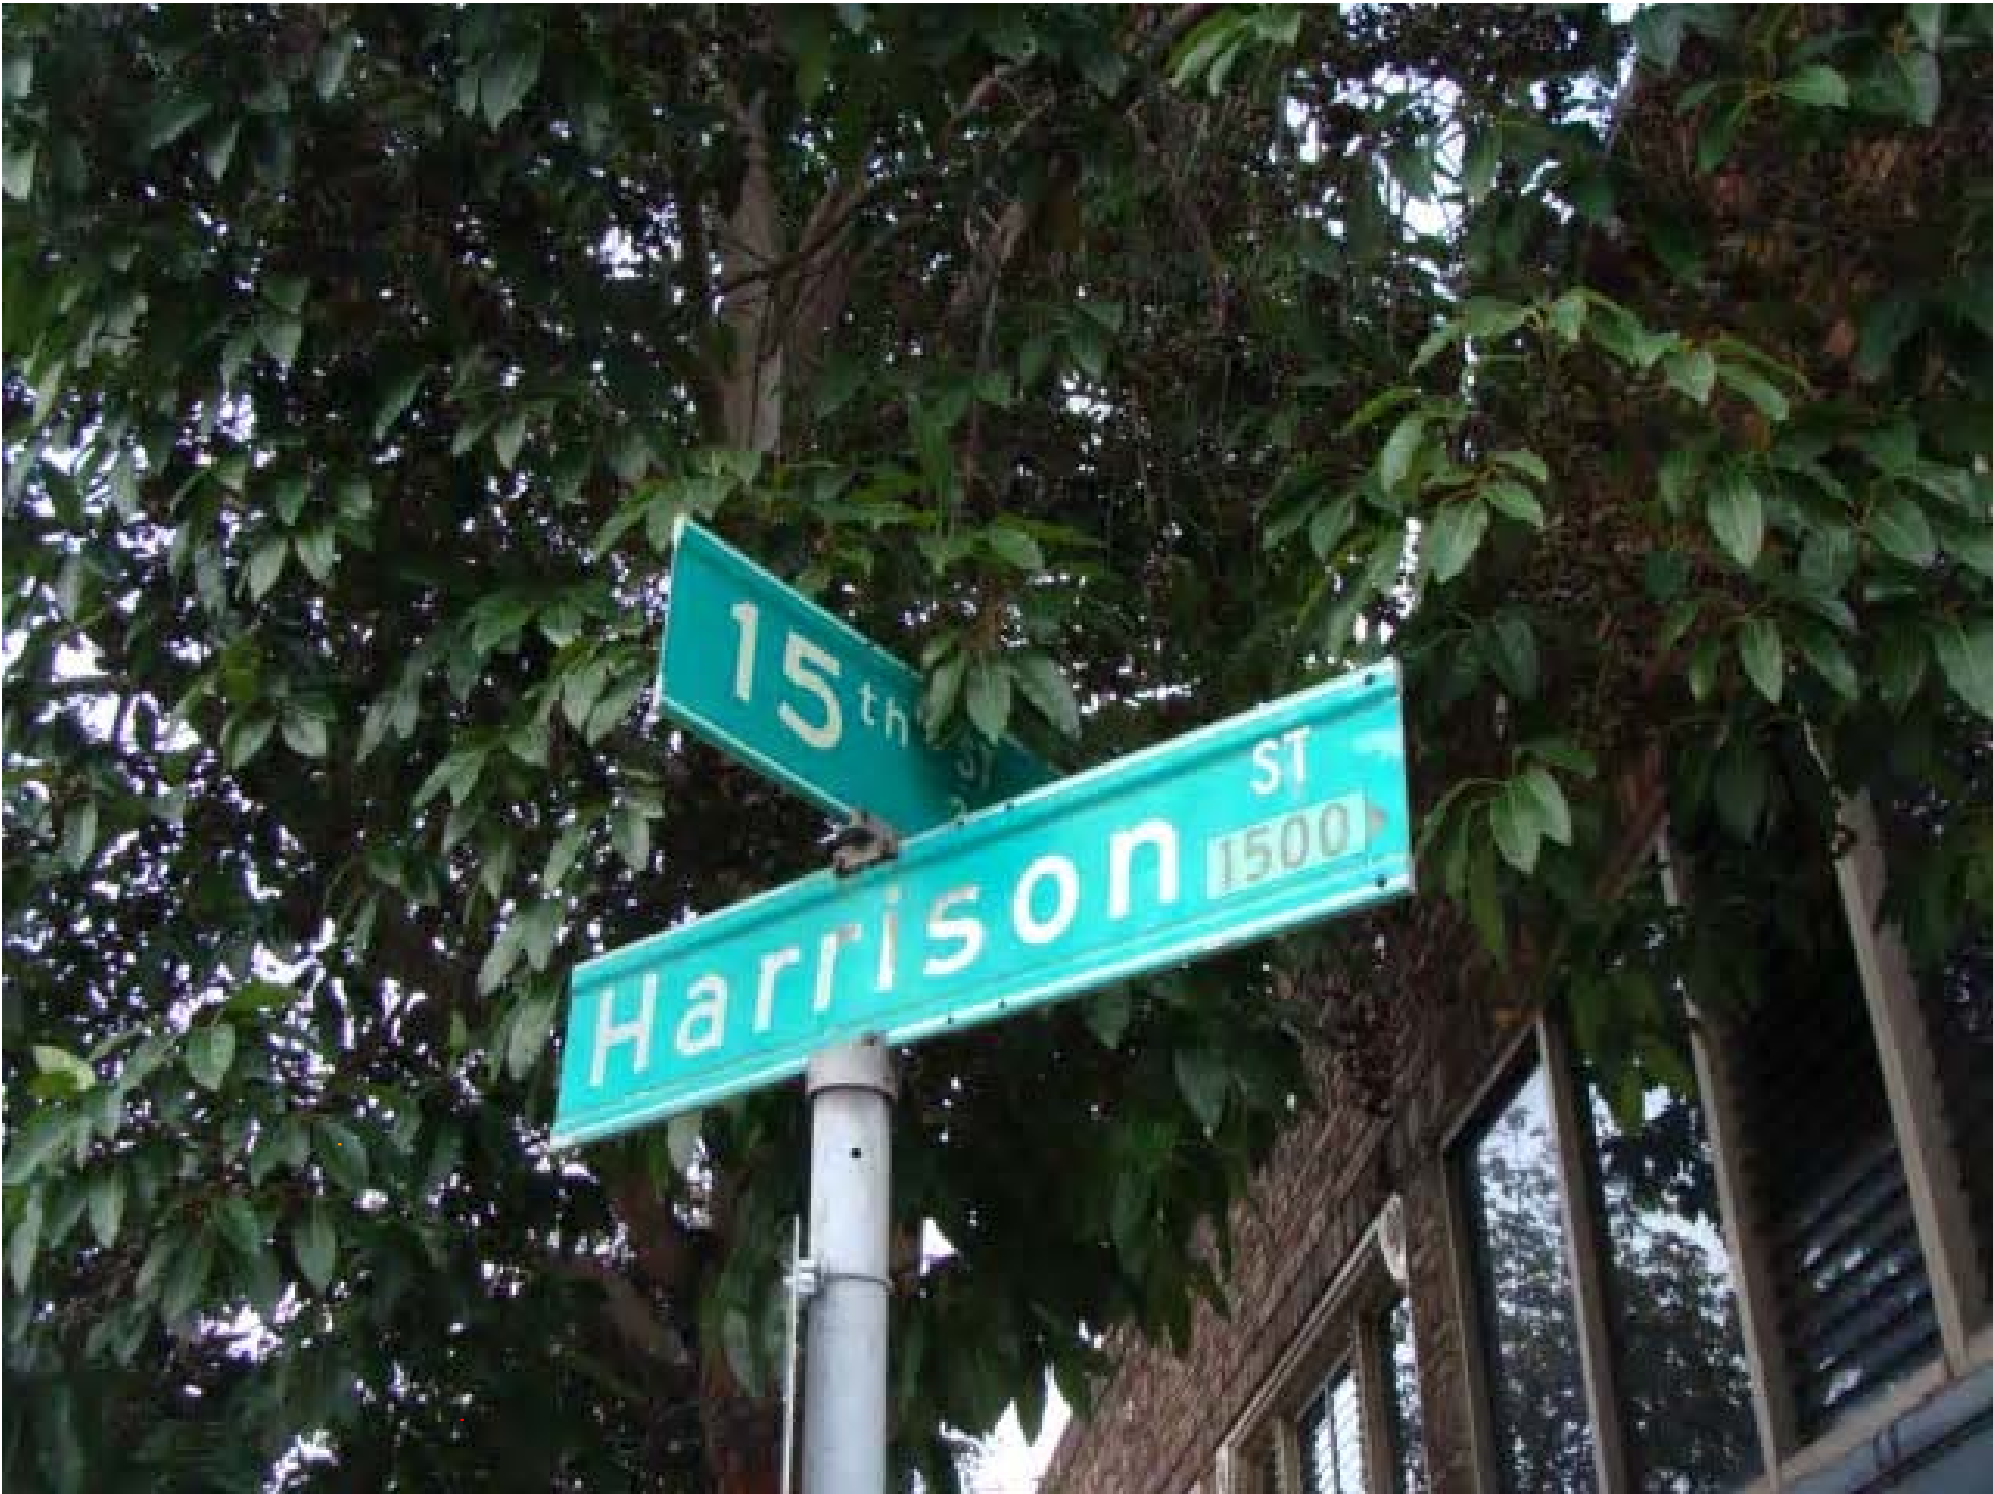
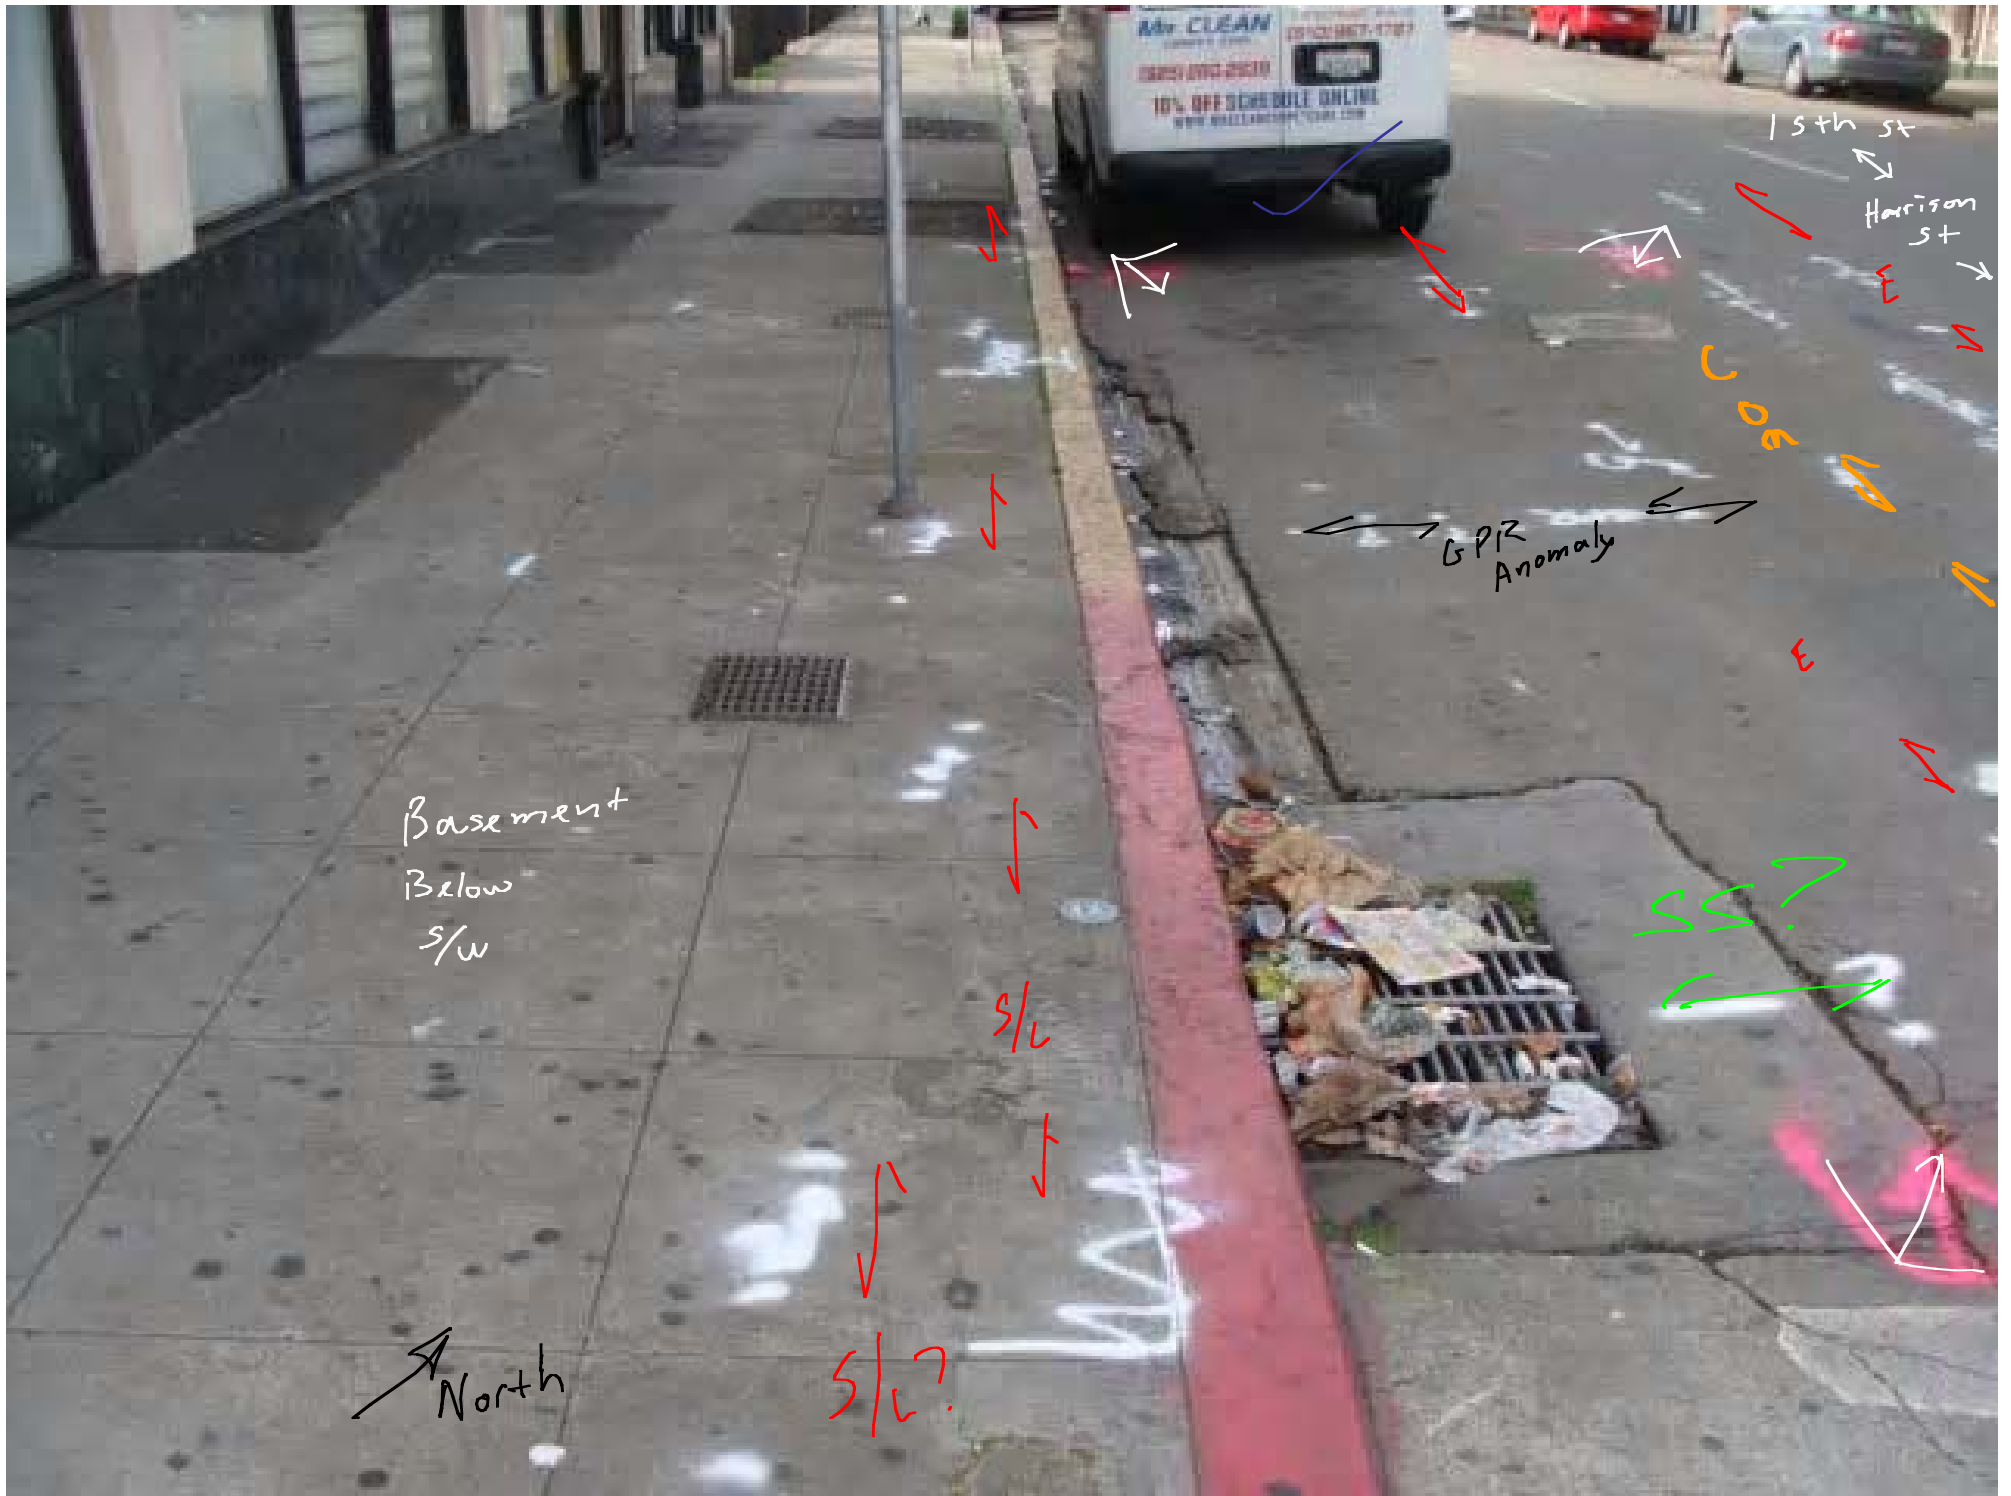
Caution of Fiber Optic Communication lines observed as trending northwest and southeast parallel with the road from a manhole located within the zone. **CABLE MAY TREND THE ENTIRE LENGTH OF 15TH ALONG EAST BOUND LANE.**

Caution of Storm Drain or Sewer pipe trending orthogonal to the curb through zone in a north- south path - visually observed from manholes in area.

Caution of GPR anomaly observed in the form of an object extending from the southern curb northeast 3-4 feet in a narrow band.

Electric: Multiple Electric ducts observed as trending east - west (Northwest-SE) in the southern 3 lanes of traffic.

Natural Gas: Main observed as trending east - west (northwest-SE) within the northern parking lane and parallel with the Curb

Water: Main observed as trending similar to nat gas mostly within northern parking lane - appears to jog a bit more north as the line continues southeast.

Communications duct/trench paths observed in northern parking lane trending northwest through the extent of the block - originating from a vault at the intersection of Harrison and 15th St.

Fiber optics communication lines present observed as being present and believed to be within the southern two lanes and trending northwest through the block.

Storm/Sewer Main visually observed to trend East - West (Northwest-SE) within the apprx center of the road in between the sewer mh that were inspected from surface.

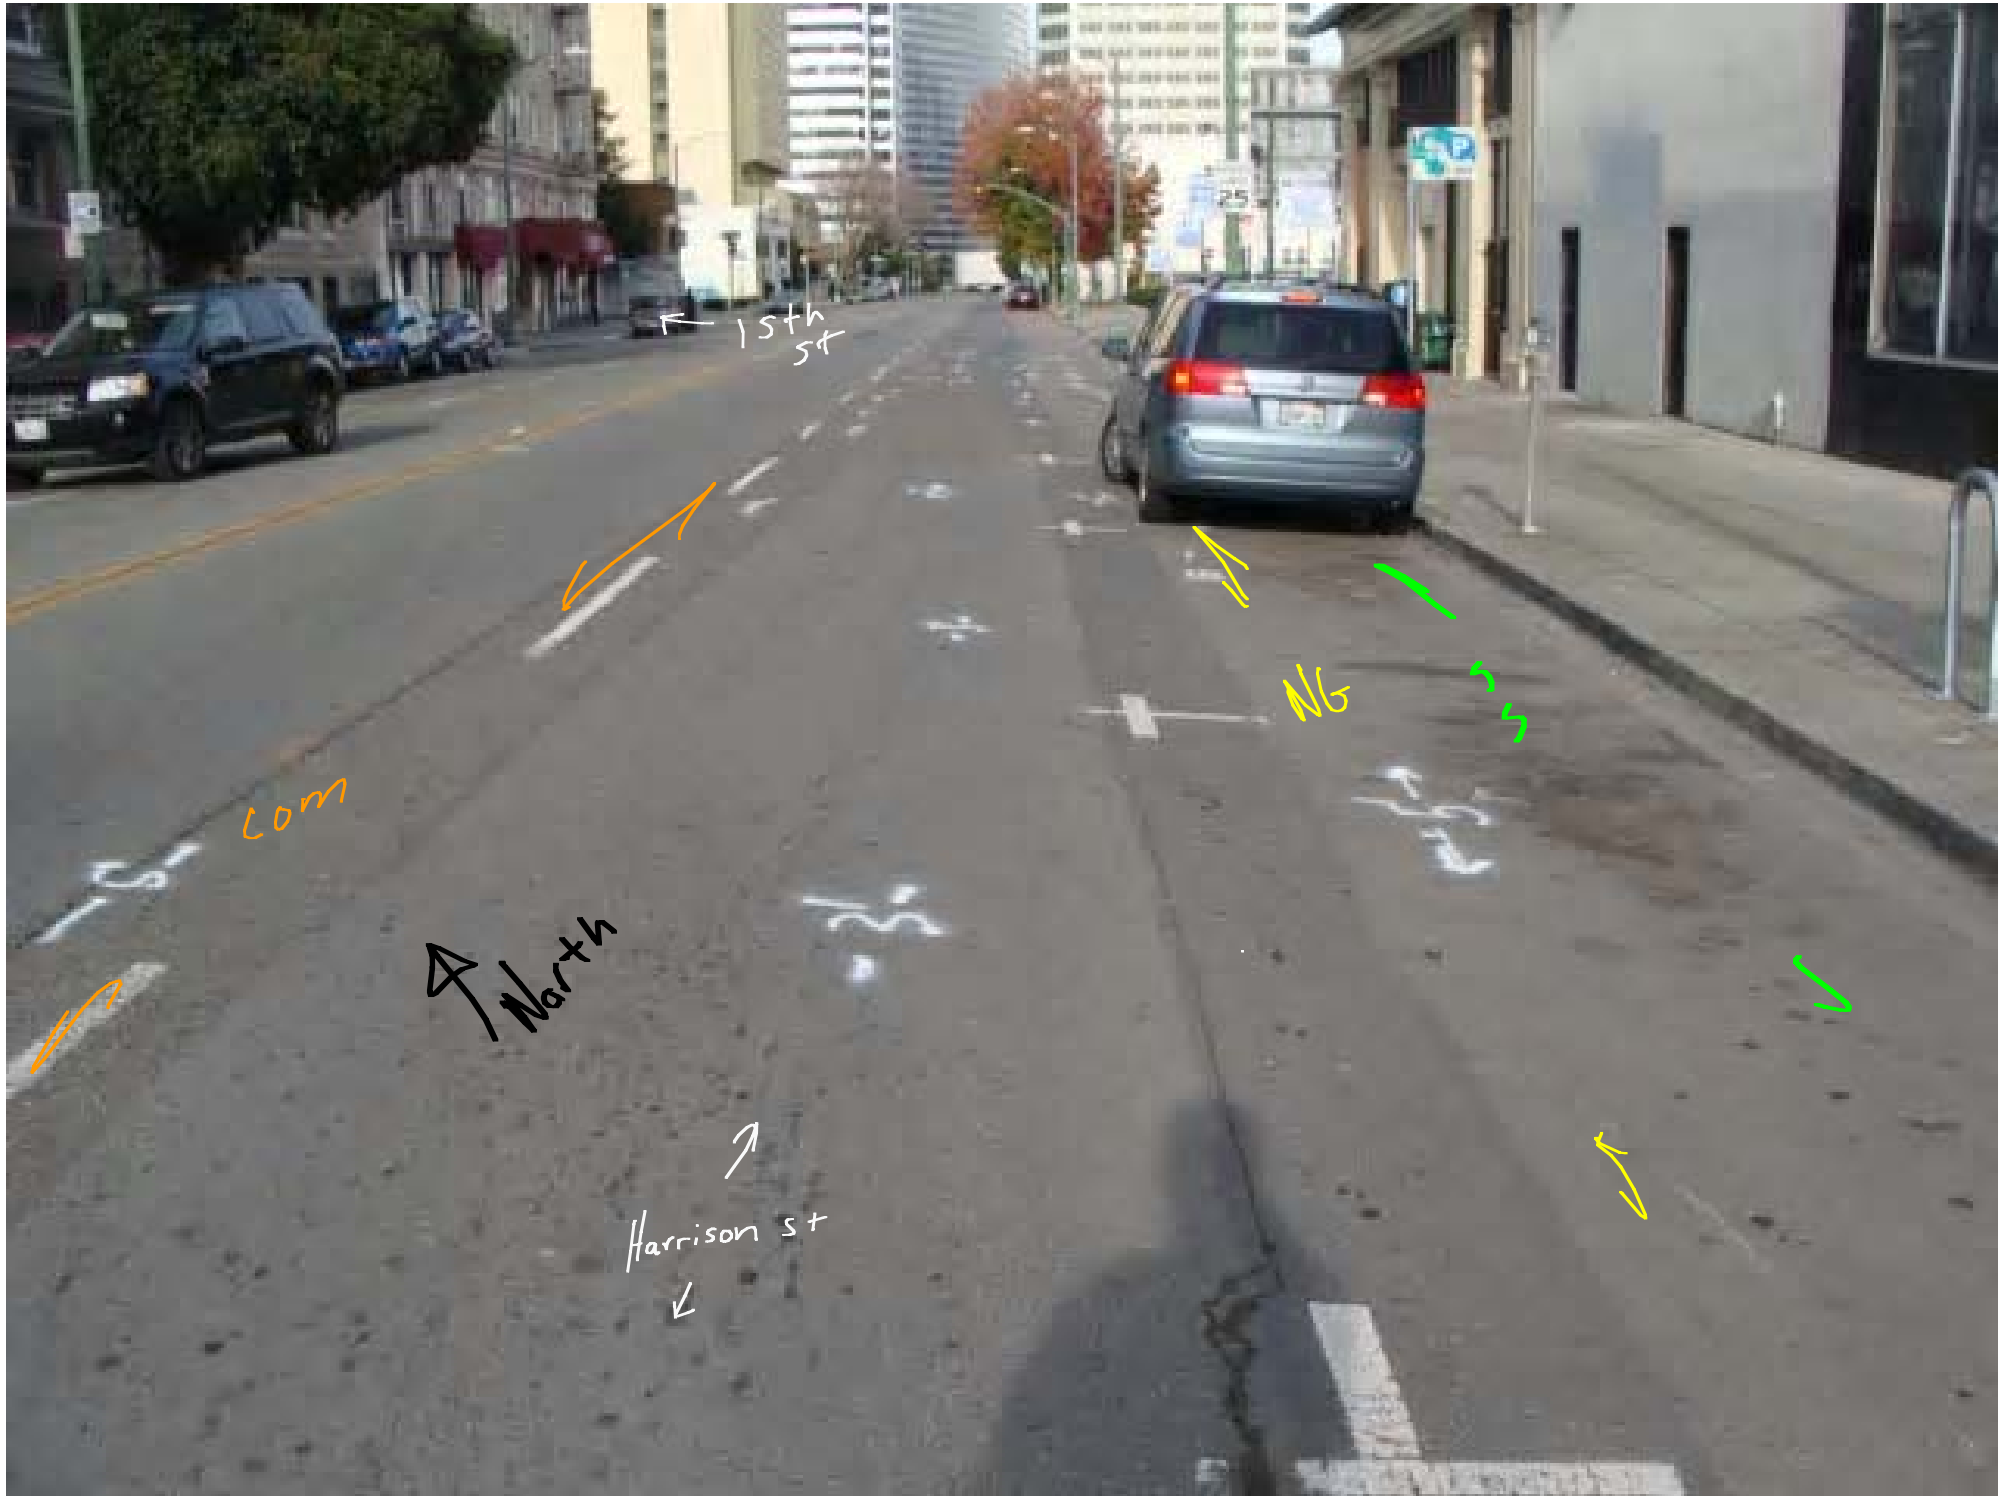
Caution is highly advised due to the presence of Gas Main observed as trending North – South (NE-SW) in the parking lane on the east side of Harrison within zone – main itself is reported to be large and high pressure. No lateral present in proposed zone, however laterals exist to the North and South. Appears to remain parallel with Curb. Observed pipe is detected with direct connect on service valves and with inline induction.

Caution of fiber optics communications lines observed as trending North – South (NE-SW) in easternmost northbound traffic lane staying about parallel with curb– communications vault can be found outside of zone to the North side (NE) in the eastern northbound traffic lane

Caution of Storm/Sewer lines visual observed as trending through zone in a North – South (NE-SW) direction. Visual indications of the flow line are approximately 1 to 3 feet west of curb within zone.

Caution of Electric service observed as trending southeast from the center lane of the road and leading a path into the sidewalk and entering a building in visible conduit

Caution of Street lighting in Curb immediately east of zone – lighting lines are observed as trending northeast in line with the curb.

Caution of Former USTs observed in sidewalk east of zone – this tank(s) is reported as being filled in place with visible potential surface inlets remaining – caution is advised as the western edge of the tank may extend beyond the curb into the road to a small extent – please refer to photos.

Caution of Water service lateral observed as trending east from the main on the west side of the road and continuing to the meter location and east to building wall.

Caution of multiple occurrences of possible nonconductive facilities which were observed by means of GPR – one object appears to trend northeast parallel with the curb and several potential objects are observed as being perpendicular to the curb within the zone.

LOCATE ENERGY ISOLATION INCLUDING WATER AND GAS AT THIS SITE AND SAWCUT, JACKHAMMER, AIRKNIFE

DIG CAREFULLY IN EACH LOCATION. /
