**TRANSMITTAL LETTER  
SITE MITIGATION AND CONTINGENCY PLAN FOR  
REDEVELOPMENT CONSTRUCTION  
6701 – 6707 SHELLMOUND STREET  
EMERYVILLE, CALIFORNIA**

**SITE MANAGEMENT AND CONTINGENCY PLAN  
FOR REDEVELOPMENT CONSTRUCTION  
6701 – 6707 SHELLMOUND STREET  
EMERYVILLE, CALIFORNIA**

**MAY 19, 2015**

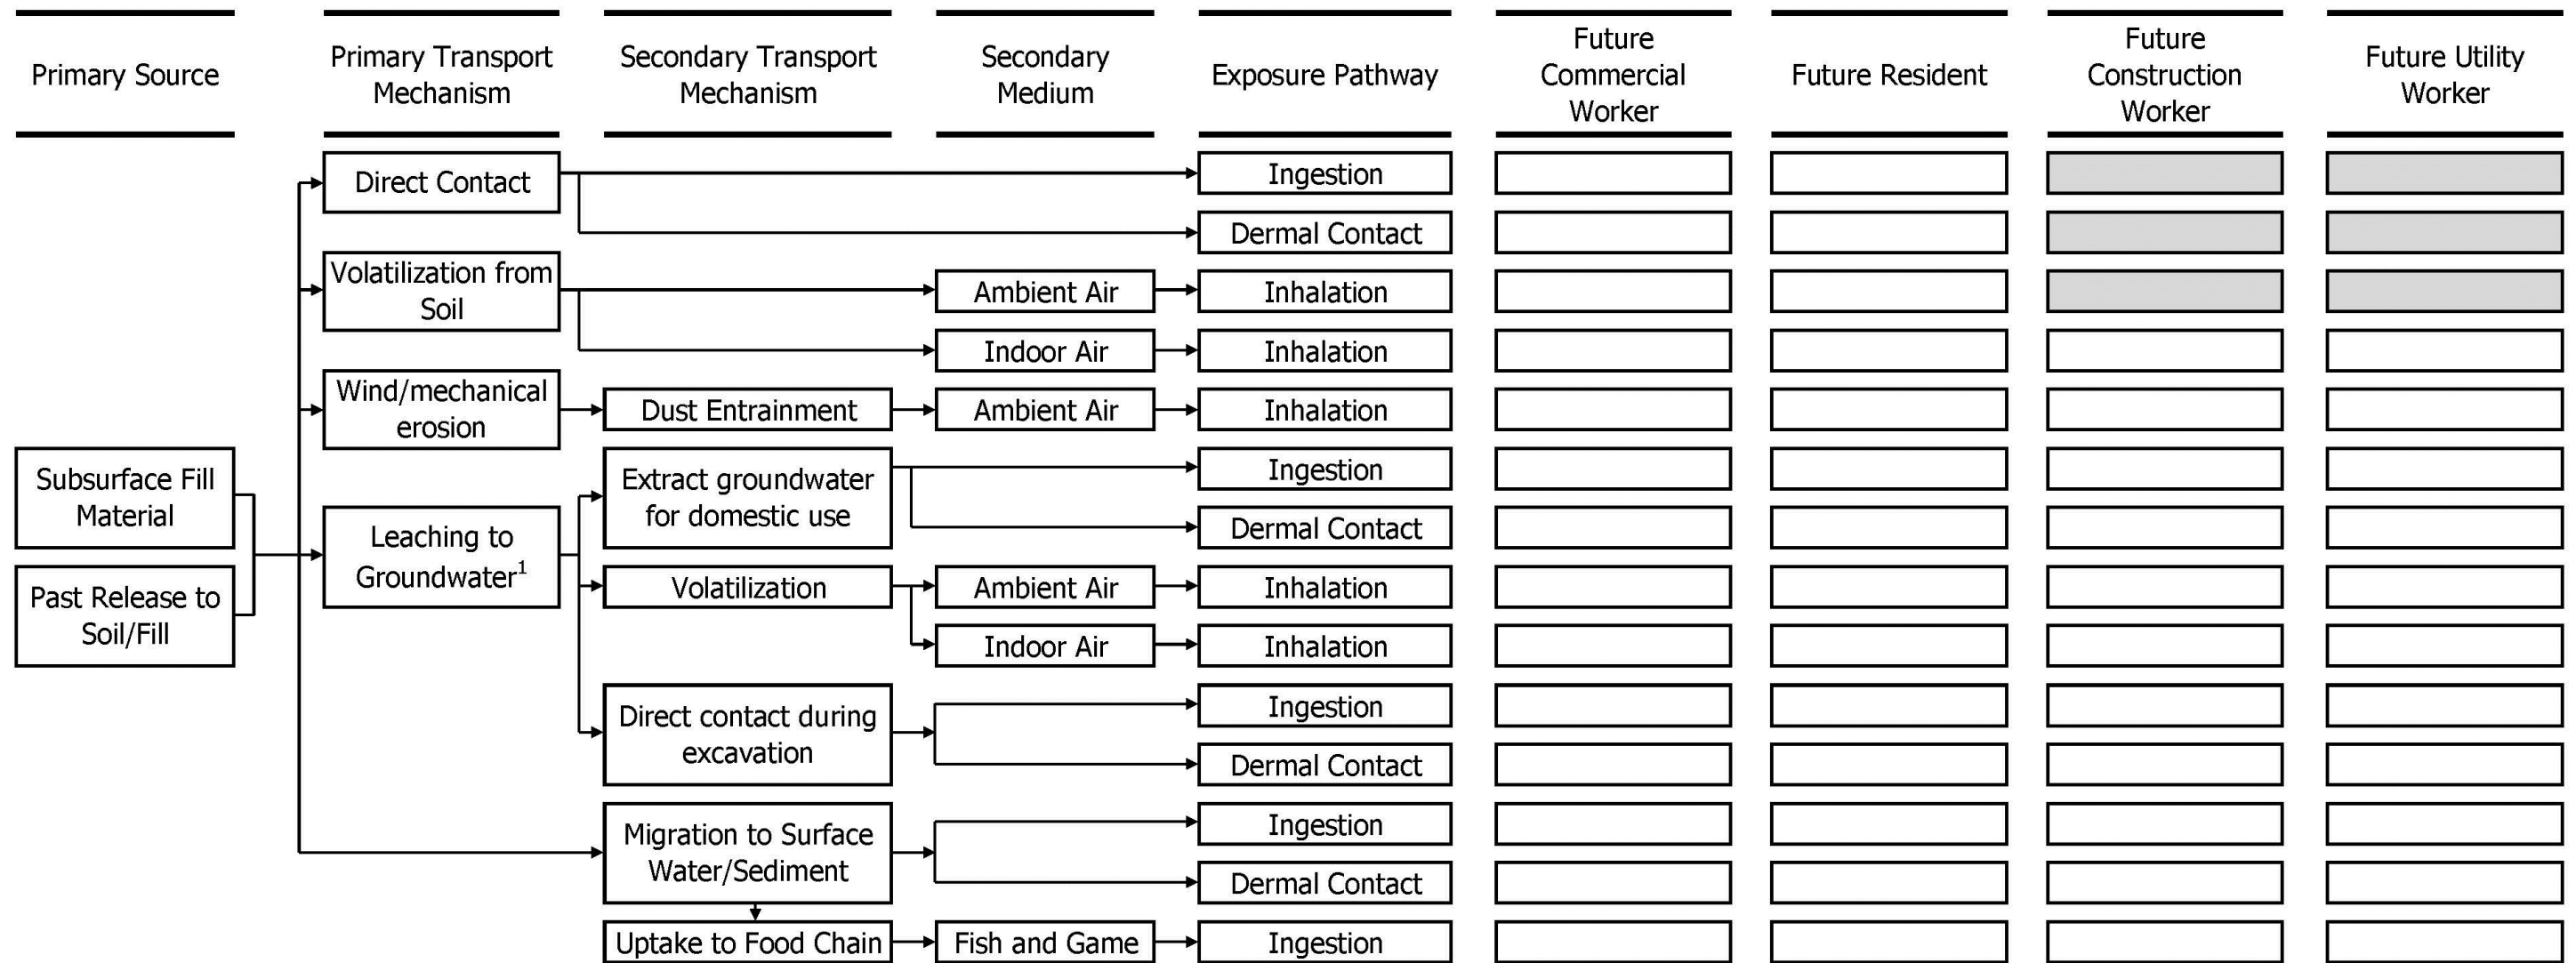
# Conceptual Site Model

Receptor likely to be exposed via this route, so exposure pathways are considered potentially complete and significant.

Receptor may be exposed via this route; however, exposure is likely insignificant based on engineering and institutional controls.<sup>2</sup>
