Environmental Technical Services

May 19, 1992

RE: The Removal of Two Underground Storage Tanks and the
Subsequent Field Sampling at:

GIFFORD RESIDENCE
891 UNION STREET
ALAMEDA, CALIFORNIA

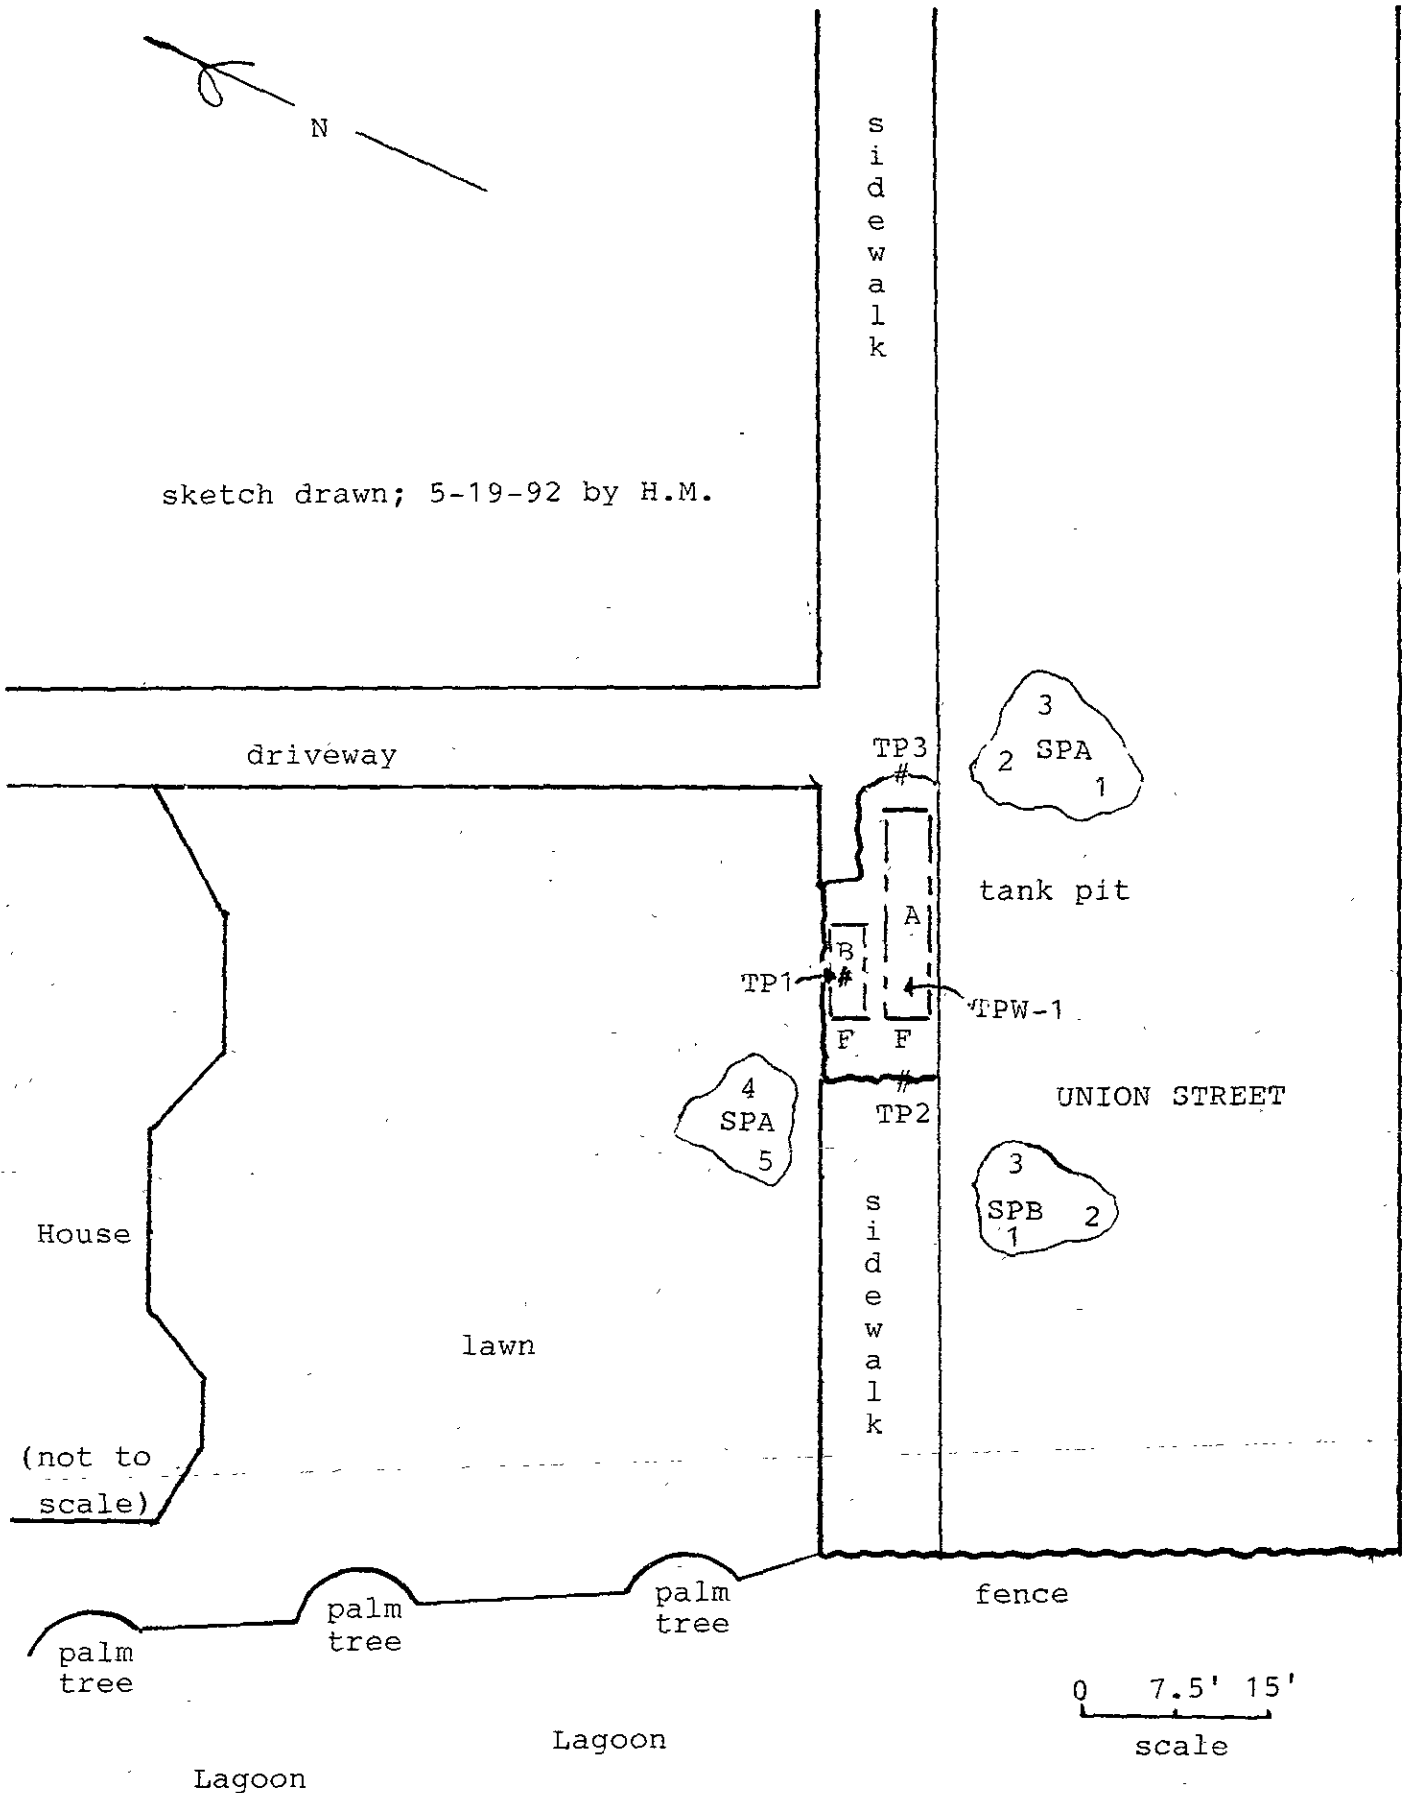
TANK REMOVAL 5/11/92

See accompanying site diagram for the tank location prior to removal, field sampling designations, and sampling depths.

<u>Sample#</u>	<u>Matrix</u>	<u>Location</u>	<u>Depth</u>
TP-1	Soil	Beneath 600-gal. tank	8.5'
TP-2	Soil	Capillary sidewall 1,500-gal. tank, fill end	11.5'
TP-3	Soil	Capillary sidewall 1,500-gal. tank, opposite fill end	11.5'
TPW-1	Water	Tank Pit Groundwater	13.0'
SPA1-SPA5	Soil	Composite stockpile sample	2.5'
SPB1-SPB3	Soil	Composite stockpile sample	2.5'
