**TABLE 3**  
**SUMMARY OF WELL SURVEY RESULTS**

Vulcan Materials Company  
Pleasanton Facility  
501 El Charro Road,  
Pleasanton, California

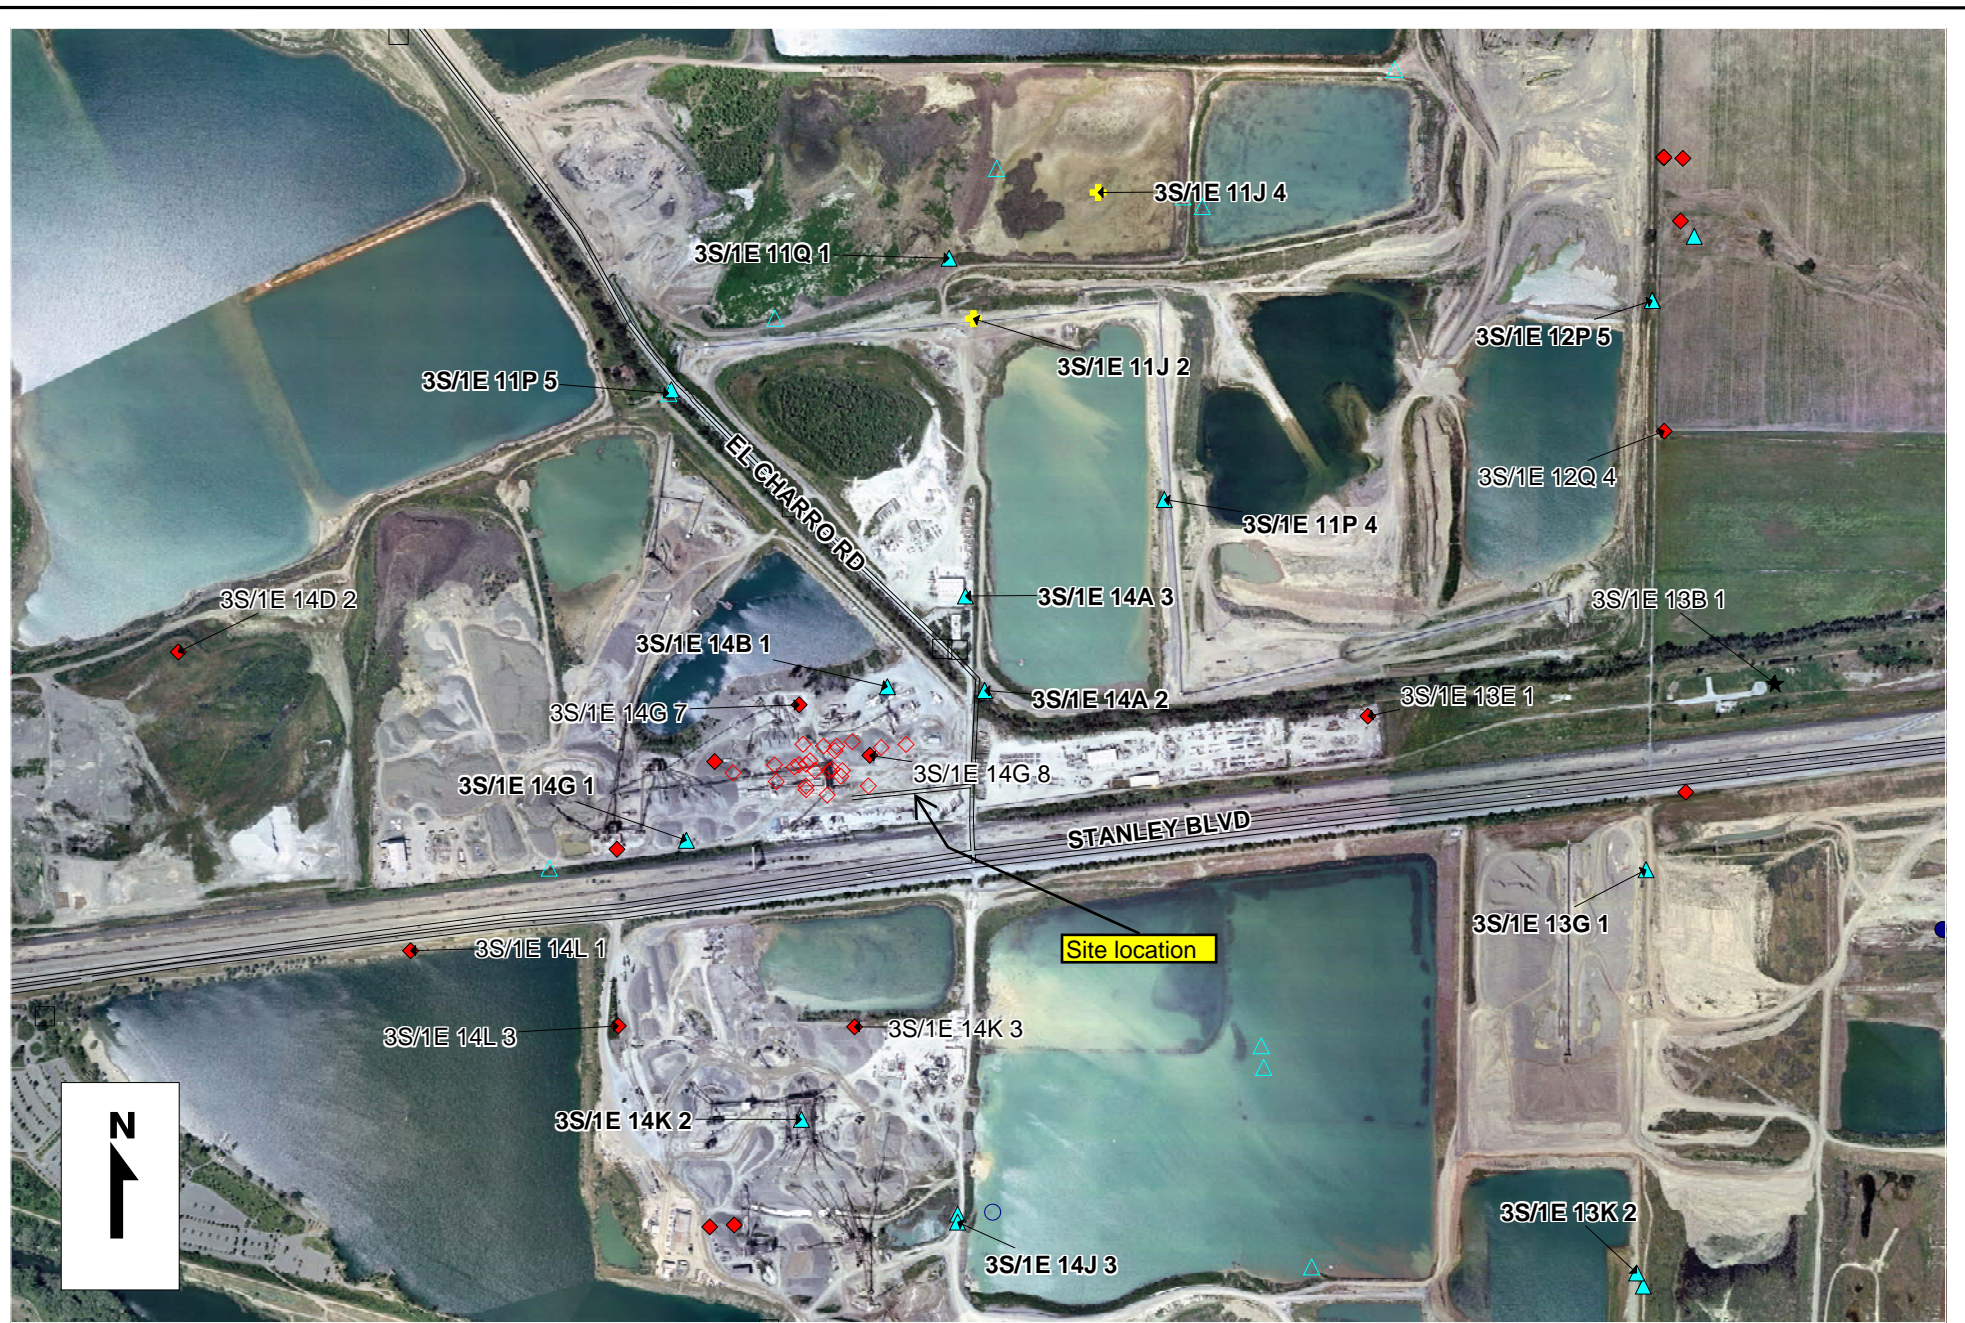
**WELL LOCATION MAP**

1 = Reference the Zone 7 Water Agency's Well Locations Map for locations.
