**PROJECT:** Proposed 59th Street Widening/Results of Environmental Review

August 19, 1999  
SCI 537.014

**Results of Environmental Review,  
Soil Sampling, and Chemical Analyses  
Proposed 59<sup>th</sup> Street Widening  
Emeryville, California**

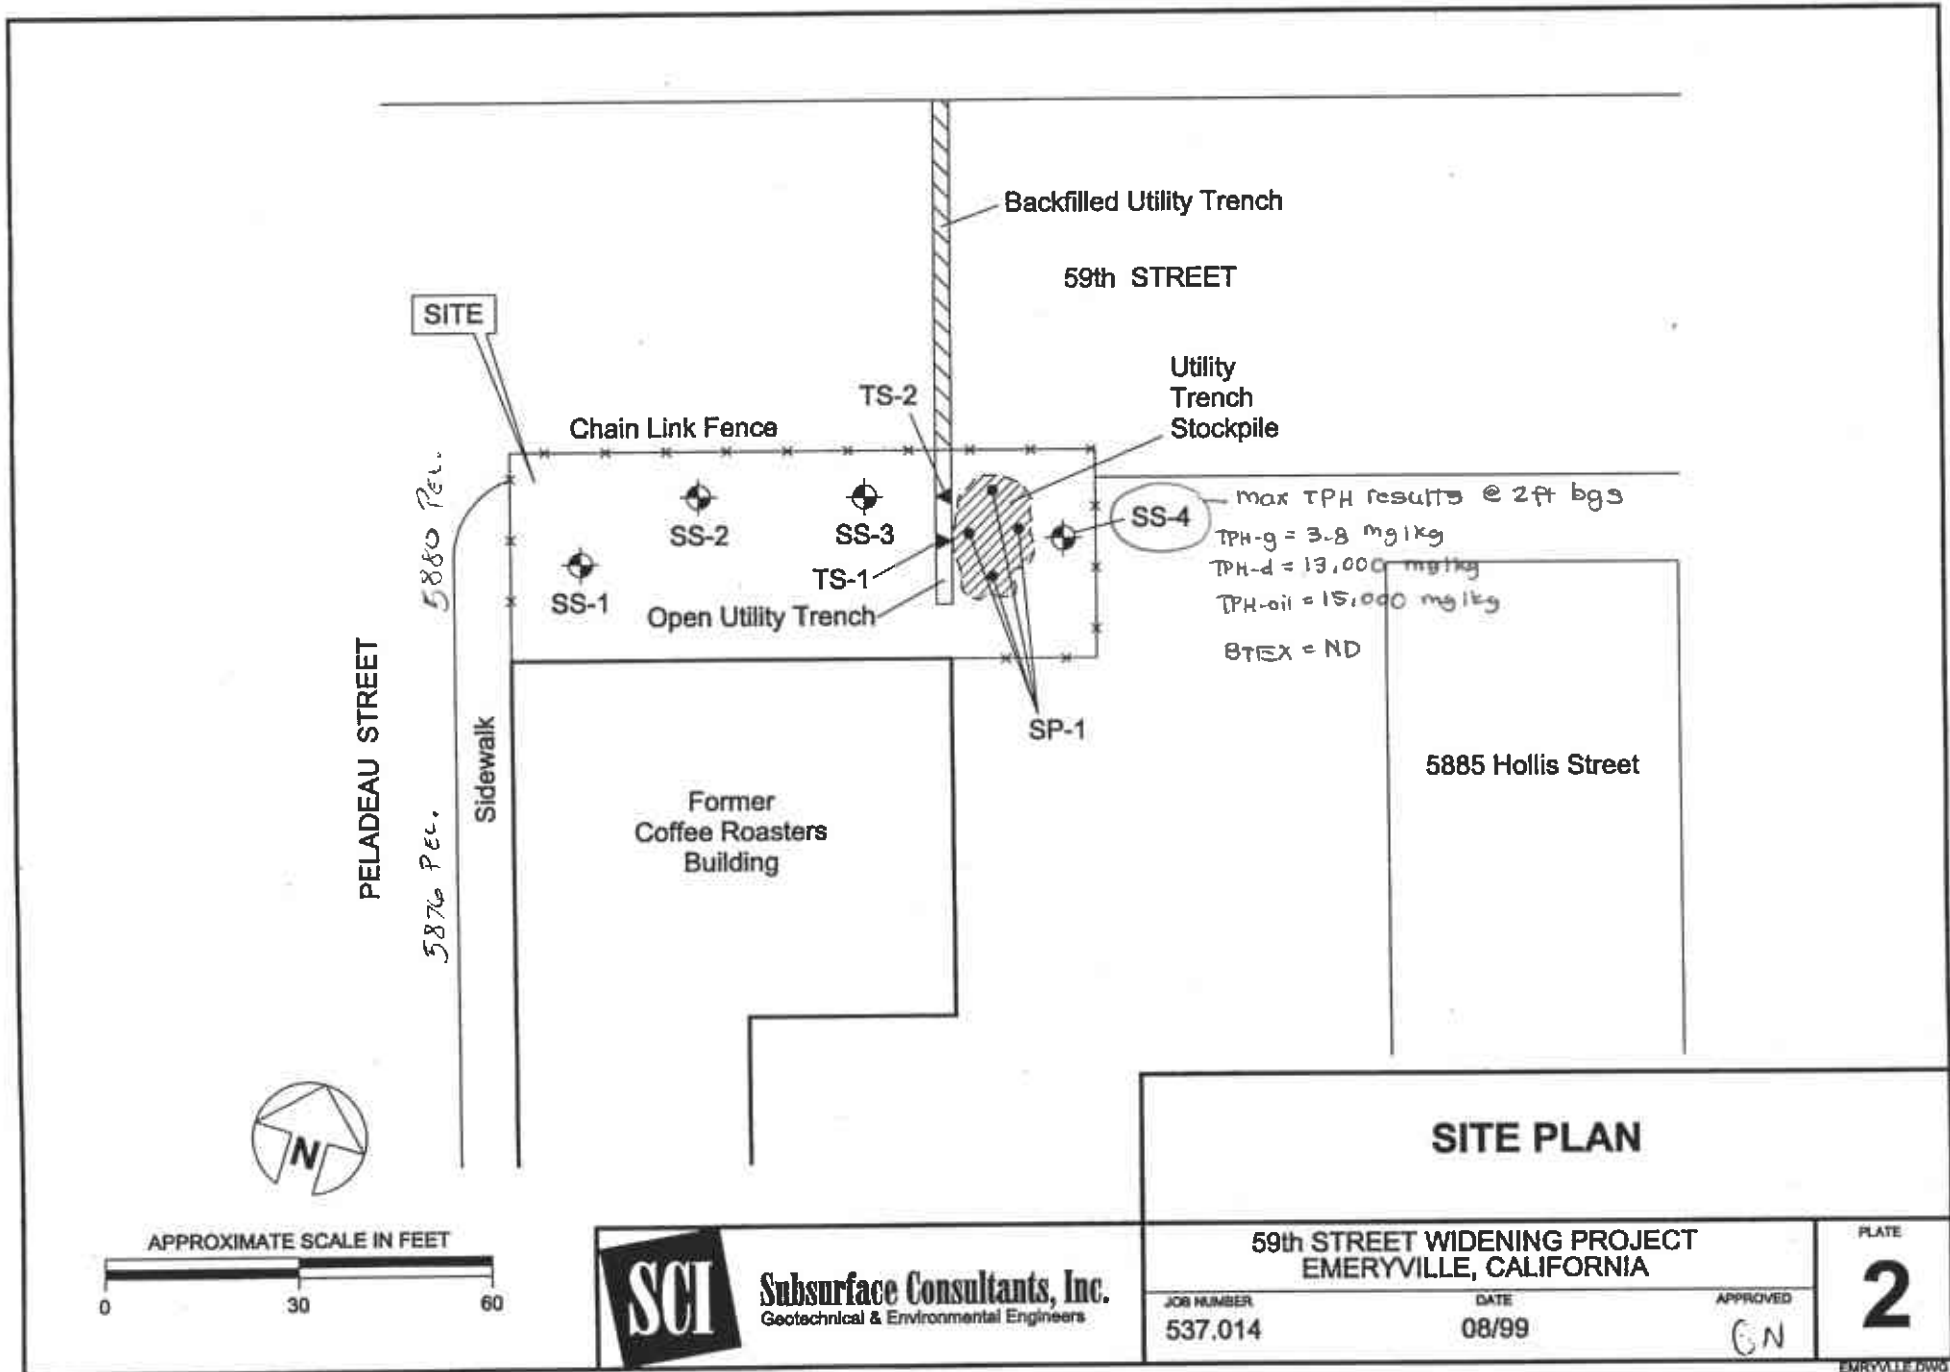
PLATE  
**2**

On August 5, 1999, a four-part composite sample of stockpiled soils (SP-1) was collected. SCI estimates that the stockpile comprises approximately 10 to 20 cubic yards (CY) of soil. On August 9, 1999, a rubber-tired excavator and operator were used to excavate four 4-foot deep test pits (SS-1 through SS-4). Samples were collected at 2 feet and 4 feet below ground surface (bgs) in each test pit. Shallow soil samples were also collected from the two inside walls of the open portion of the utility trench at 2 feet bgs (TS-1 @ 2' and TS-2 @ 2'). Soil samples were contained in stainless steel tubes, capped with Teflon-lined caps, and chilled during storage. Upon completion of soil sampling, the excavated soil was placed back in the test pit from which it originated, and was tamped with the backhoe bucket. Locations of the test pit, utility trenches, and stockpile sampling points are shown on Plate 2.

**SITE PLAN**

On the basis of the results of our study, SCI recommends that near-surface soils in the vicinity of TS-1 and SS-4 that have TEH concentrations above 1,000 mg/kg, be excavated and removed from the Site. We recommend that the limits of excavation be approximately 10 feet wide (north to south) by 25 feet long and 3 feet deep. Confirmation soil samples should be collected from the side walls and bottom of the excavation to check the hydrocarbon concentrations remaining in soils following excavation activities.

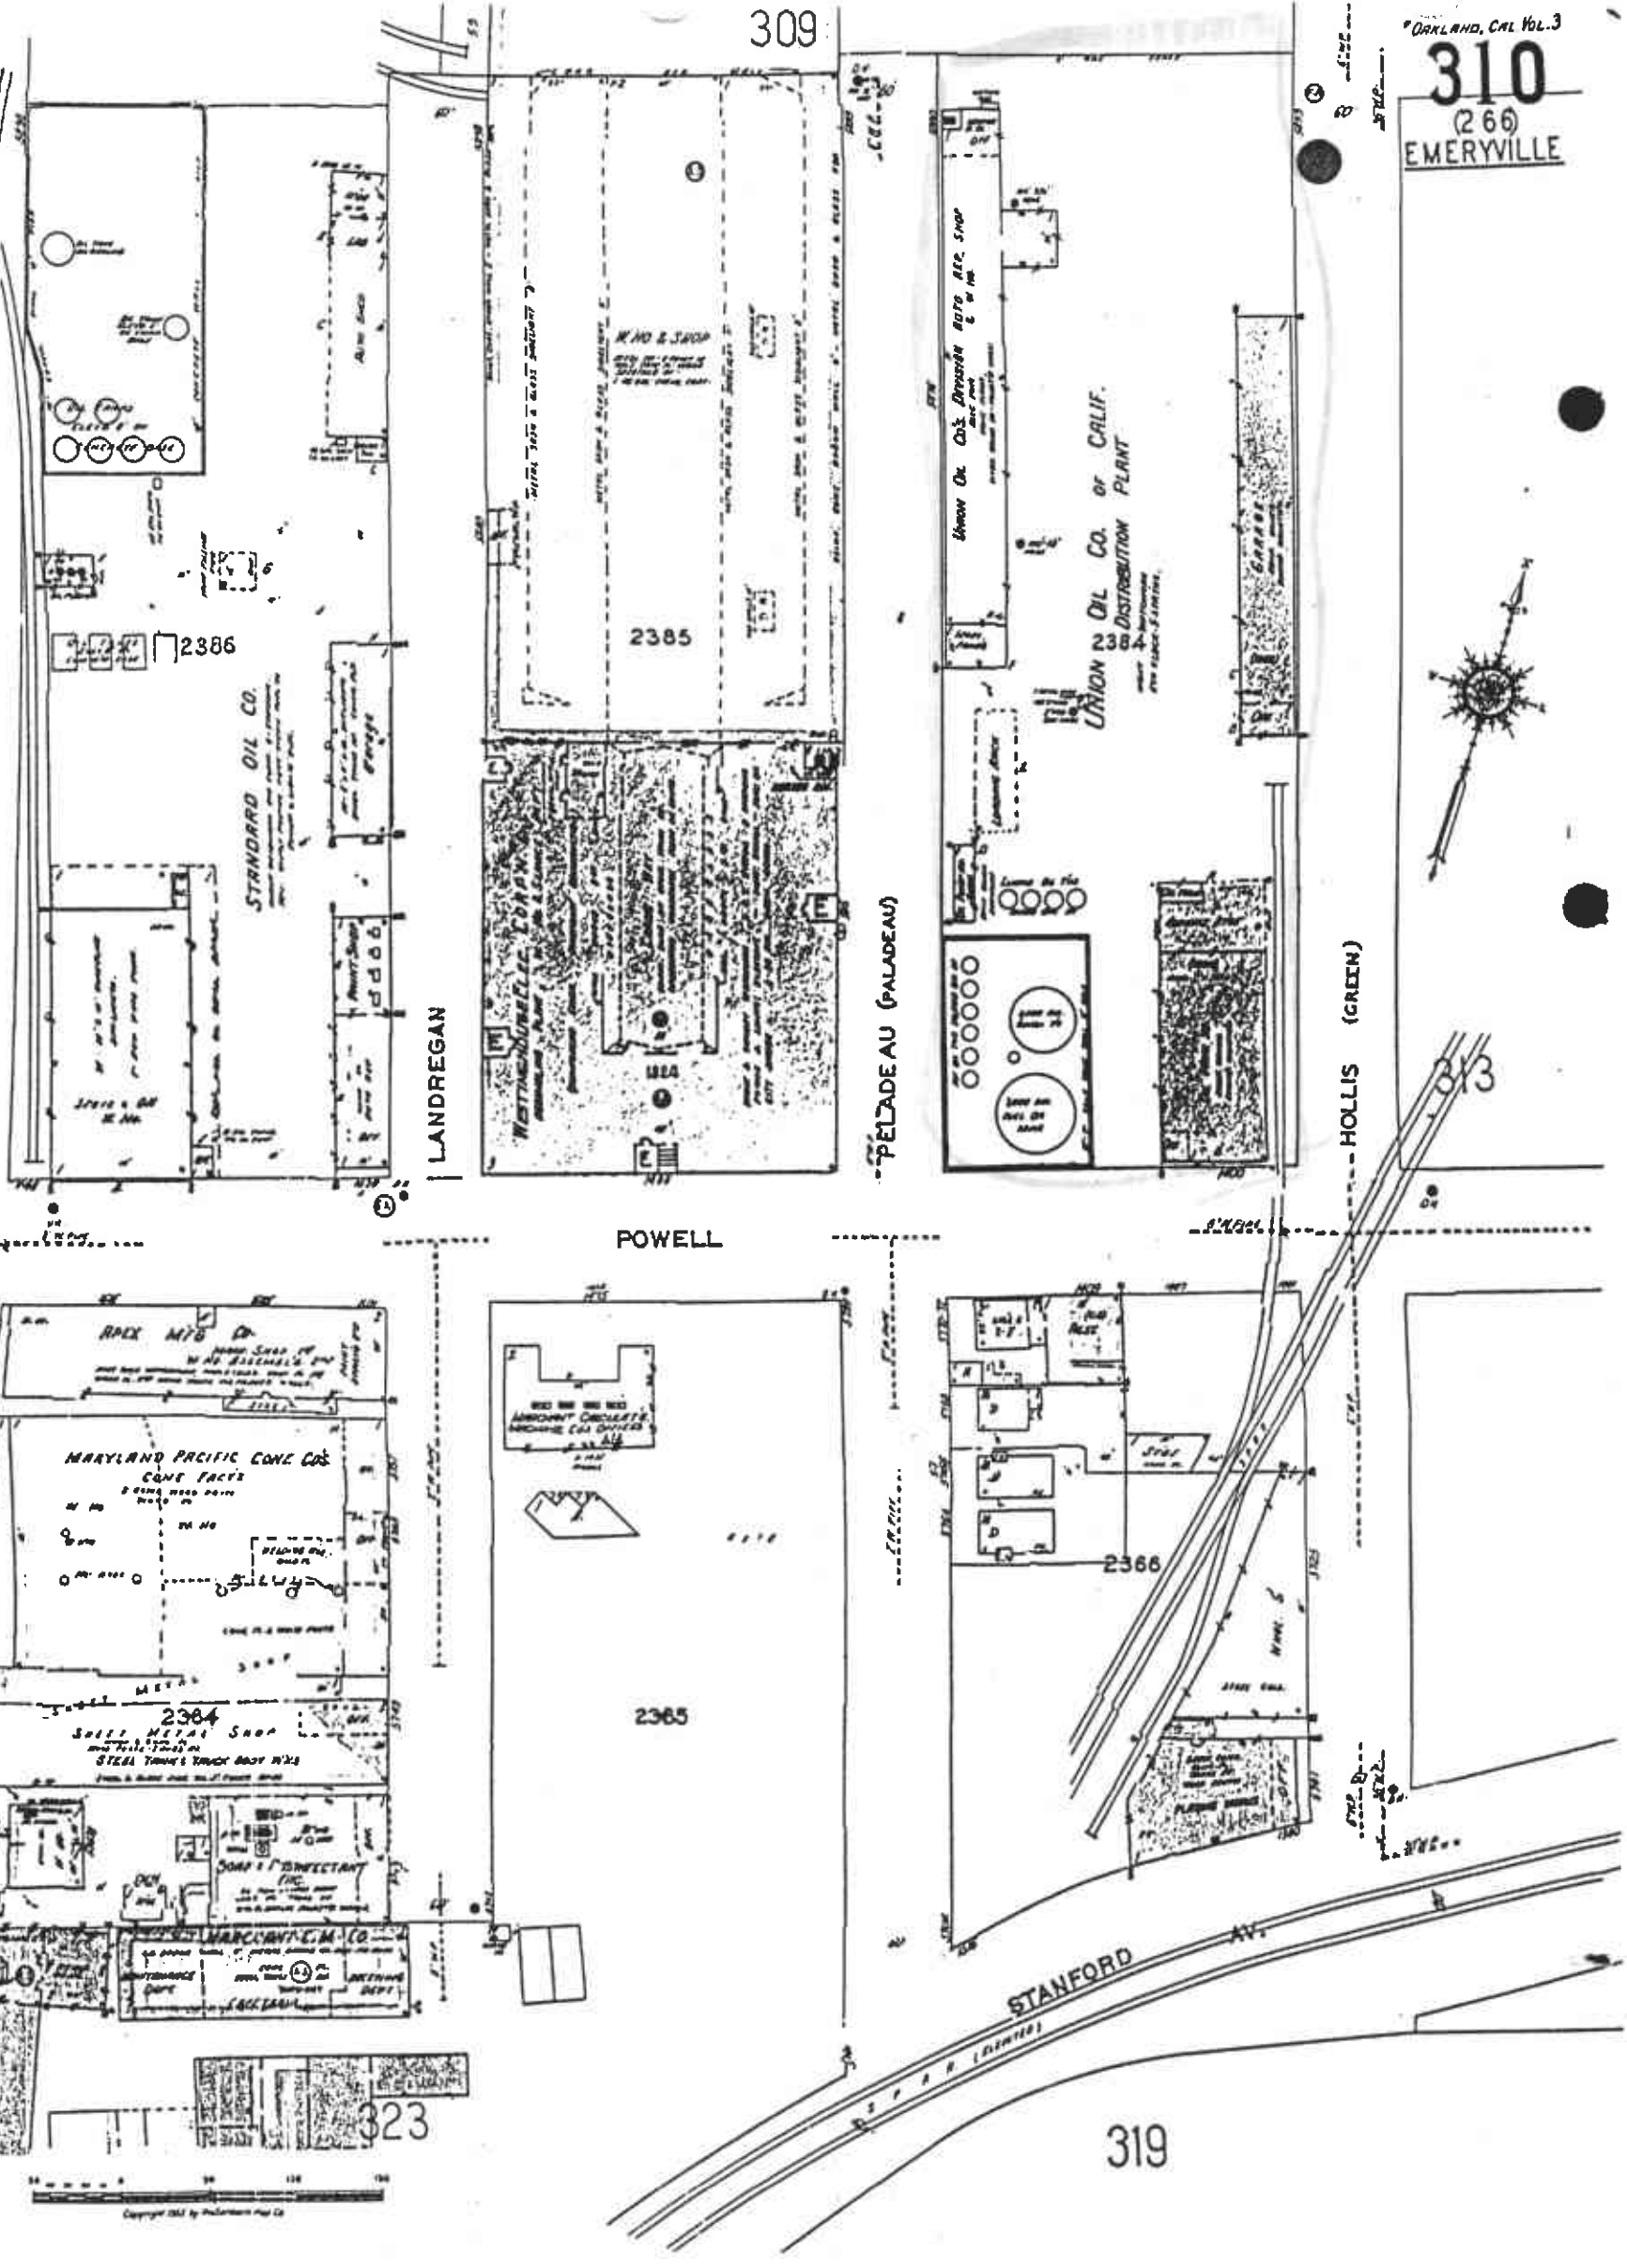
1952

This map shows the Site as being vacant. The property to the south adjacent to the Site is occupied by the Union Oil Company auto repair shop. A heater with an iron chimney is located inside the shop at the corner of 59<sup>th</sup> and Peladeau Streets, adjacent to the Site. A small motor oil storage container is shown located right outside the auto repair shop on Site soil. The entire block where the Site resides is occupied by other Union Oil facilities, including a garage along Hollis Street, oil and gasoline storage tanks at the corner of Peladeau and Powell Streets, and an oil warehouse at the corner of Hollis and Powell Streets. 59<sup>th</sup> Street is paved between Hollis and Peladeau as it appears today. The large building across Peladeau Street is identified as Westinghouse Electric Corporation assembling plant.

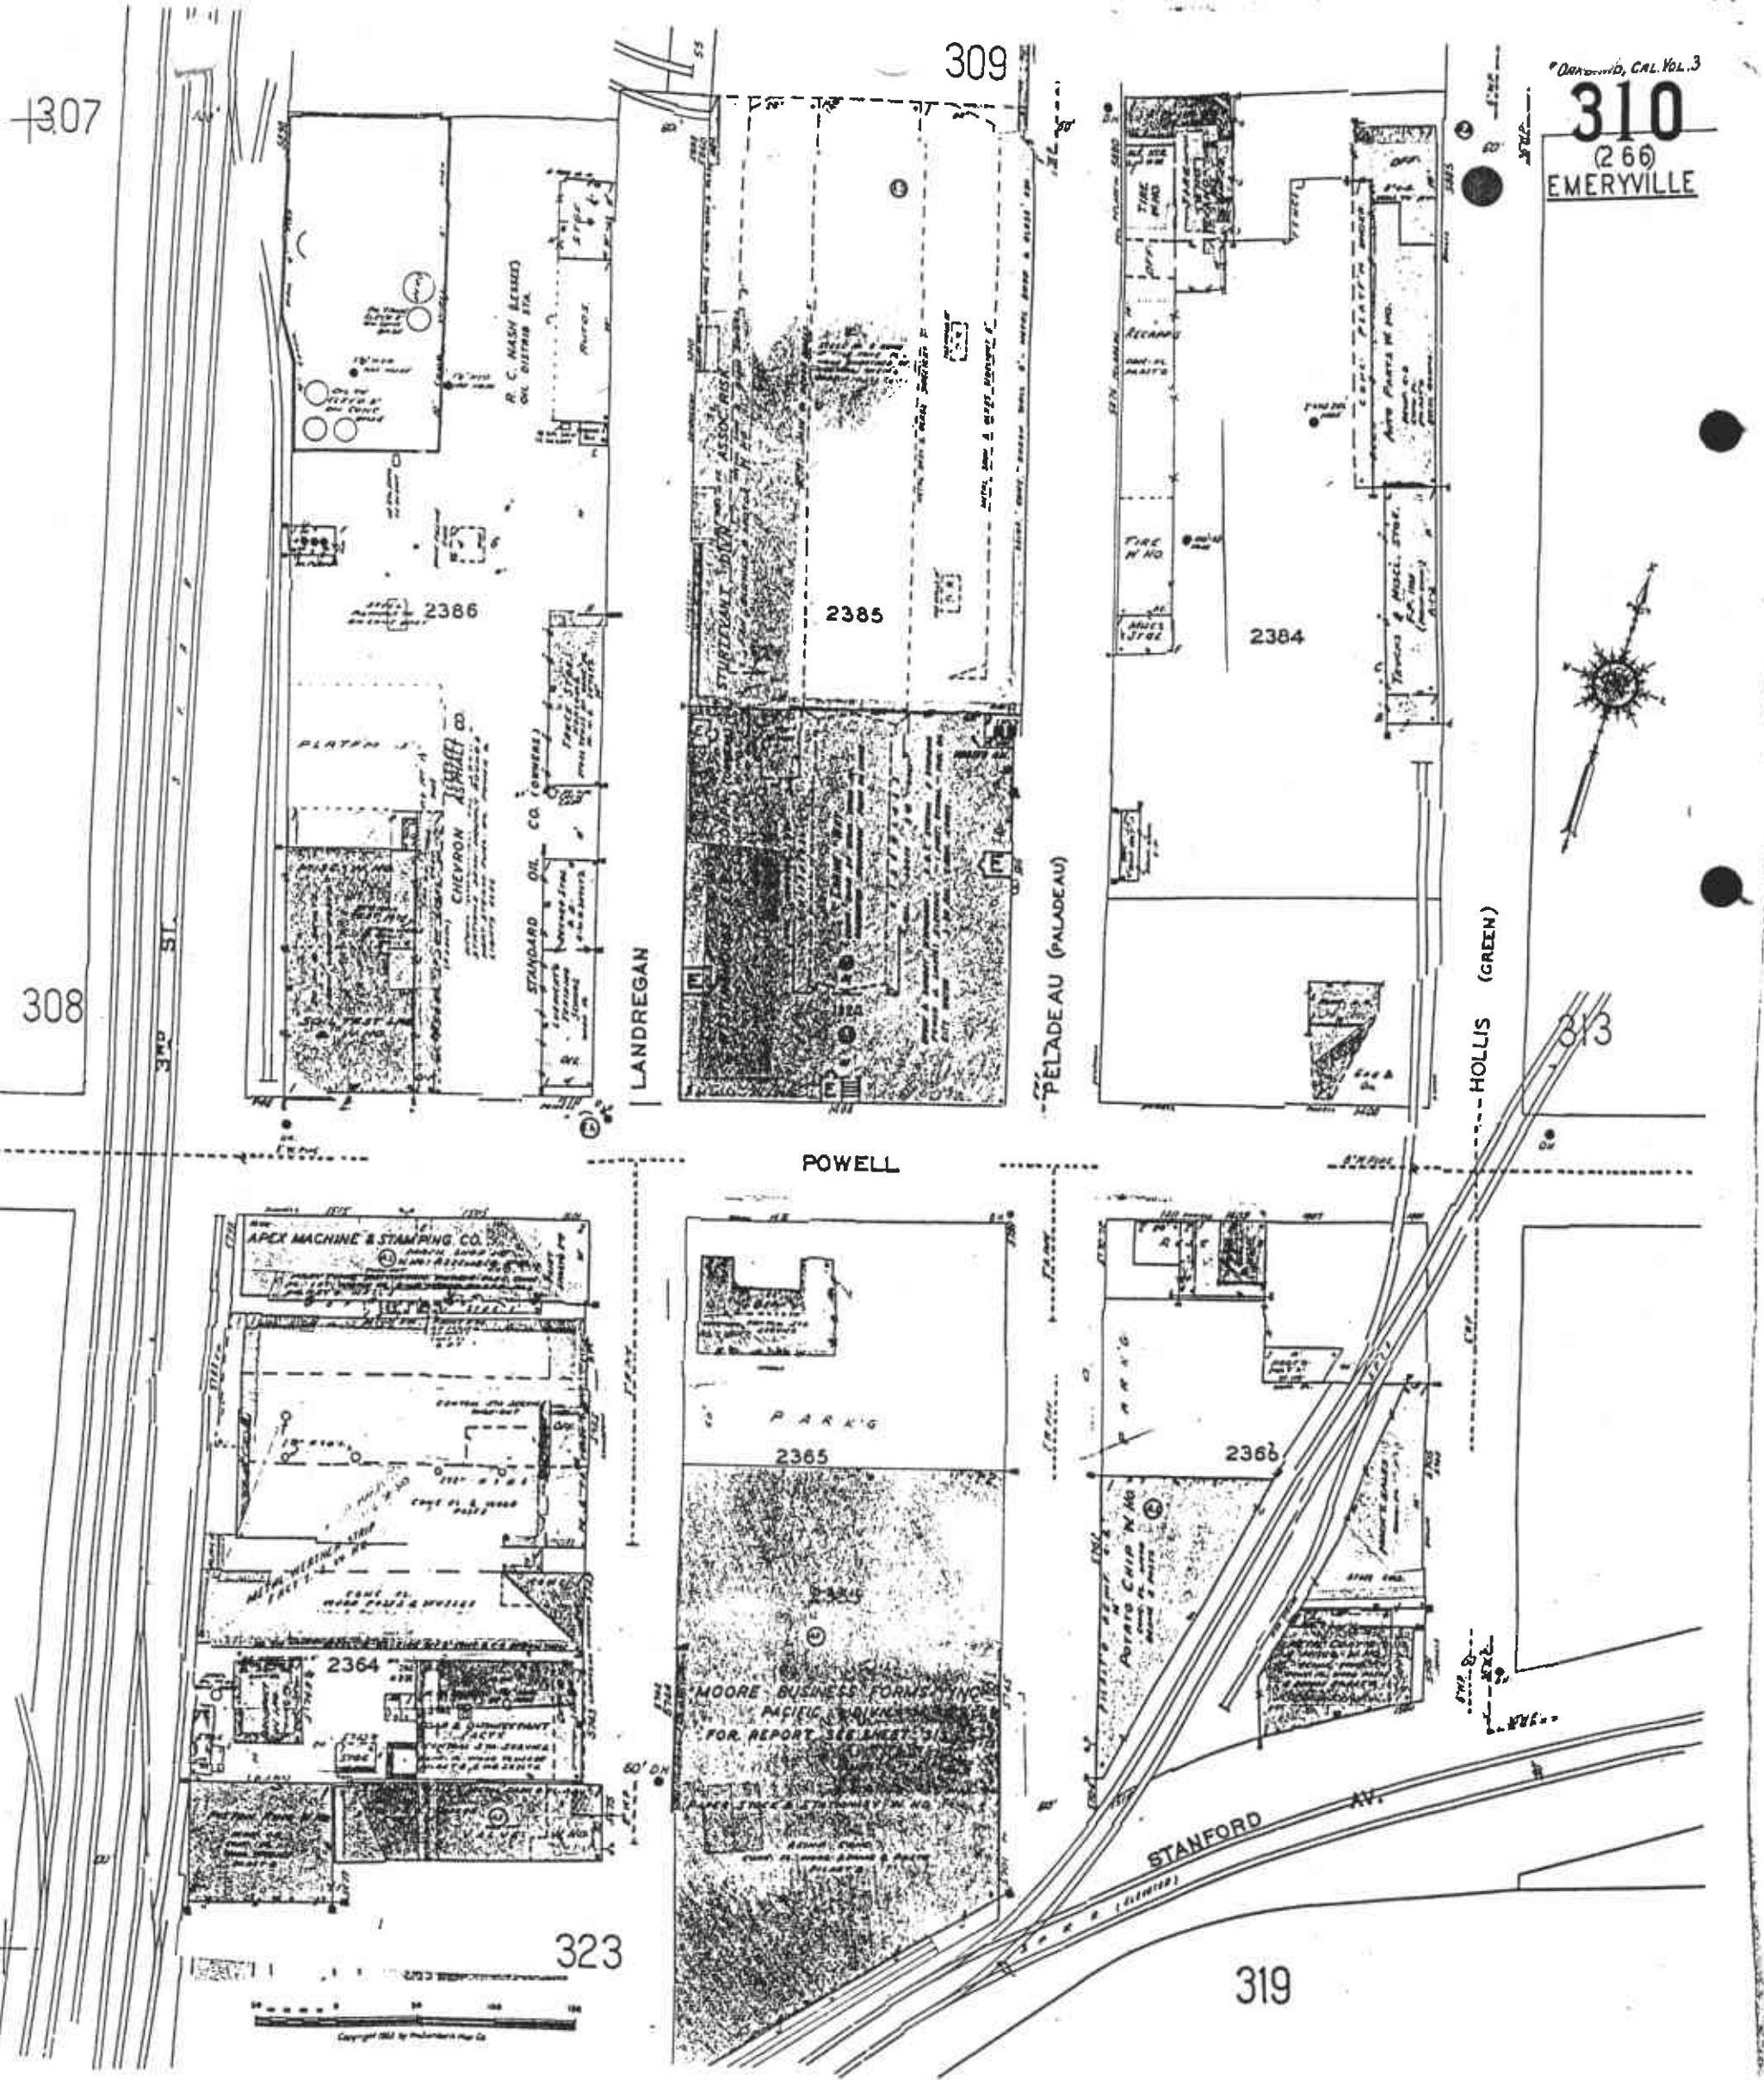
The auto repair shop has been converted into a tire warehouse, and a building addition has been added to the north end of the shop, occupying most of the Site. The garage along Hollis Street has been converted into an auto parts warehouse.

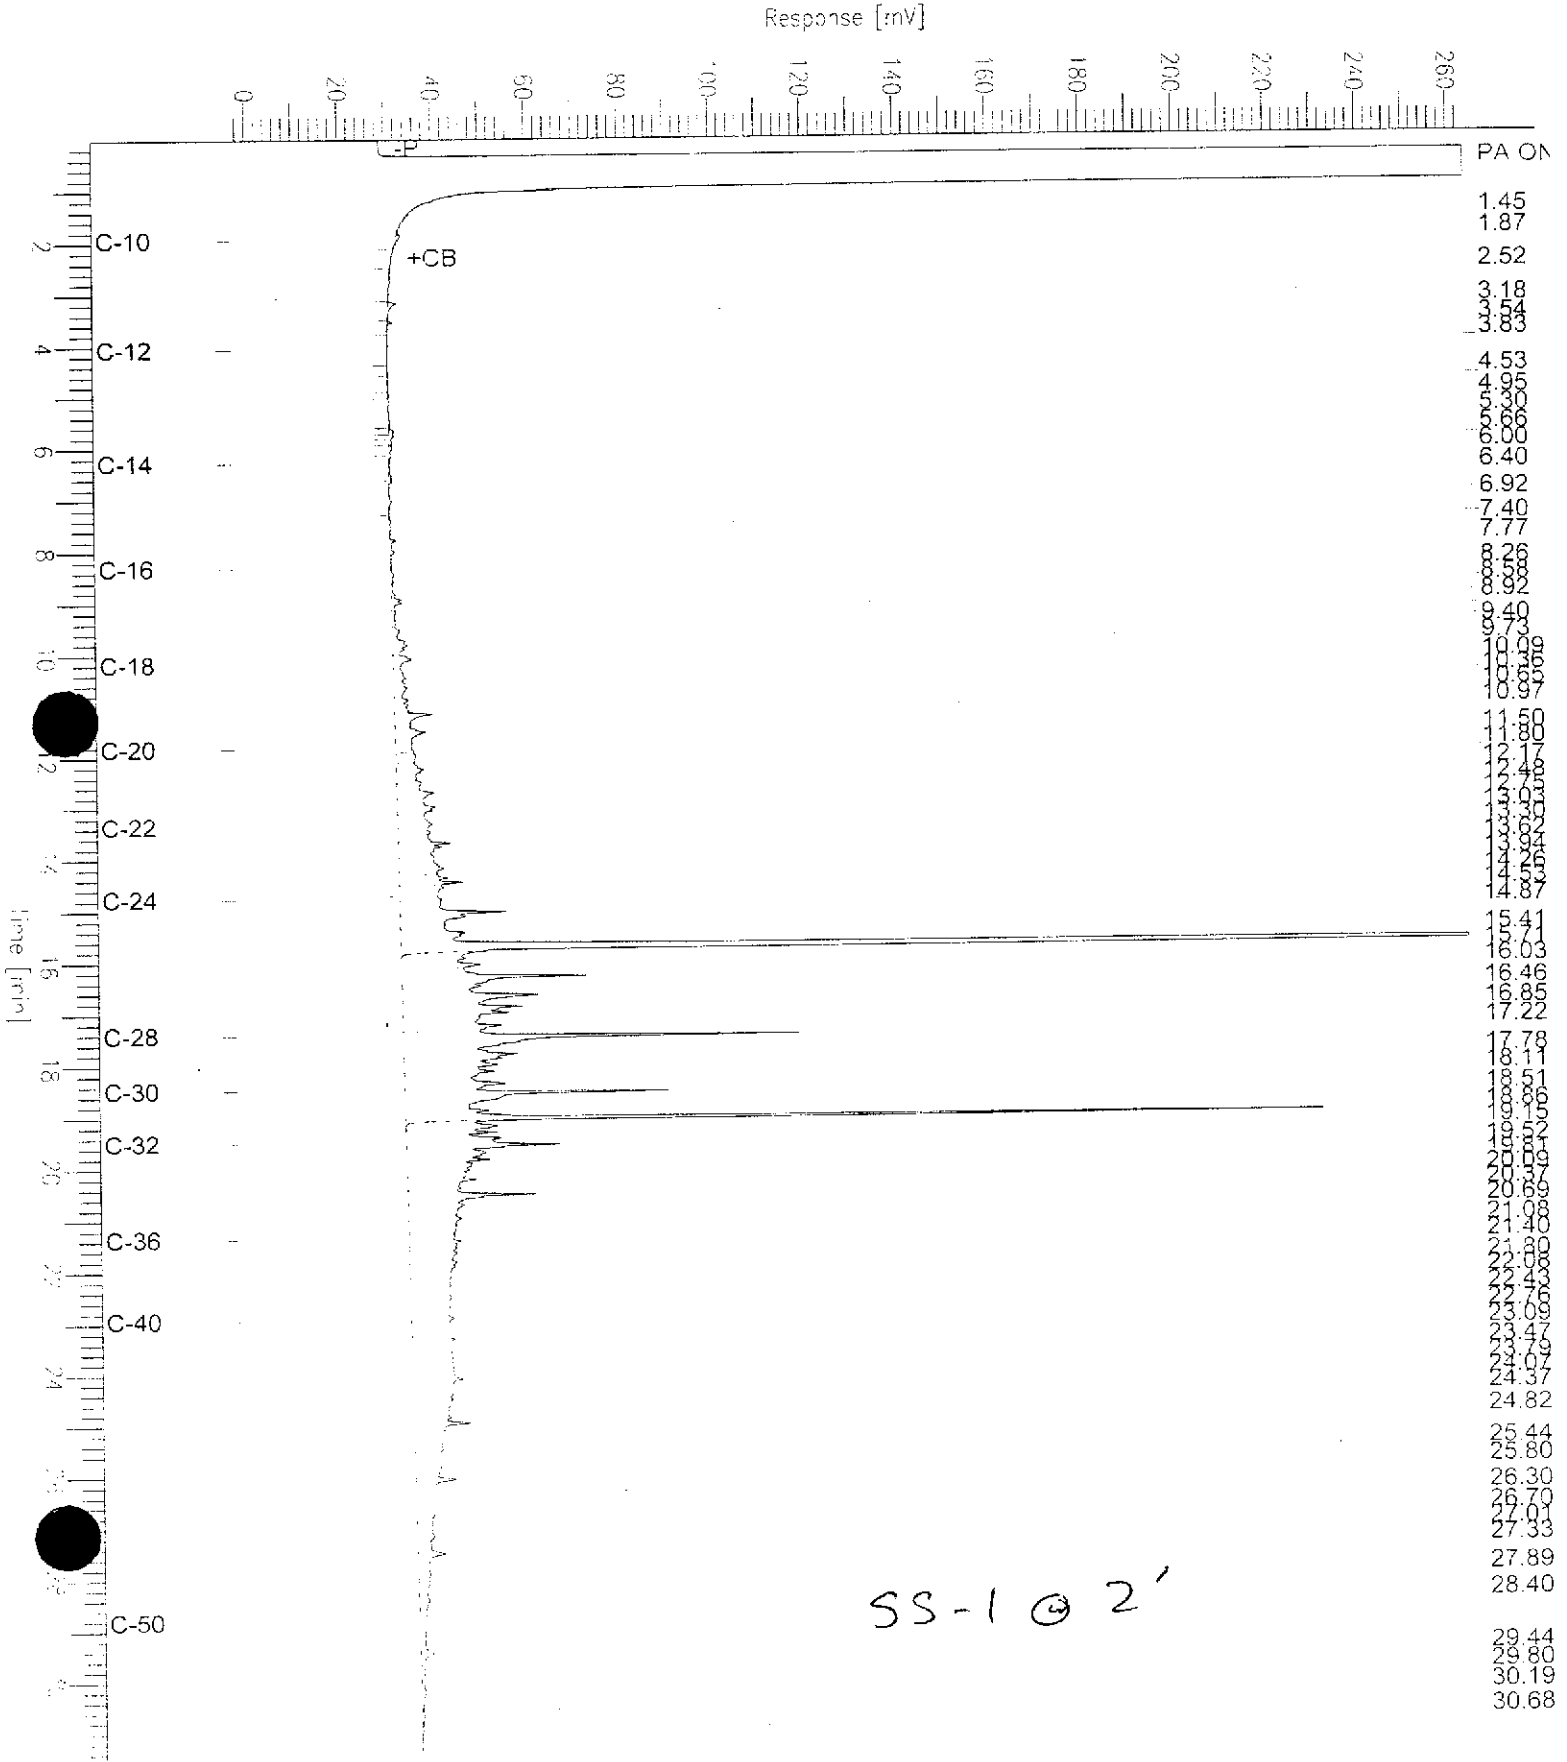
Sample Name : 140848-002,49836  
 File : G:\GC13\CHB\223B007.RAW  
 Method : BTEH201.MTH  
 Start Time : 0.01 min  
 Scale Factor : 0.0

End Time : 31.91 min  
 Plot Offset : 5 mV

Sample #: 49836  
 Date : 8/12/99 07:44 AM  
 Time of Injection: 8/12/99 12:41 AM  
 Low Point : 5.16 mV  
 High Point : 324.64 mV  
 Plot Scale: 319.5 mV

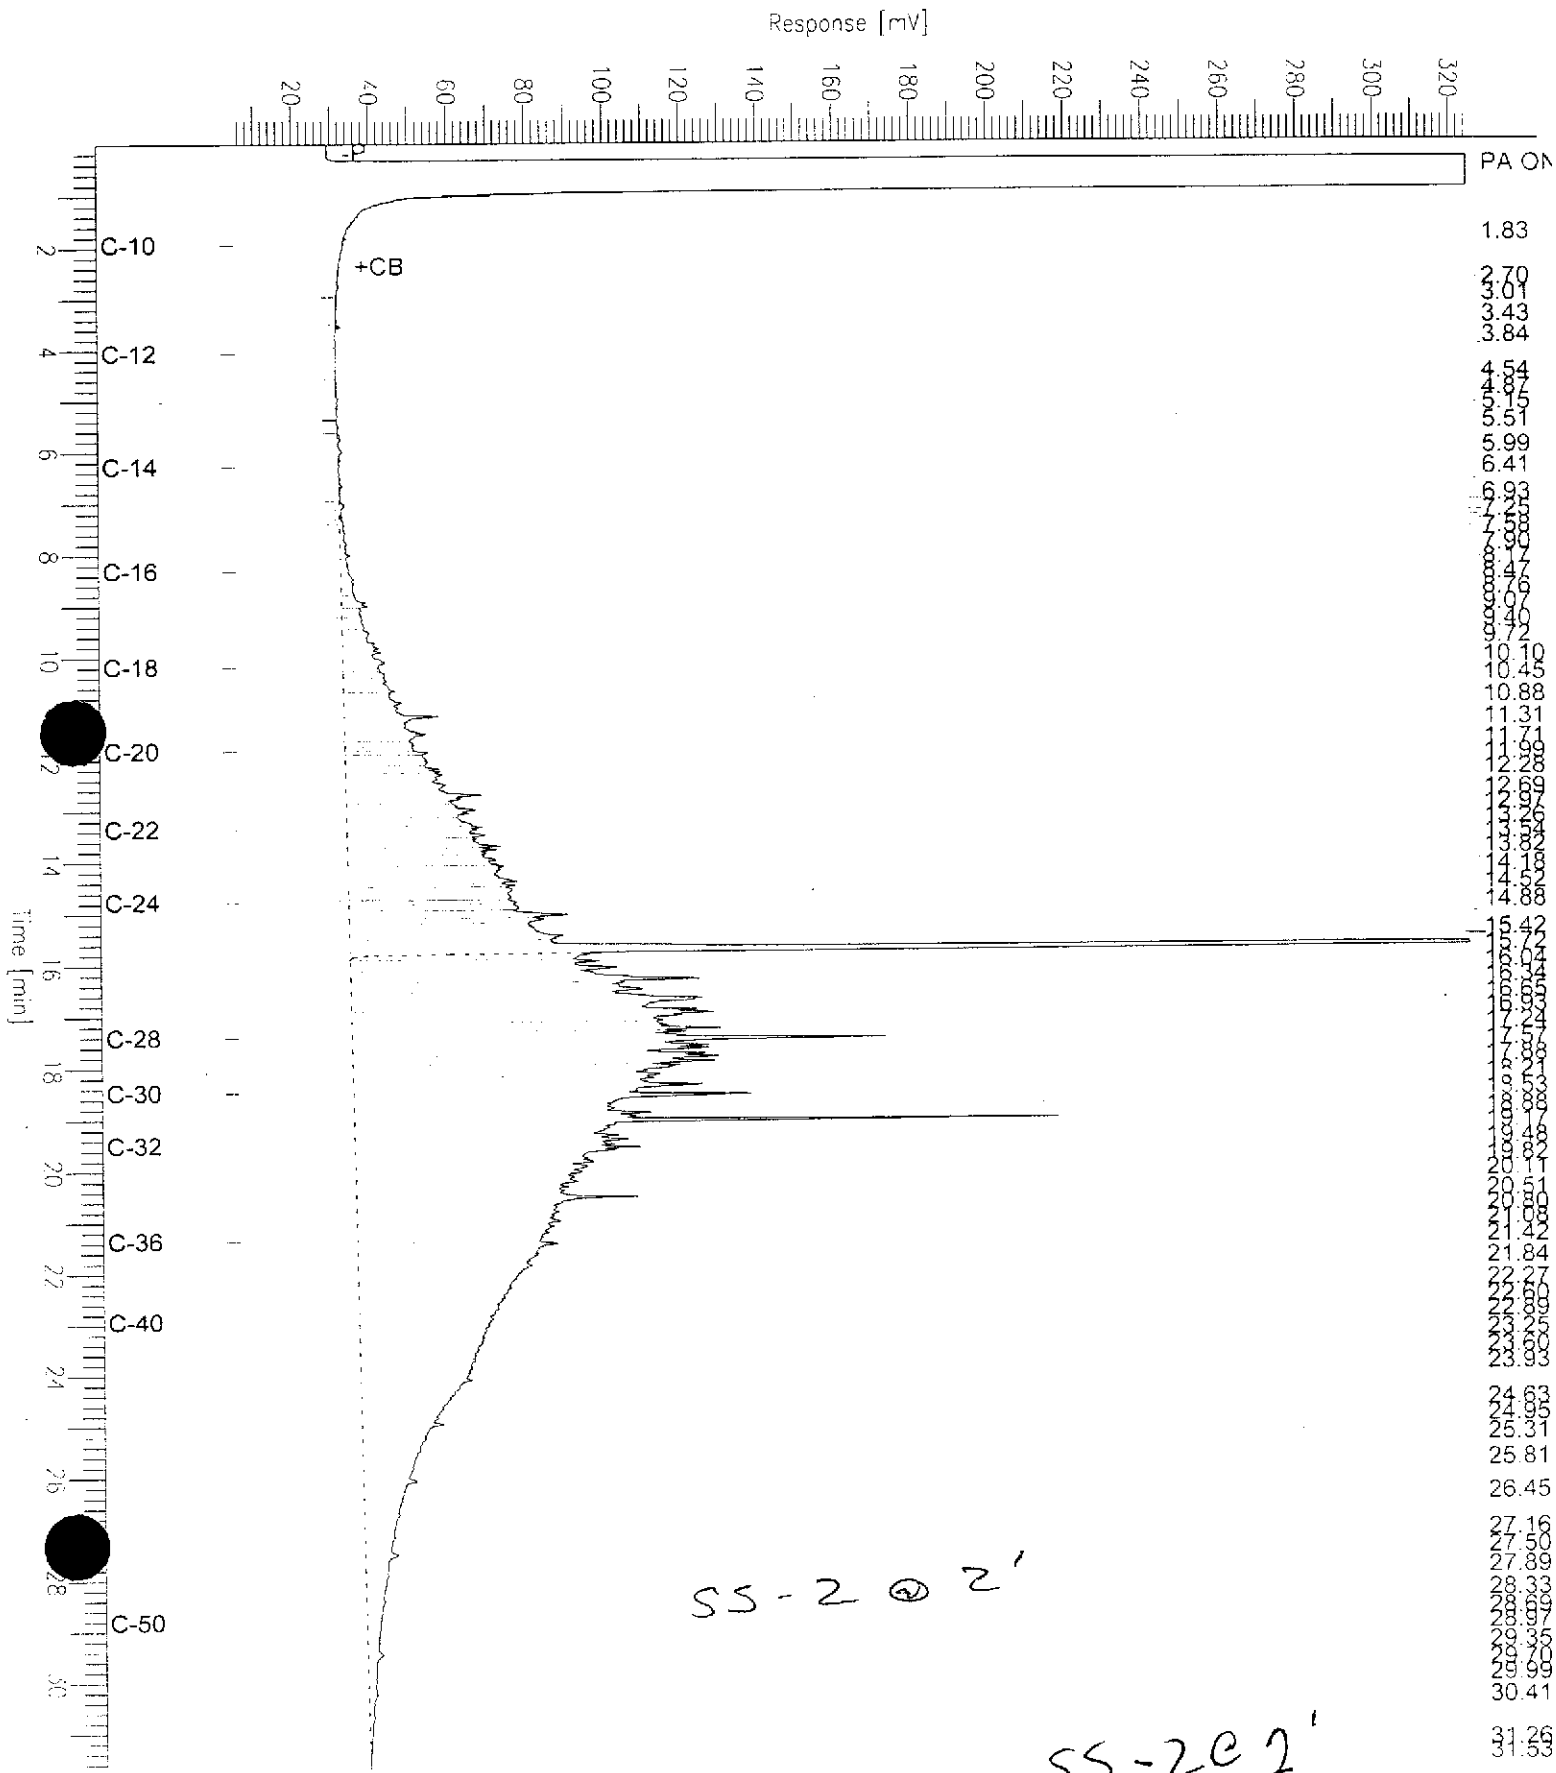
Sample Name : 140848-003,49836  
 File : G:\GC13\CHB\223B008.RAW  
 Method : BTEH201.MTH  
 Start Time : 0.01 min  
 Scale Factor : 0.0

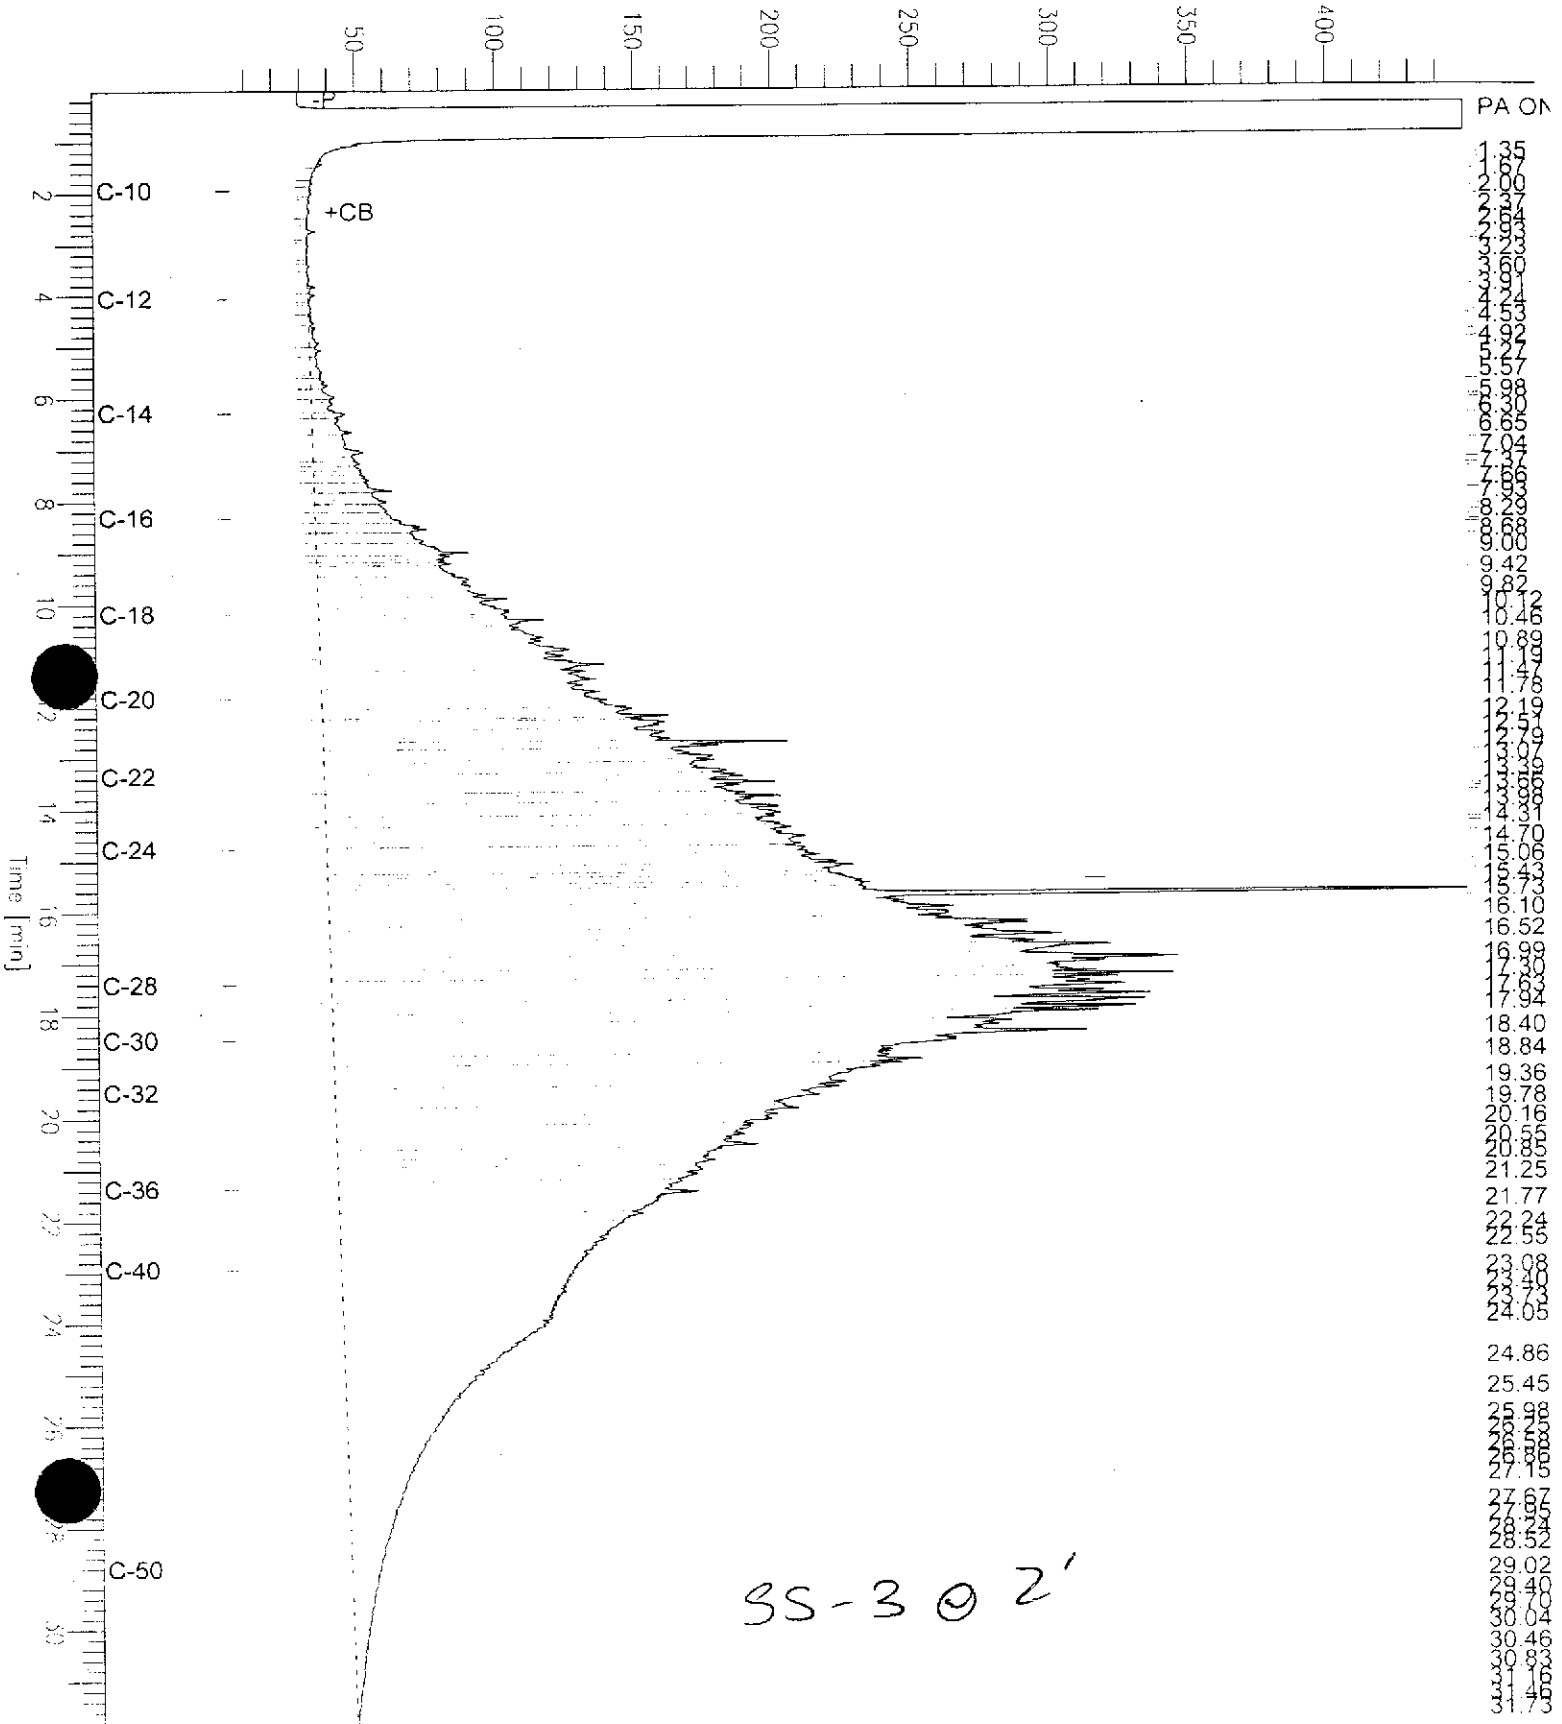
Sample Name : 140848-004,49836  
File Name : G:\GC13\CHB\223B009.RAW  
Method : BTEH201.MTH  
Start Time : 0.01 min  
Scale Factor : 0.0

Sample #: 49836  
Date : 8/12/99 07:46 AM  
Time of Injection: 8/12/99 02:04 AM  
Low Point : -2.81 mV  
Plot Scale: 242.6 mV

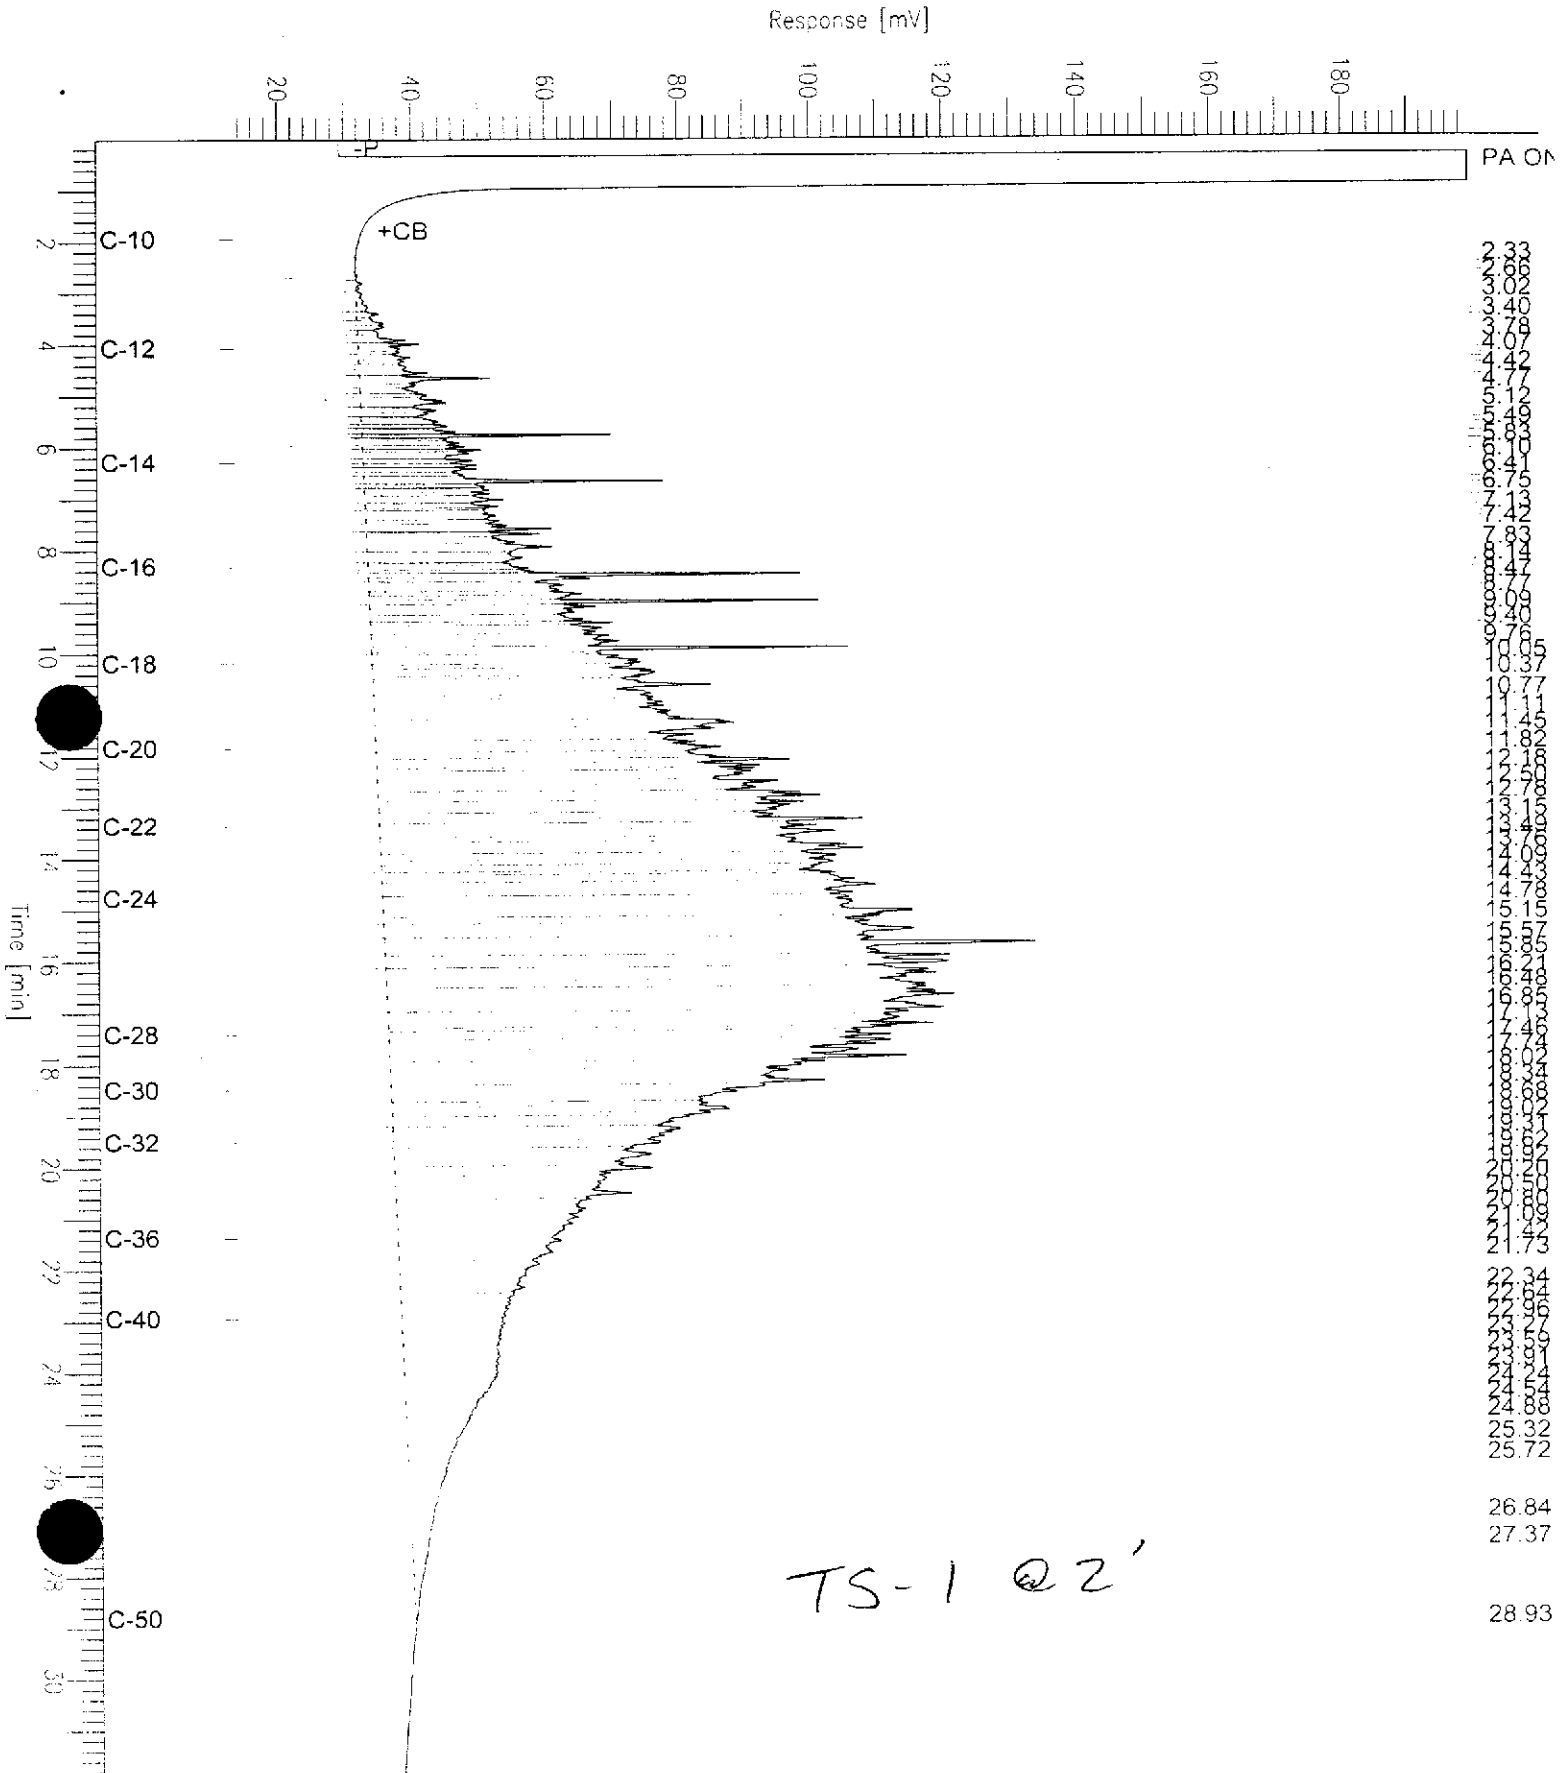
Sample Name : 140848-006,49836  
 File : G:\GC13\CHB\223B030.RAW  
 Method : BTEH201.MTH  
 Start Time : 0.01 min  
 Scale Factor : 0.0

End Time : 31.91 min  
 Plot Offset : -24 mV

Sample #: 49836  
 Date : 8/12/99 04:58 PM  
 Time of Injection: 8/12/99 04:41 PM  
 Low Point : -24.30 mV  
 High Point : 413.08 mV  
 Plot Scale: 437.4 mV
