**PROJECT:** Proposed 59th Street Widening/Results of Environmental Review

August 19, 1999  
SCI 537.014

**Results of Environmental Review,  
Soil Sampling, and Chemical Analyses  
Proposed 59<sup>th</sup> Street Widening  
Emeryville, California**

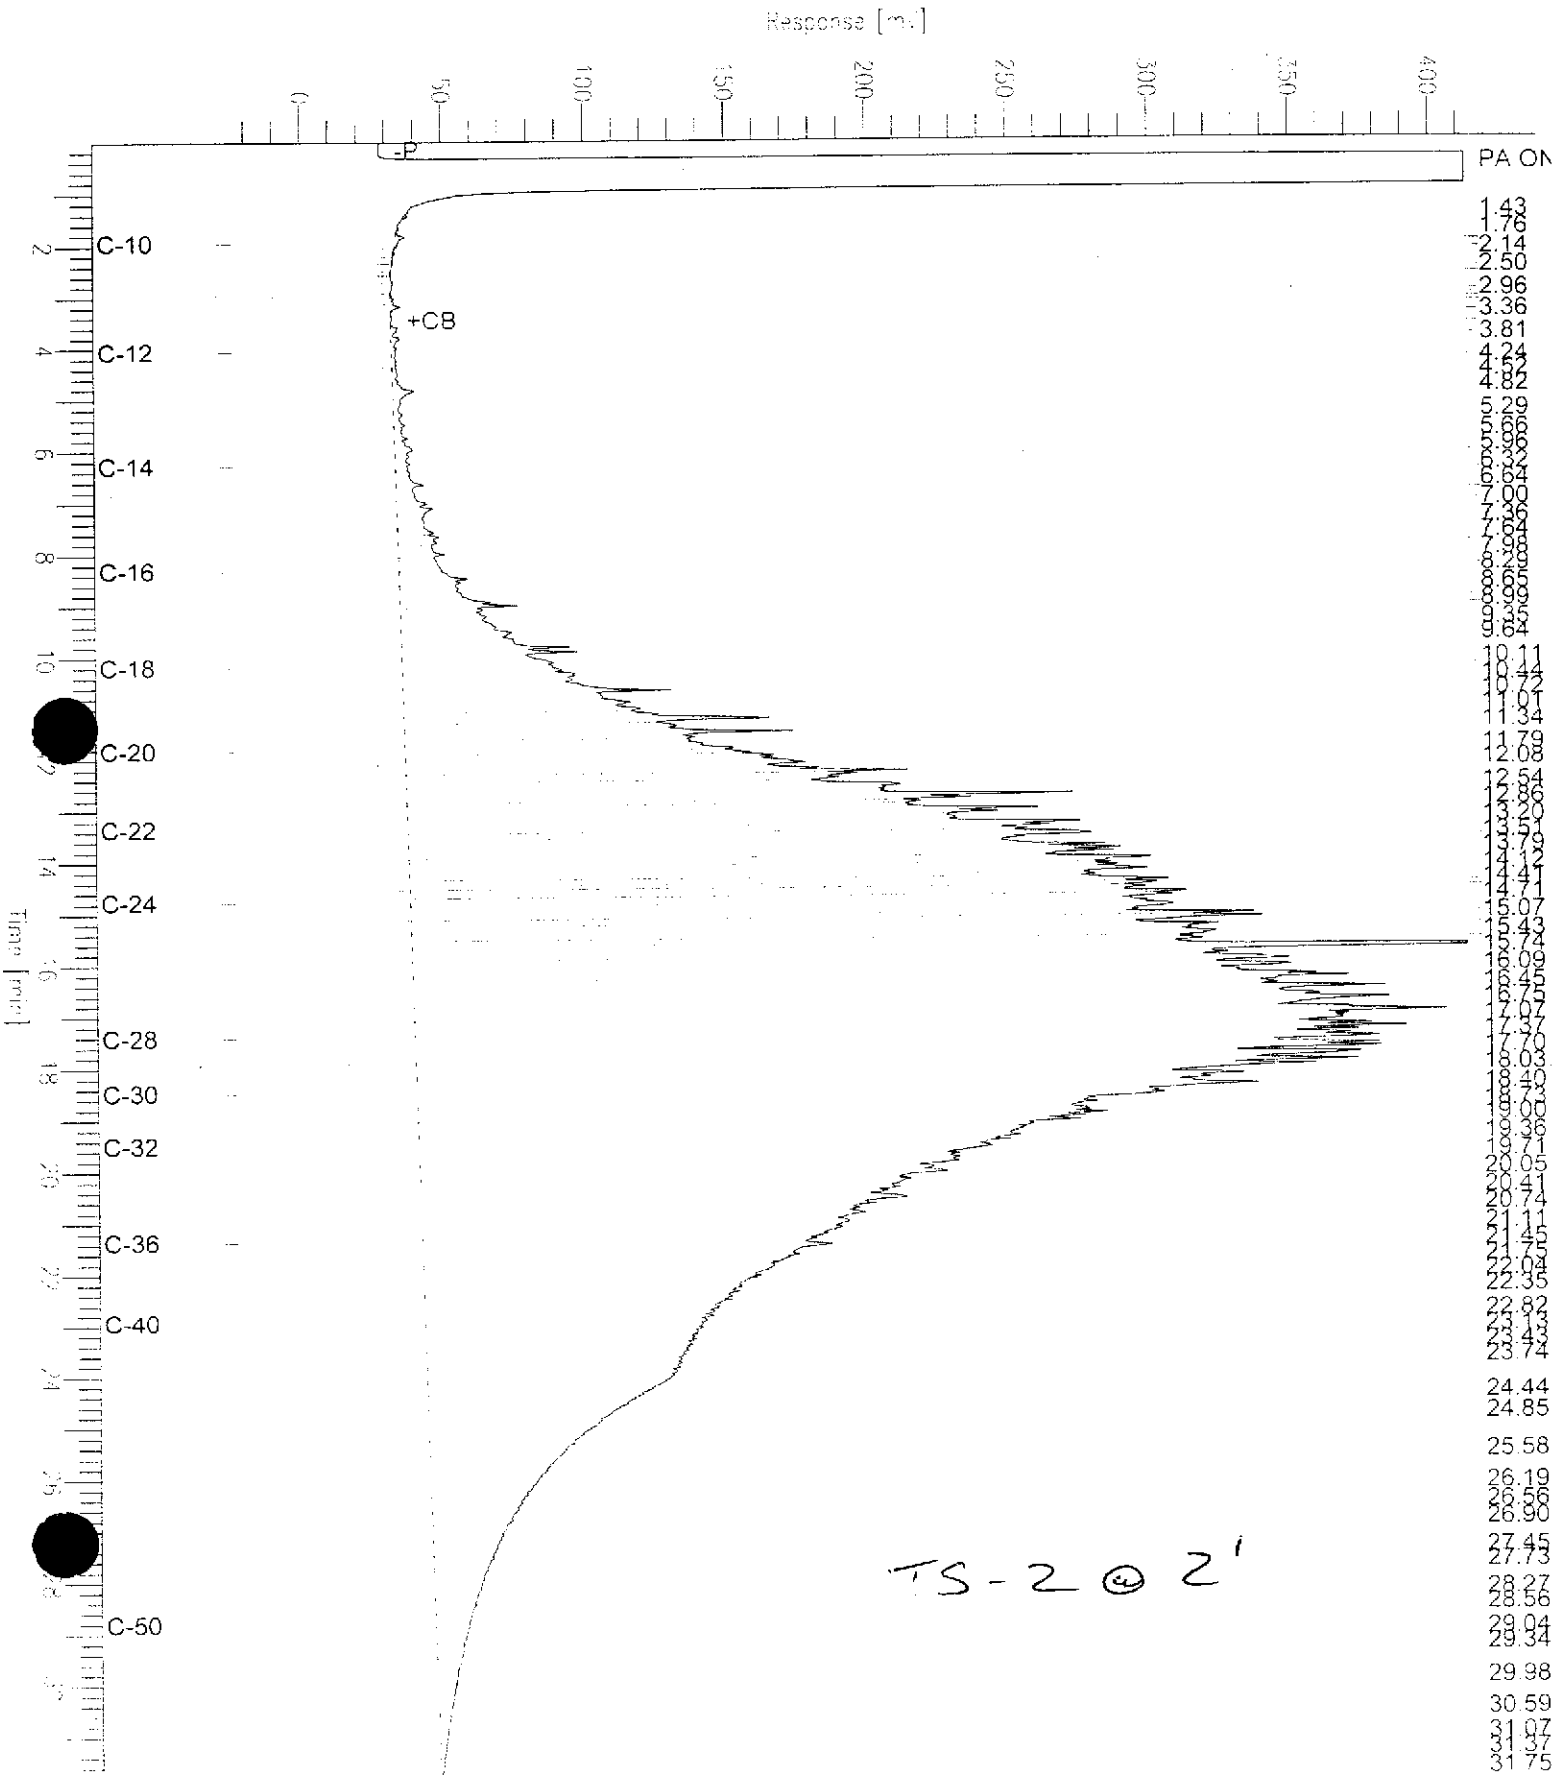
Sample Name : ccv,99ws7881,dsl  
File : G:\GC13\CHB\223B002.RAW  
Meth : BTEH201.MTH  
Start Time : 0.01 min  
Scale Factor: 0.0

Sample #: 500mg/l  
Date : 8/12/99 07:41 AM  
Time of Injection: 8/11/99 09:13 PM  
Low Point : 4.31 mV  
High Point : 319.88 mV  
Plot Scale: 315.6 mV

*Diesel Standard*

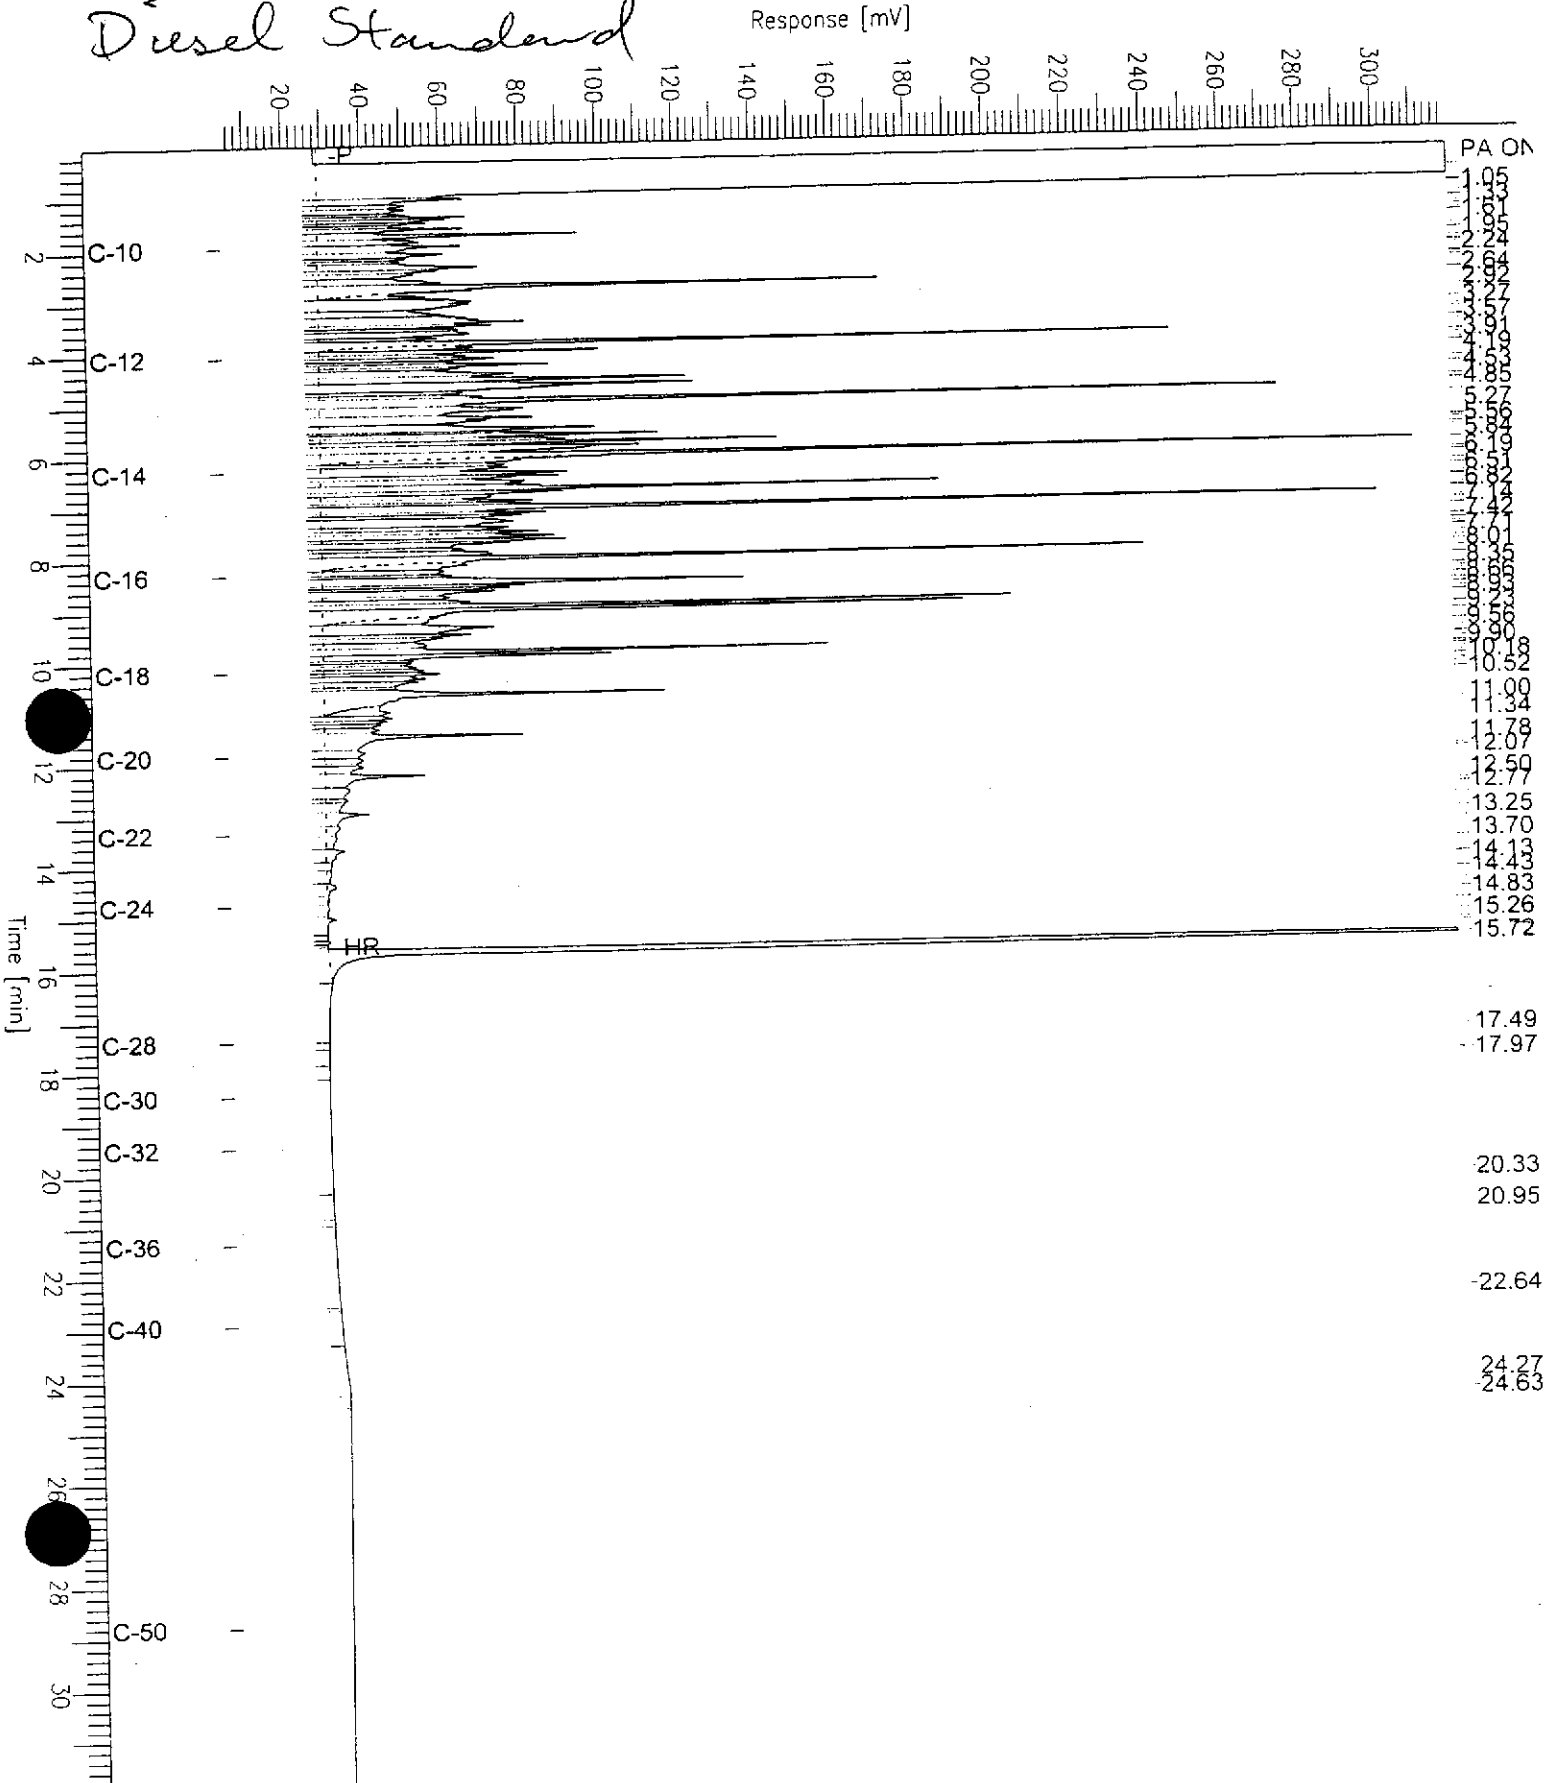
Sample Name : ccv,99ws7880,mo  
 File : G:\GC13\CHB\223B003.RAW  
 Method : BTEH201.MTH  
 Start Time : 0.01 min  
 Scale Factor : 0.0

*Motor Oil Standard*

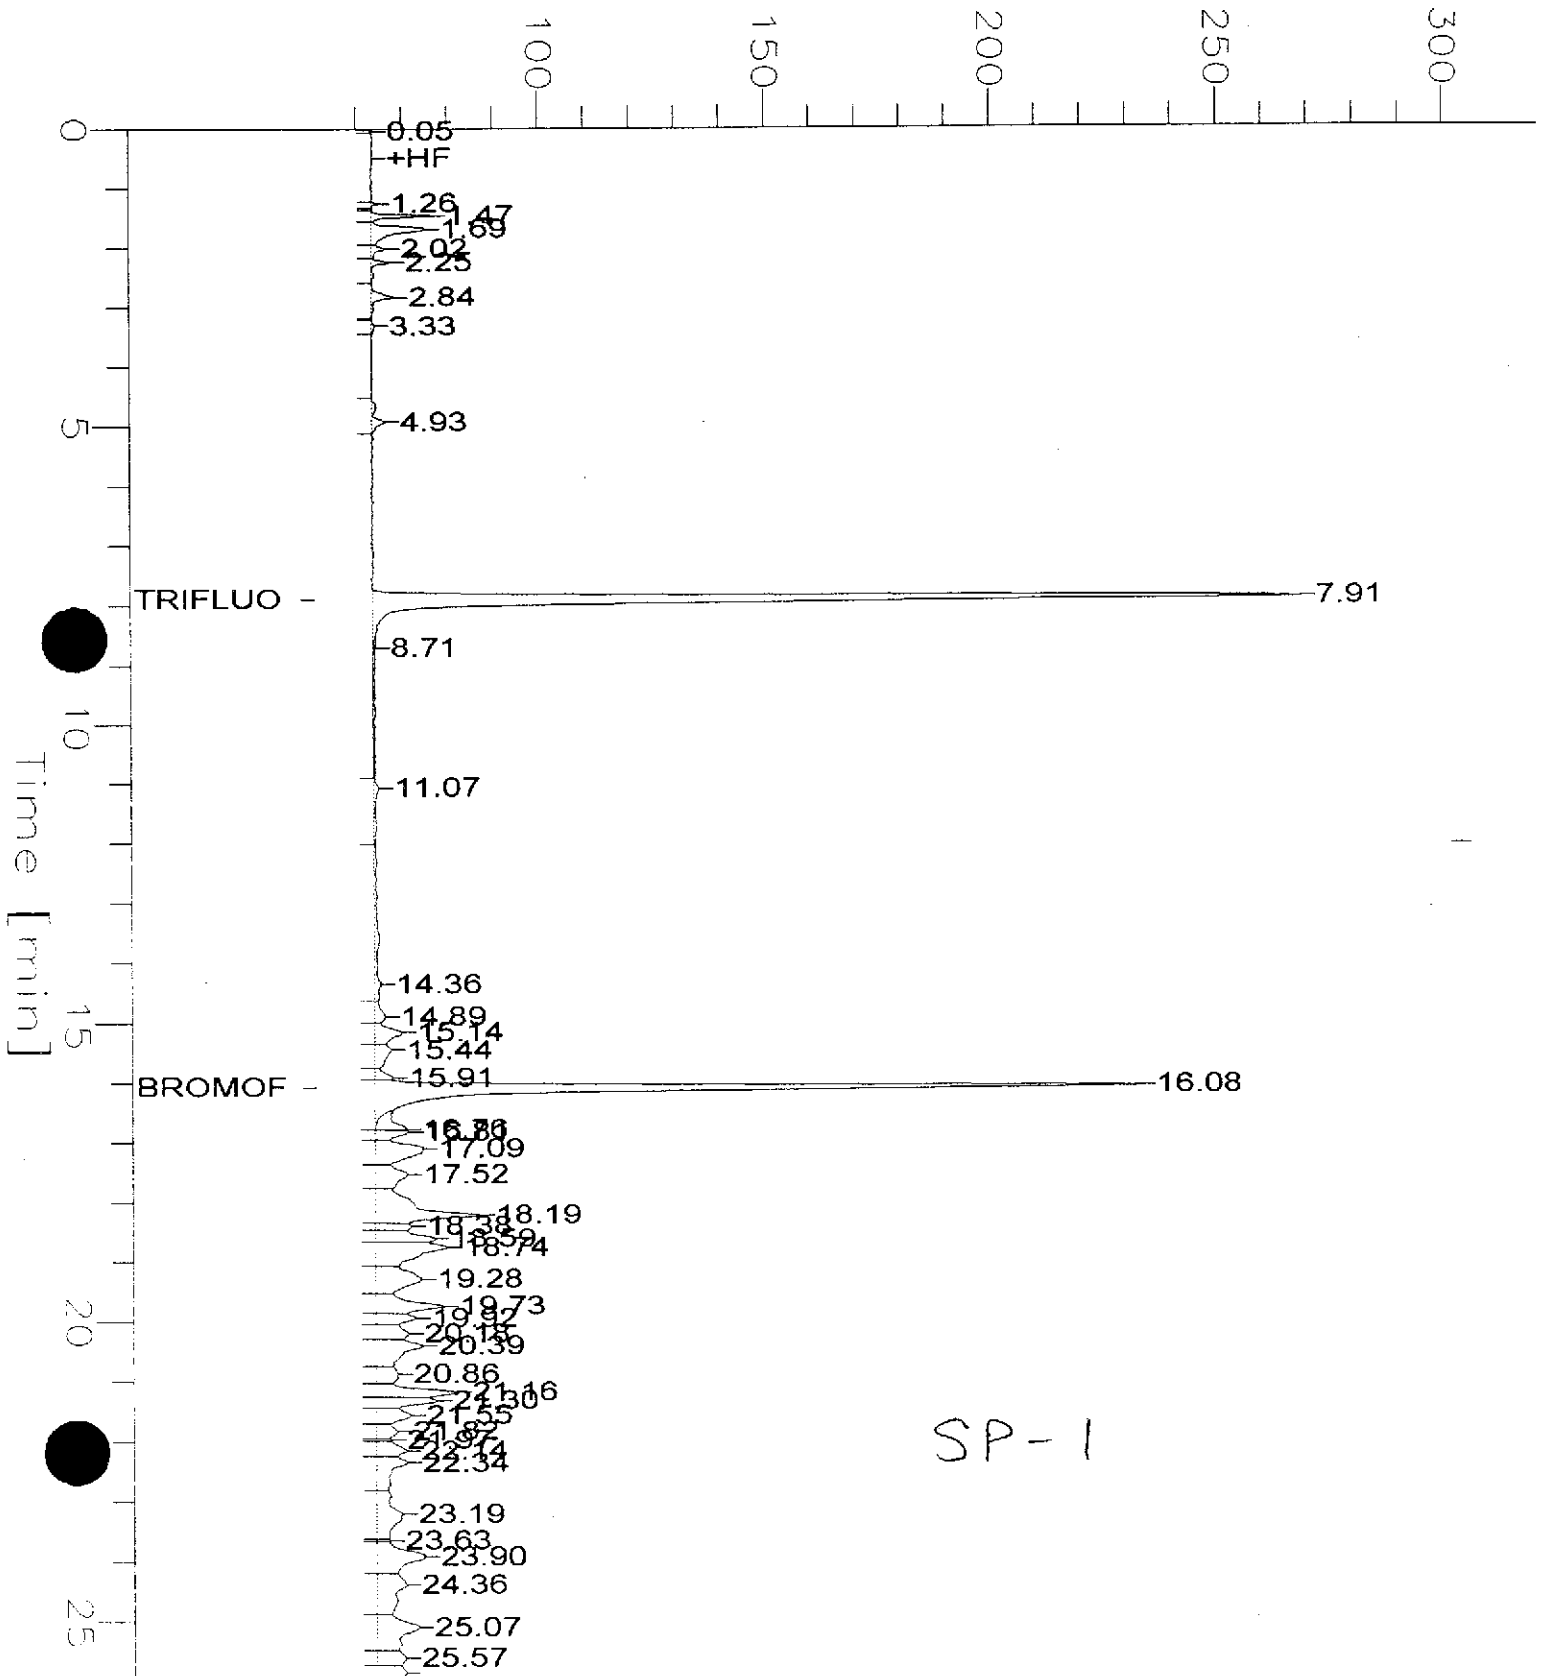
GC04 TVH 'J' Data File Rtx1FID

Sample Name : CCV/LCS, QC04411, 99WS7780, 49776  
File : G:\GC04\DATA\218J001.raw  
Met : TVHBTXE  
Start Time : 0.00 min  
Scale Factor : -1.0

Sample #: GAS  
Date : 8/6/99 11:40 AM  
Time of Injection: 8/6/99 11:14 AM  
Low Point : 50.21 mV  
Plot Scale: 250.0 mV  
High Point : 300.21 mV

*Gasoline Standard* Response [mV]

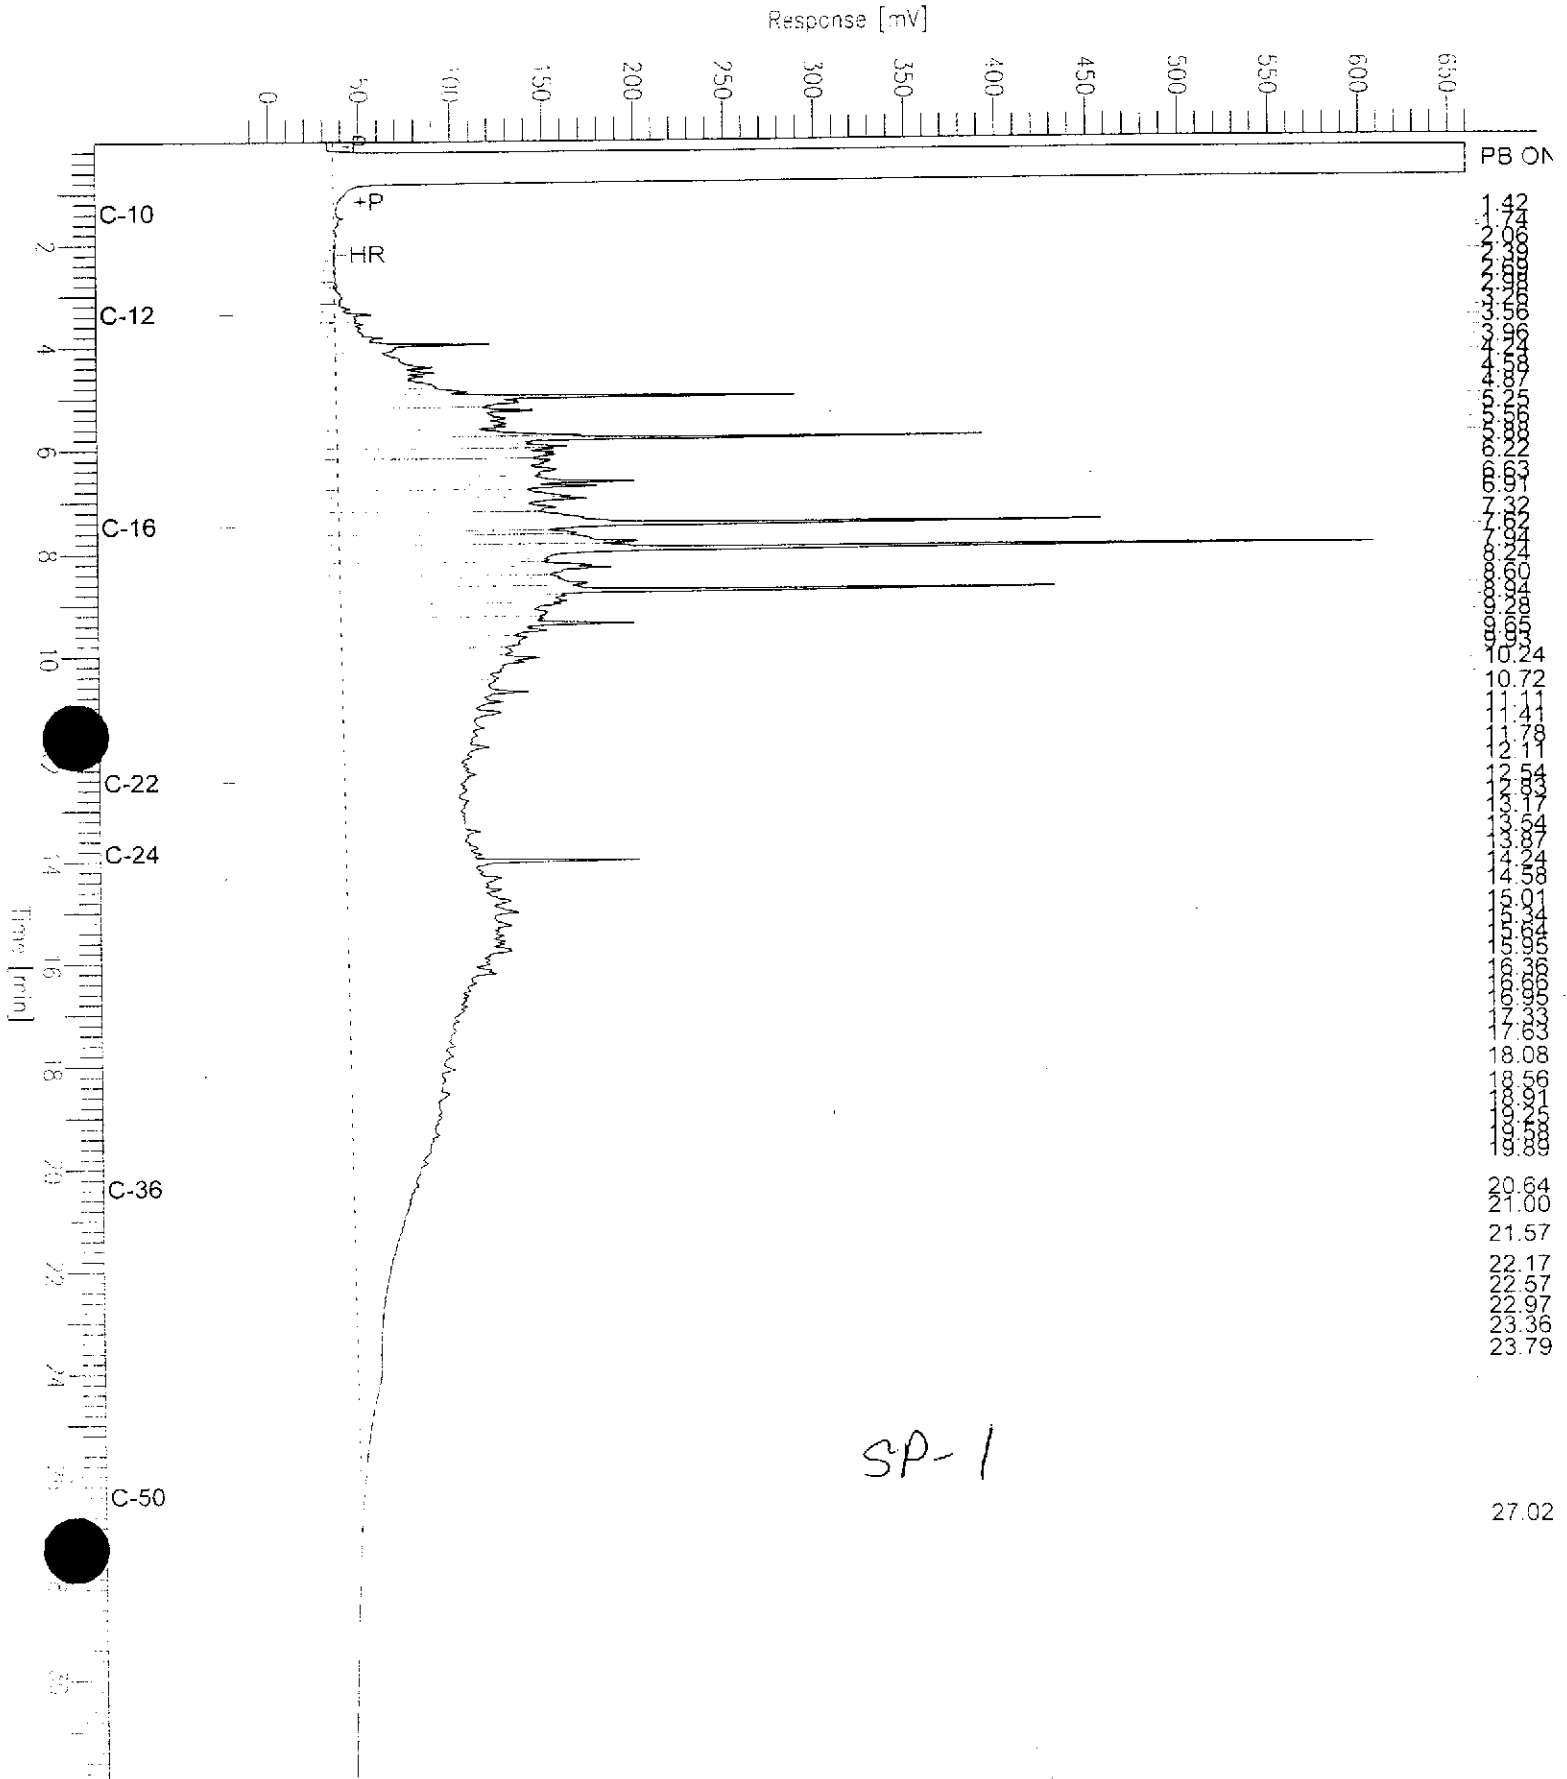
Sample Name : 140805-001,49804  
 FileName : C:\GC15\CHB\222B038.RAW  
 Meth : BTEH203.MTH  
 Start Time : 0.01 min  
 Scale factor: 0.0

Sample #: 49804  
 Date : 8/12/99 08:21 AM  
 Time of Injection: 8/11/99 08:51 PM  
 Low Point : -19.42 mV  
 High Point : 660.09 mV  
 Plot Scale: 679.5 mV  
 End Time : 31.91 min  
 Plot Offset: -19 mV
