Golder Associates Inc.

May 7, 1997

SUBJECT: ADDITIONAL SAMPLING RESULTS FOR 2364 BAUMANN AVENUE, SAN LORENZO, CALIFORNIA

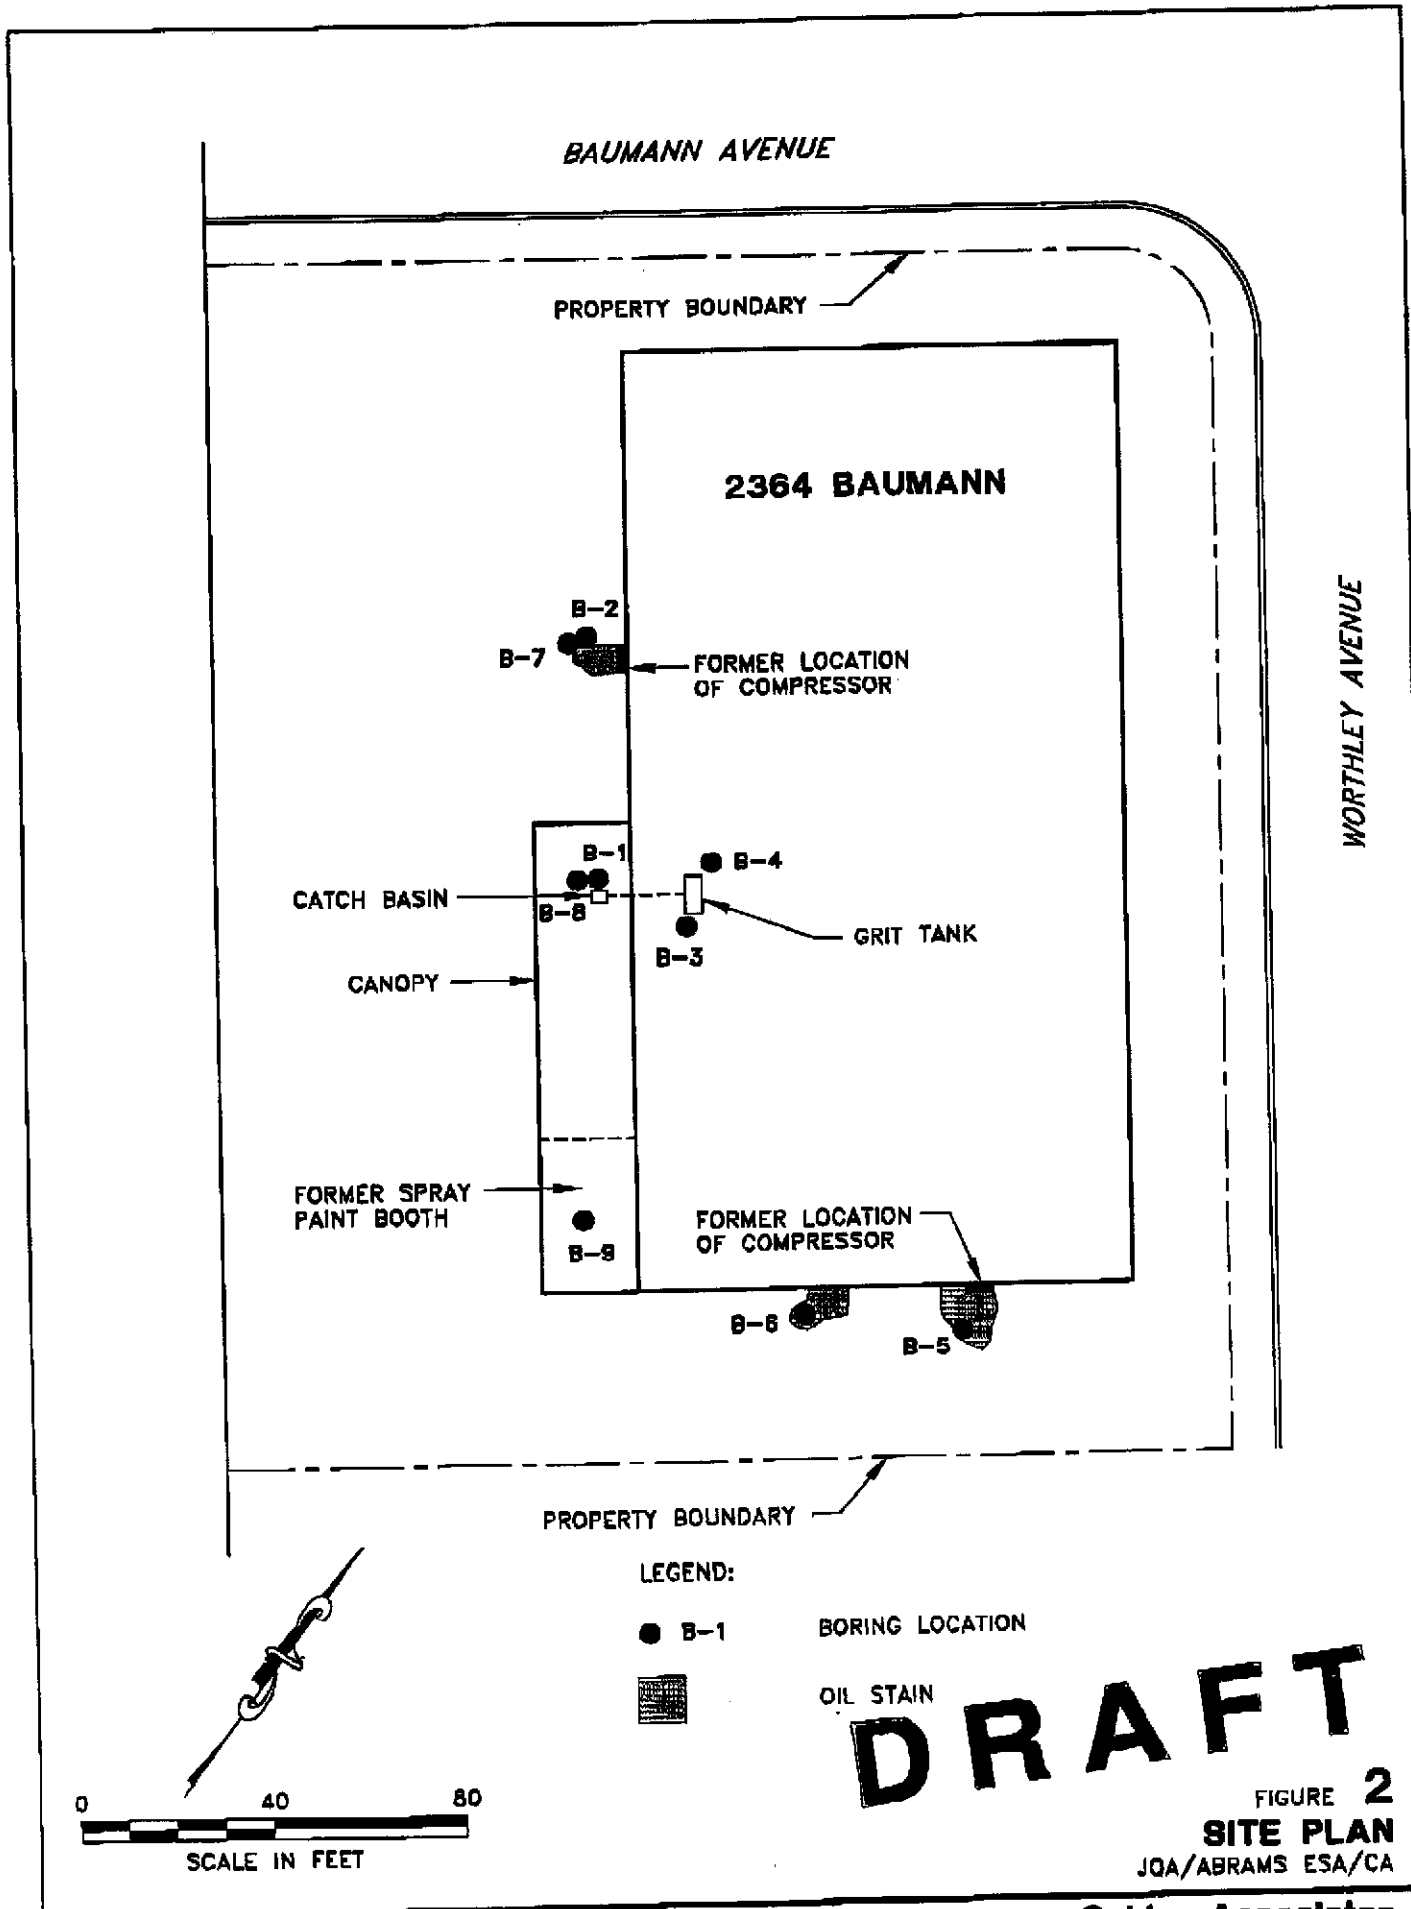
Golder performed additional soil and groundwater sampling on May 2, 1997. Three borings were advanced; boring B-7 in the oil-stained compressor area (adjacent to boring B-2), boring B-8 next to the grit tank/catch basin (adjacent to boring B-1), and boring B-9 in the center of the former paint booth. The locations of the additional and previous borings are shown in Figure 2.
