**PHASE I ENVIRONMENTAL SITE ASSESSMENT
THE FORMER CHROMEX PLATING FACILITY
AT THE CHARLES LOWE COMPANY
1400 PARK AVENUE
EMERYVILLE, CALIFORNIA**

**ENVIRONMENTAL SCIENCE AND ENGINEERING, INC
4090 NELSON AVENUE, SUITE J
CONCORD, CALIFORNIA 94520**

ESE PROJECT NO. 6-94-5246

AUGUST 23, 1994

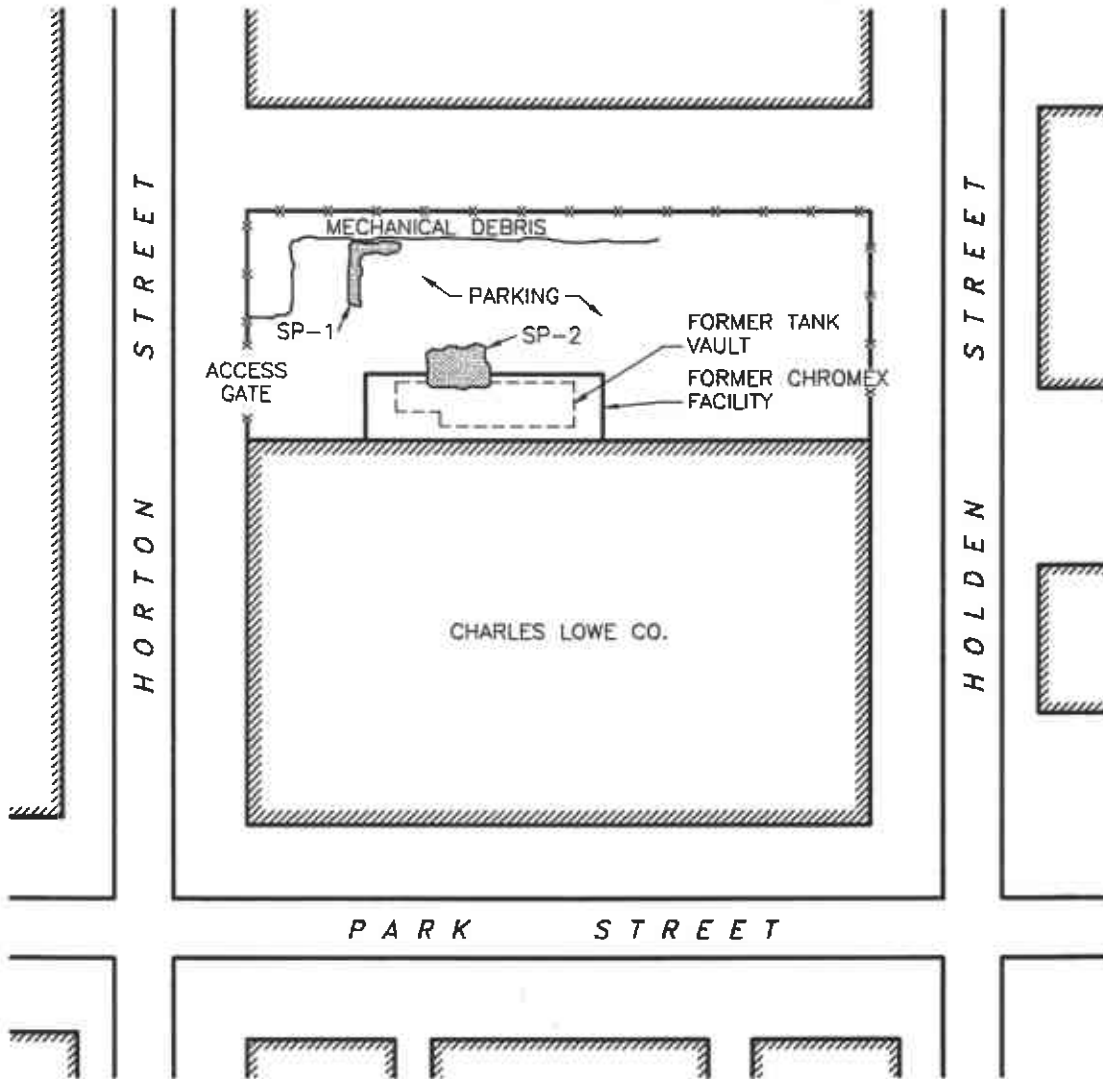
The Charles Lowe Company (Charles Lowe) produces and repairs marine and industrial equipment. Chromex was located at the north end of the Charles Lowe facility (Figure 2 - Site Map), and was a one-room structure supplying electroplating and metal spraying in support of manufacturing operations at Charles Lowe. Chromex ceased operations in January 1991 and was dismantled in June 1992.

The Property is an approximately 100- by 50-foot area at the north side of the Charles Lowe Company facility at 1400 Park Avenue, Emeryville, California. The Property is within the boundaries of the Charles Lowe facility. A parking lot access gate and 6-foot chain fence provides a barrier to public access. The Property presently consists of remnants of a concrete foundation, a back-filled excavated hole, and an uncovered stockpile of excavated soil approximately 15 x 10 x 5 feet high. Immediately to the north of the Property is a parking area for employees of Charles Lowe. On the north side of this parking lot, approximately 40 feet from the Property (but within the fenced boundary of the Charles Lowe facility), is a smaller uncovered stockpile of soil measuring approximately 10 x 5 x 2.5 feet high. According to Mr. Slade, this smaller stockpile was part of the soil excavated during dismantling of the Chromex facility.

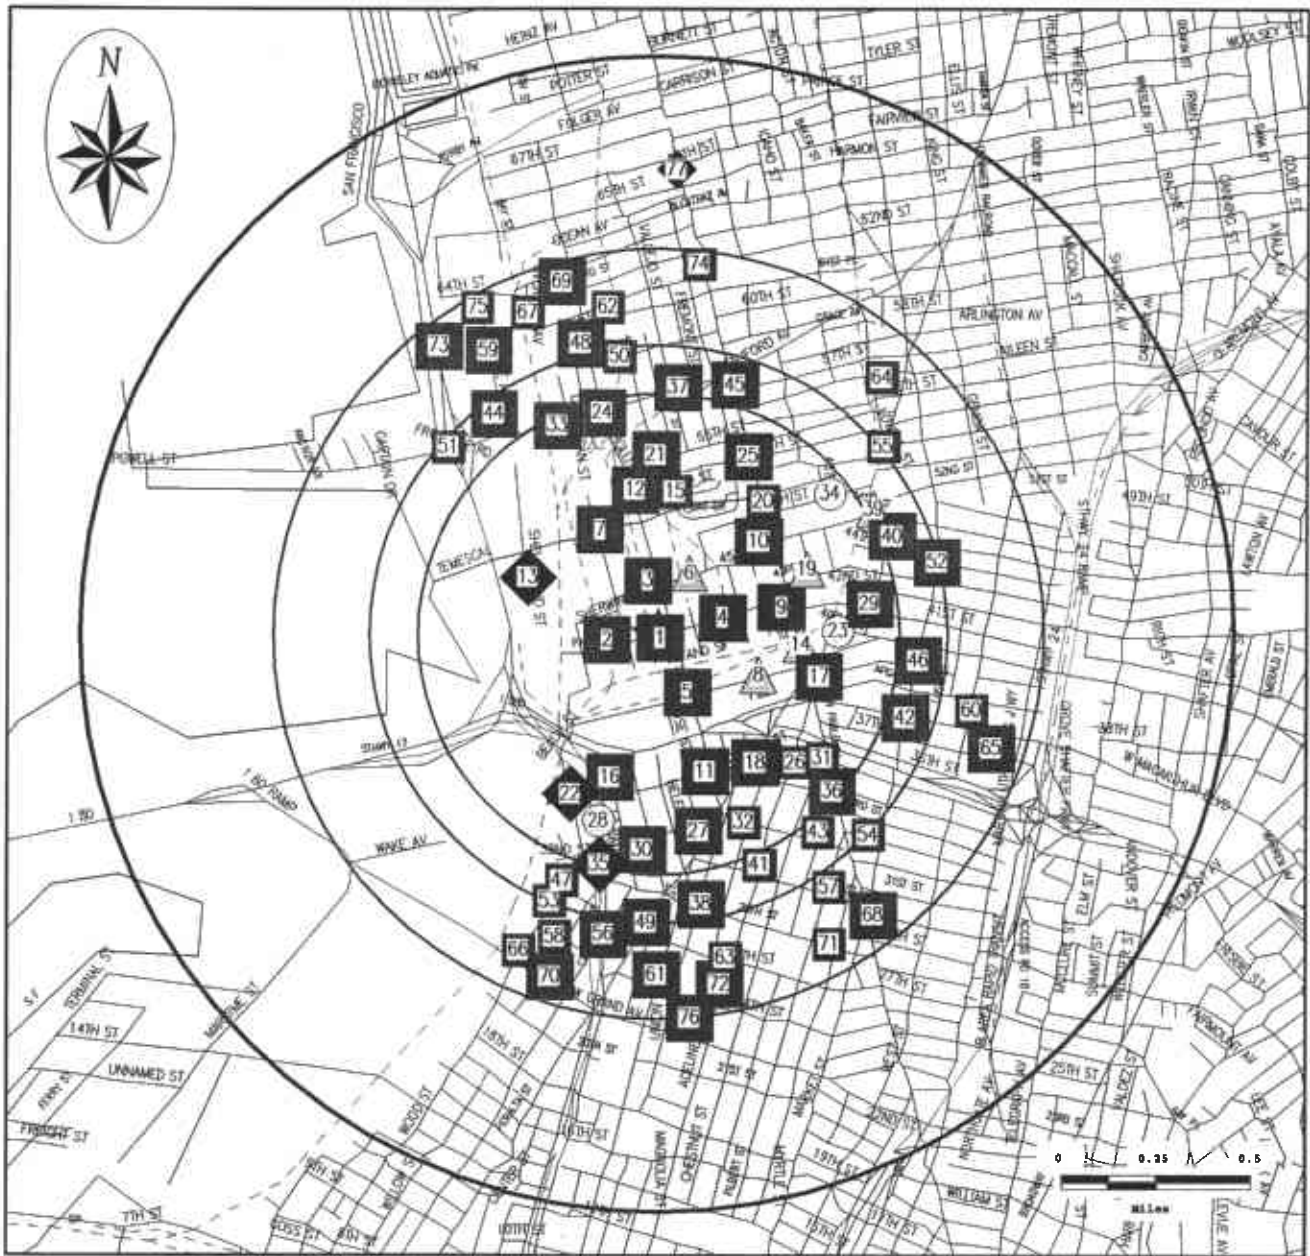
Map of Risks Within One and One-Half Miles

If additional databases are listed in the cover page of the report they are also displayed on this map. The map symbol used corresponds to the database category letter A,B,C,D.

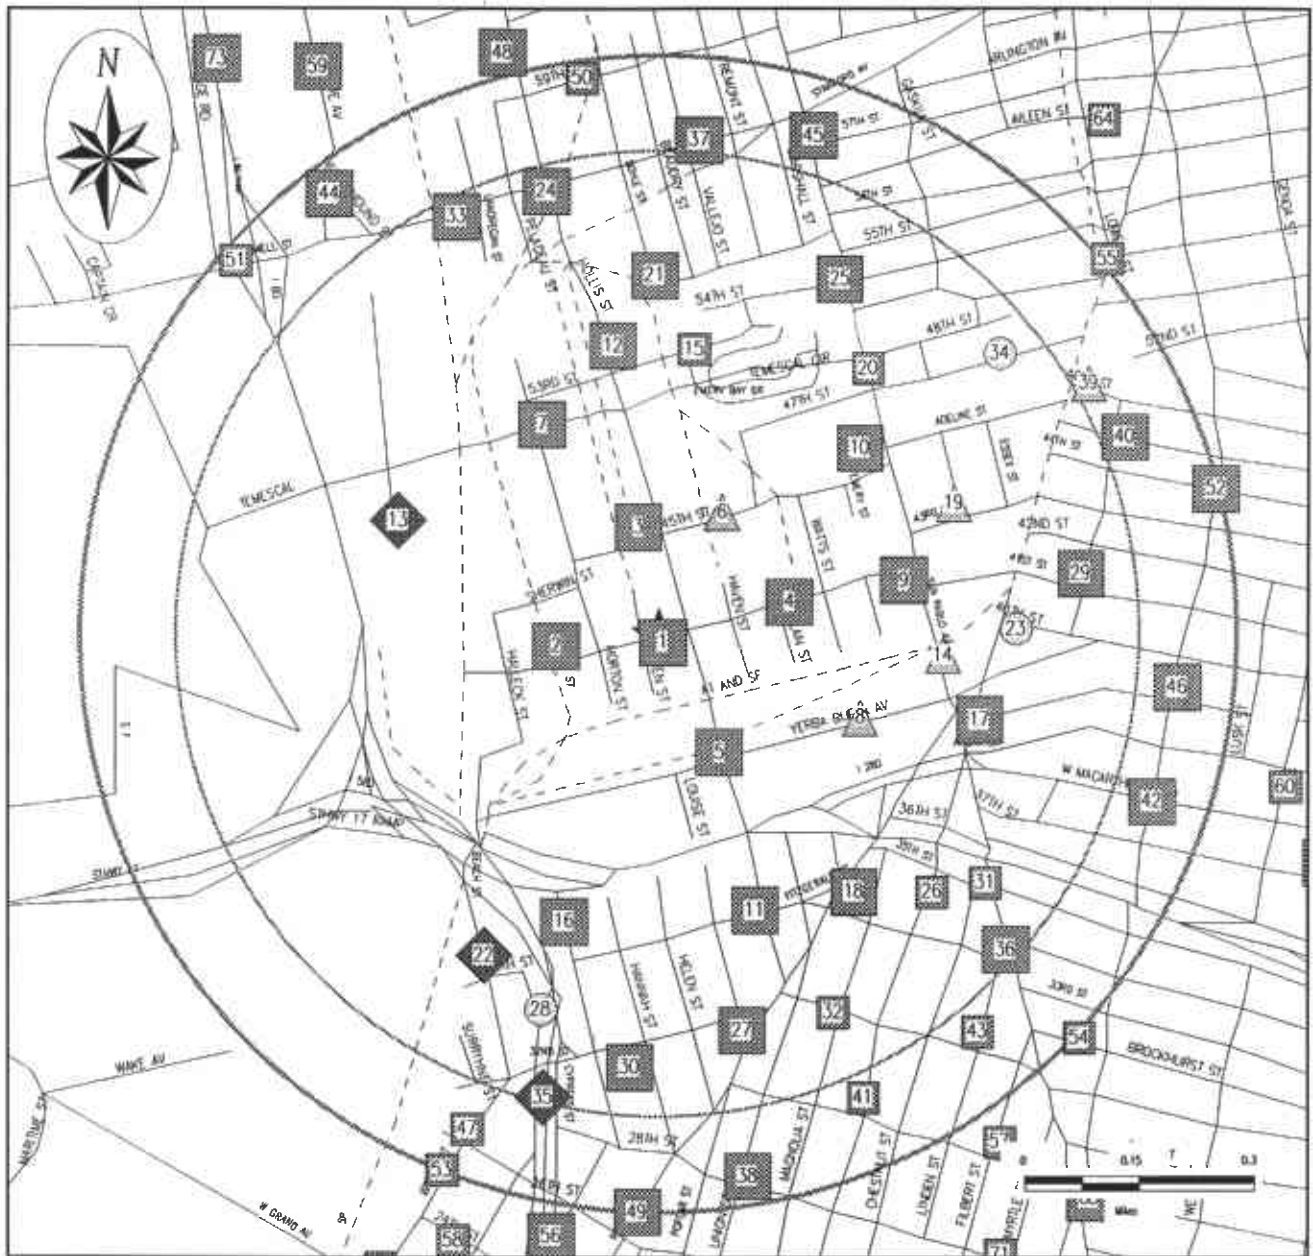
Map of Risks Within Three-Quarter Mile

If additional databases are listed in the cover page of the report they are also displayed on this map. The map symbol used corresponds to the database category letter A,B,C,D.
