Re: CITADEL Project No. 0849.1001.0
Phase II Subsurface Investigation Work Plan - Draft
Former Red Star Senior Living Apartments Development
1396 Fifth Street
Oakland, California 94607
SLIC Case Number: R00002896

Citadel Environmental Services, Inc. (Citadel) has prepared this Work Plan on behalf of Michaels Development (Client) to complete a Phase II Subsurface Investigation of the former Red Star Yeast property located at 1396 Fifth Street, Oakland, California, (Site). The Site is currently overseen by the Alameda County Department of Environmental Health (ACDEH) and has been assigned Spills, Leaks, Investigations and Cleanups (SLIC) Case ID RO0002896 and GeoTracker Global ID T06019794669.

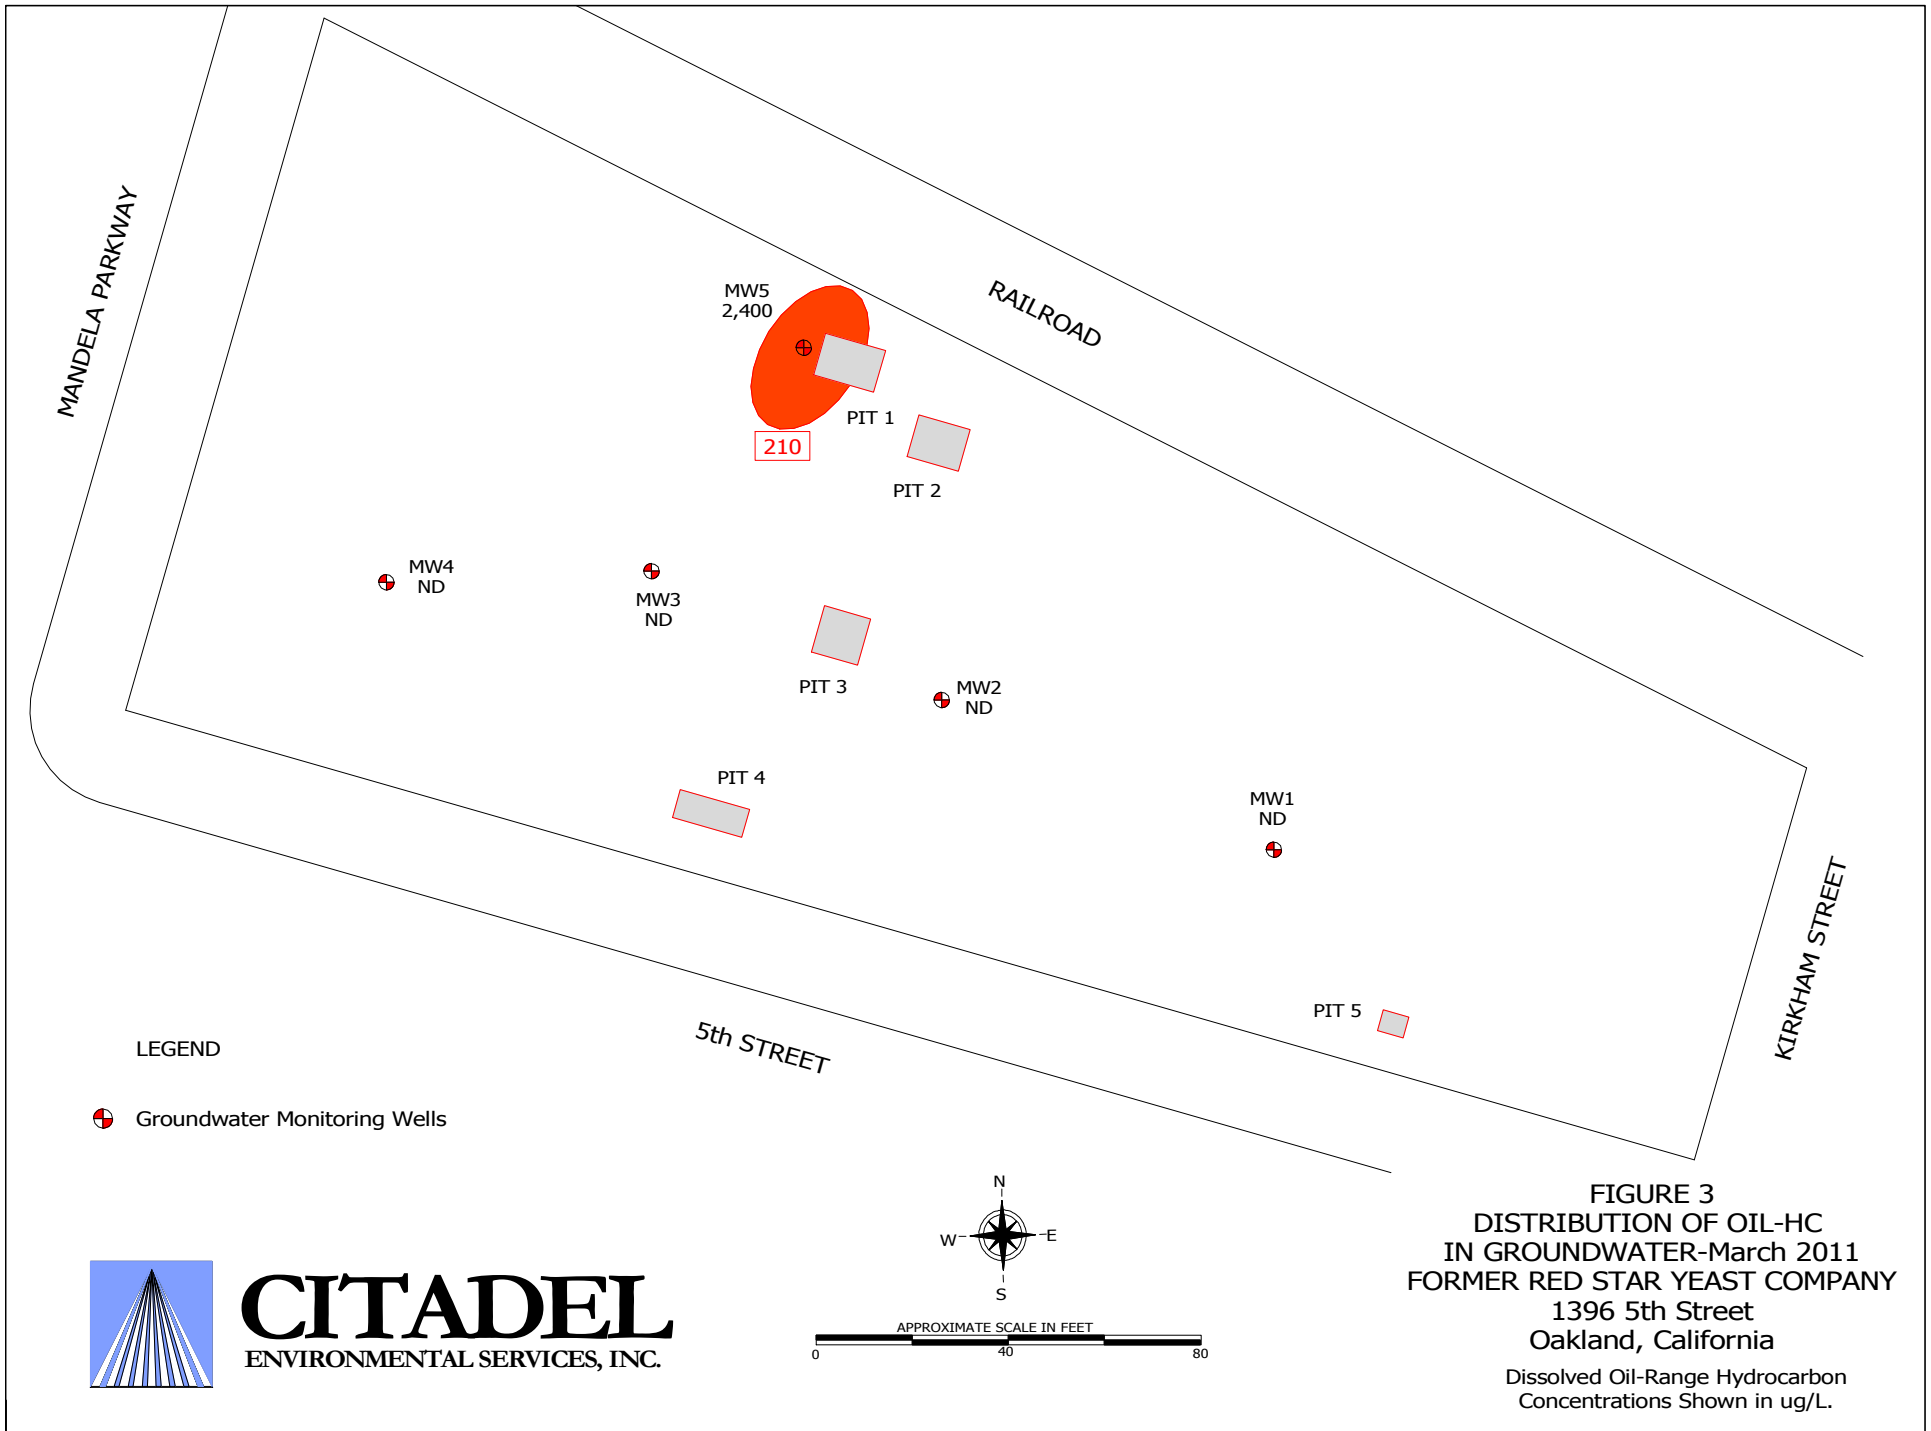
Figure 3

Groundwater Sampling Locations and Results – Citadel 2010

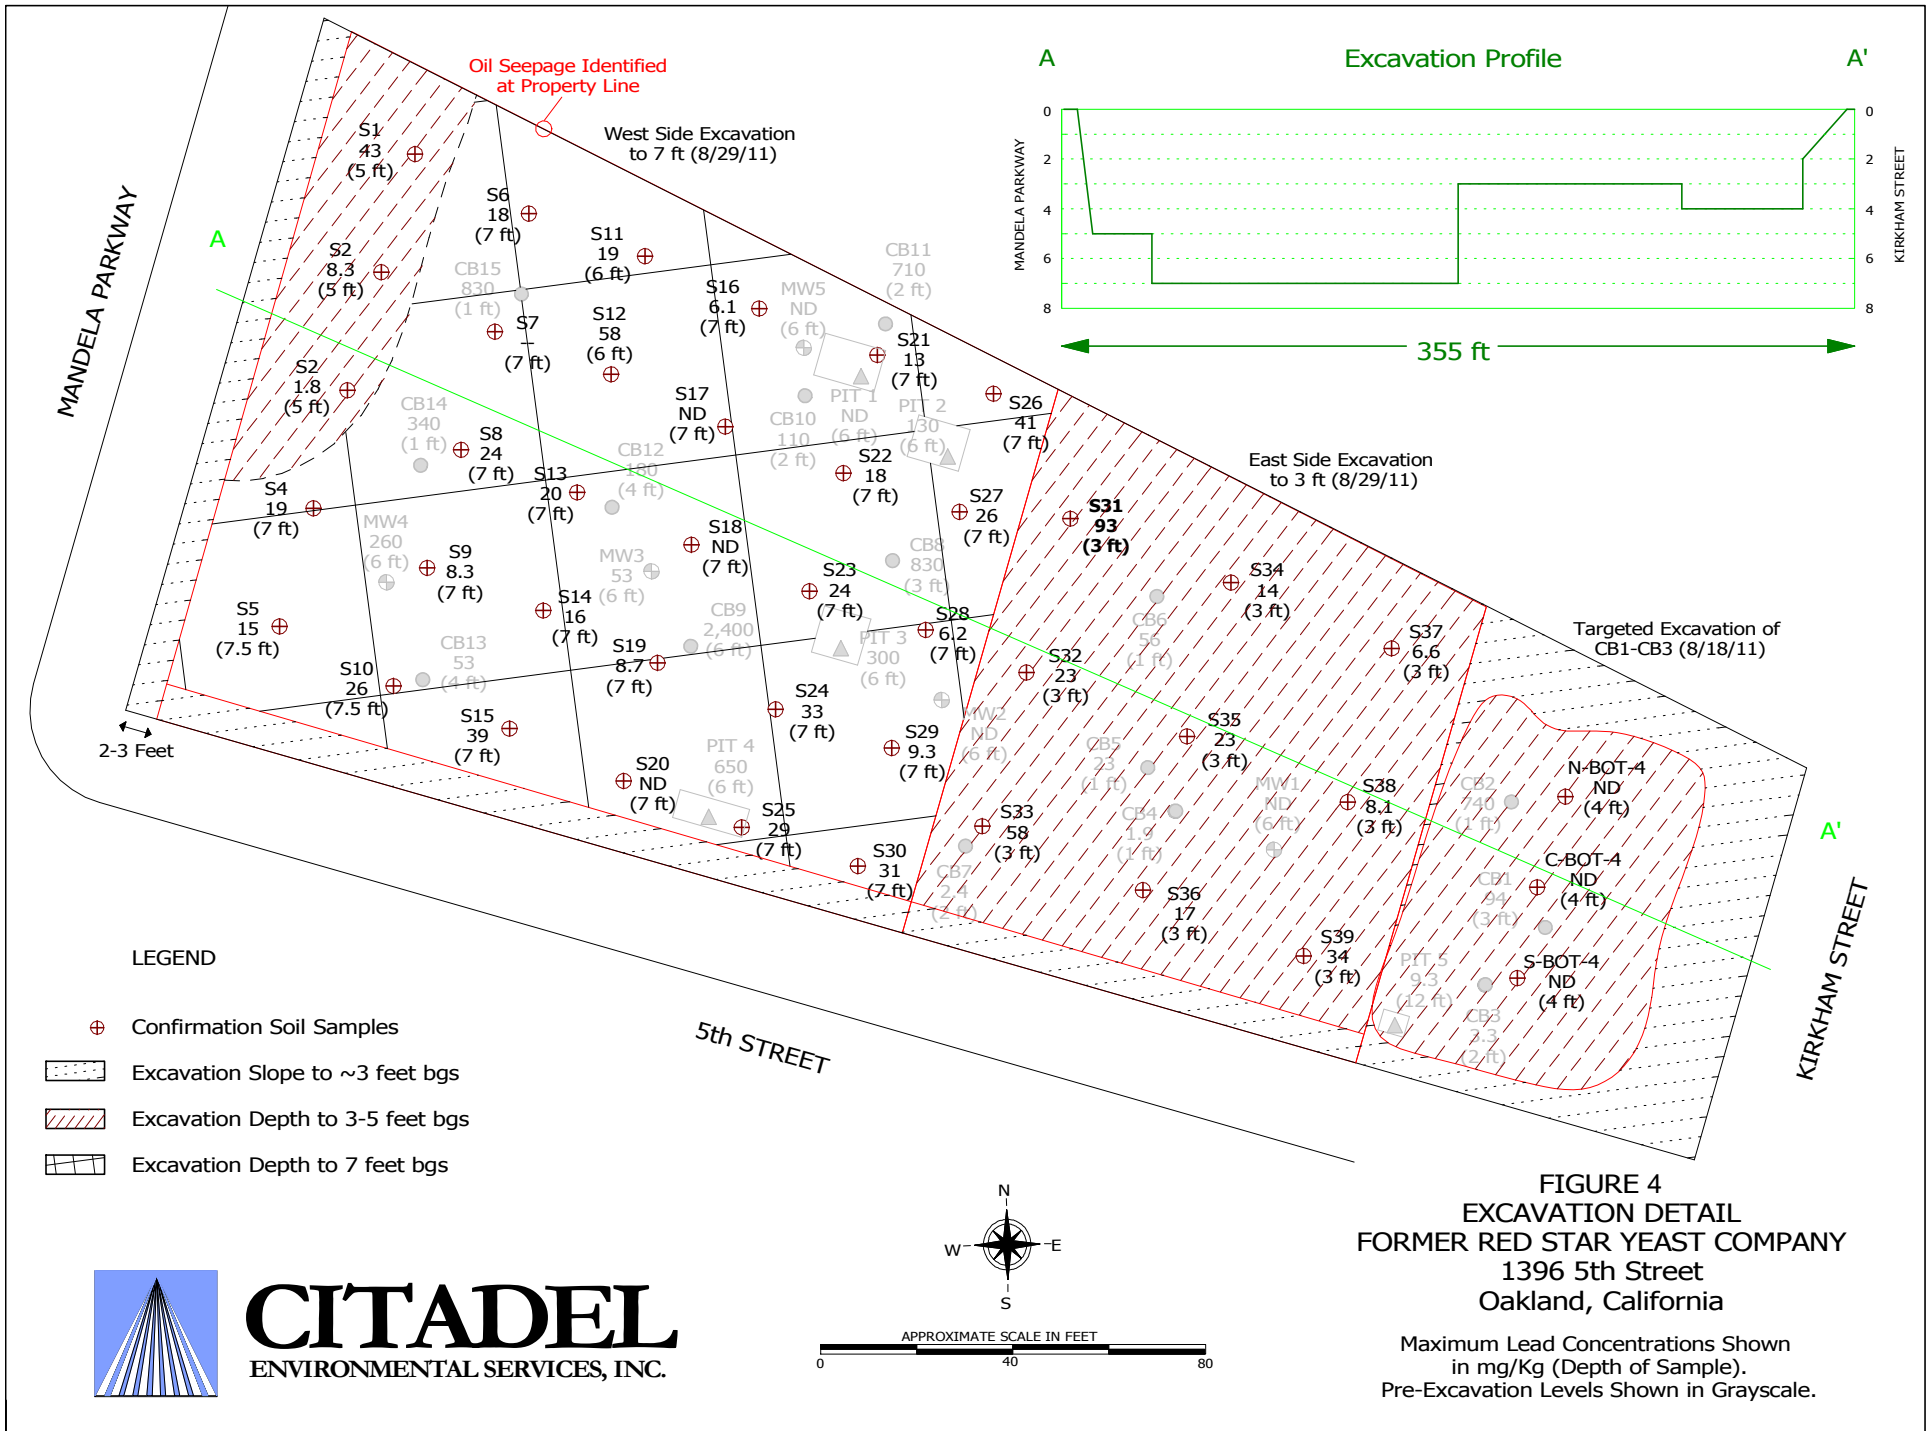
Figure 4

Confirmation Soil Sampling Locations and Results – Citadel 2011

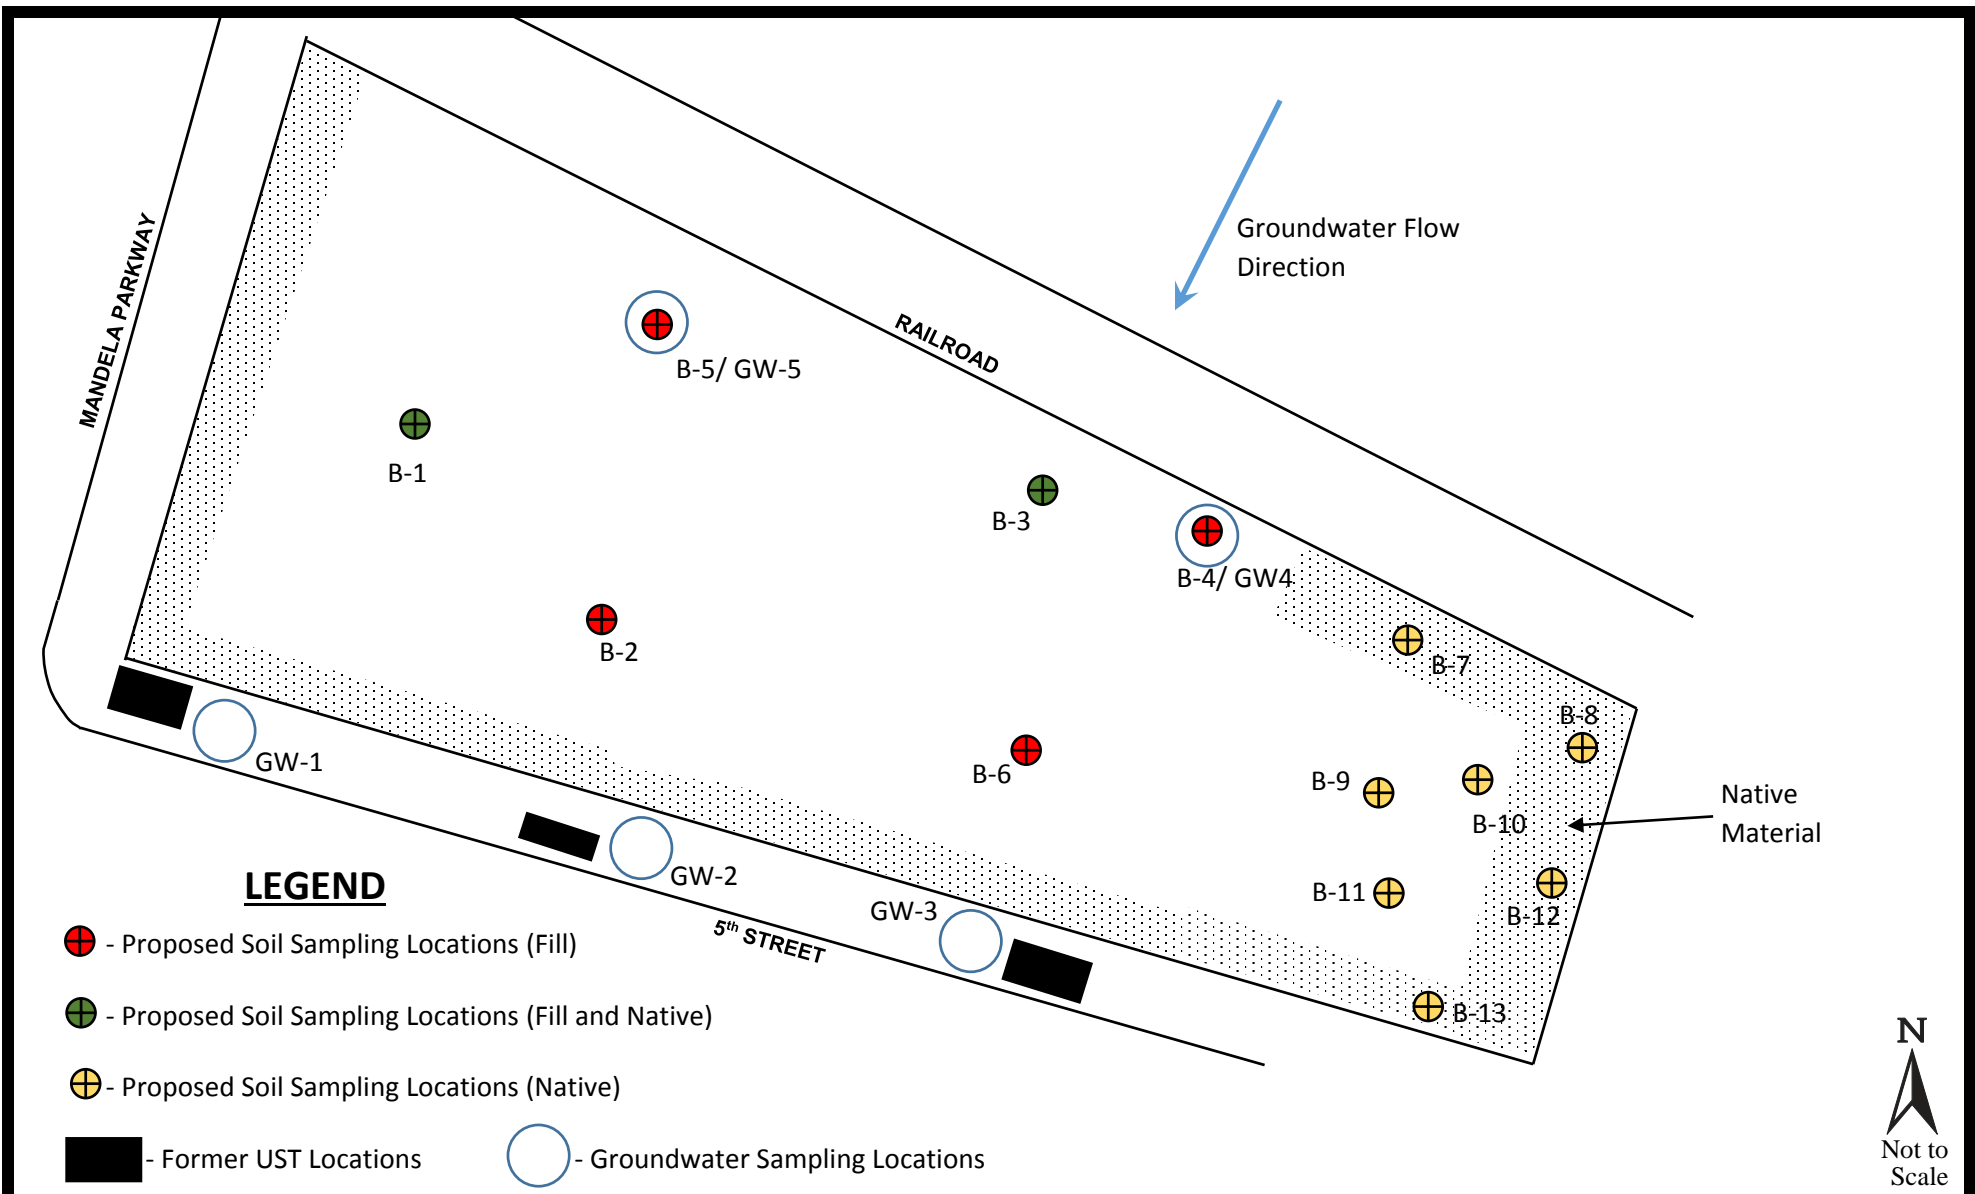
Site Map with Proposed Soil Boring and Groundwater Sampling Locations

1 was buried at a depth of approximately four feet bgs; UST No. 2 was buried at a depth of 6 1/2 feet bgs; and UST No. 4 was buried at a depth of approximately 10 feet bgs. Suspected UST No. 2 was found to be a disconnected standpipe. No associated structure for this standpipe was located. Please refer to Figure 5 for a schematic showing the UST locations.

Citadel will advance soil borings across the Site (SB-1 through SB-4) using a hand auger or equivalent method. The borings will be advanced to a depth of seven feet below ground surface (bgs), and soil samples will be collected at one, three, five, and seven feet bgs. Soil samples will also be collected at the groundwater sampling location GW-4 at three, five, and seven feet bgs. The soil borings will be logged in the field and screened with a PID for the presence of VOCs. Soil samples will be collected in stainless steel or brass sleeves sealed with Teflon tape and airtight plastic caps.

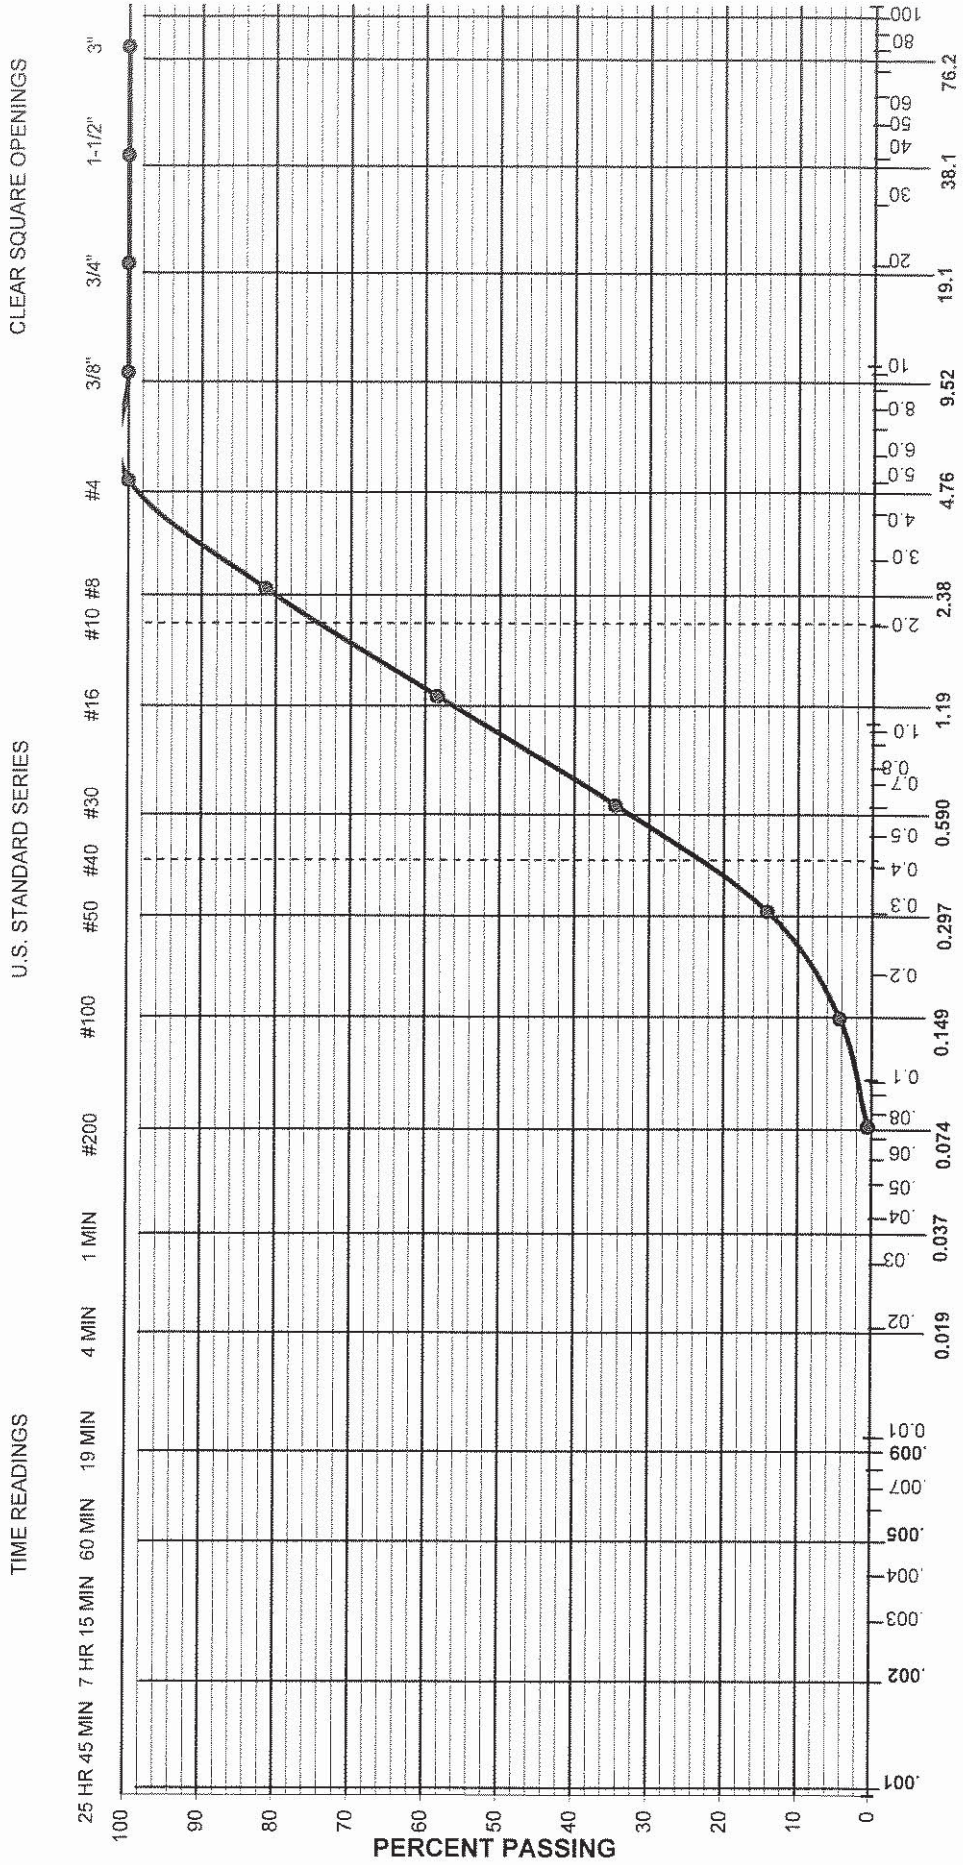
HYDROMETER ANALYSIS

SIEVE ANALYSIS

CLAY (PLASTIC) TO SILT (NON-PLASTIC)	SAND		GRAVEL		COBBLE
	FINE	MEDIUM	COARSE	FINE	COARSE

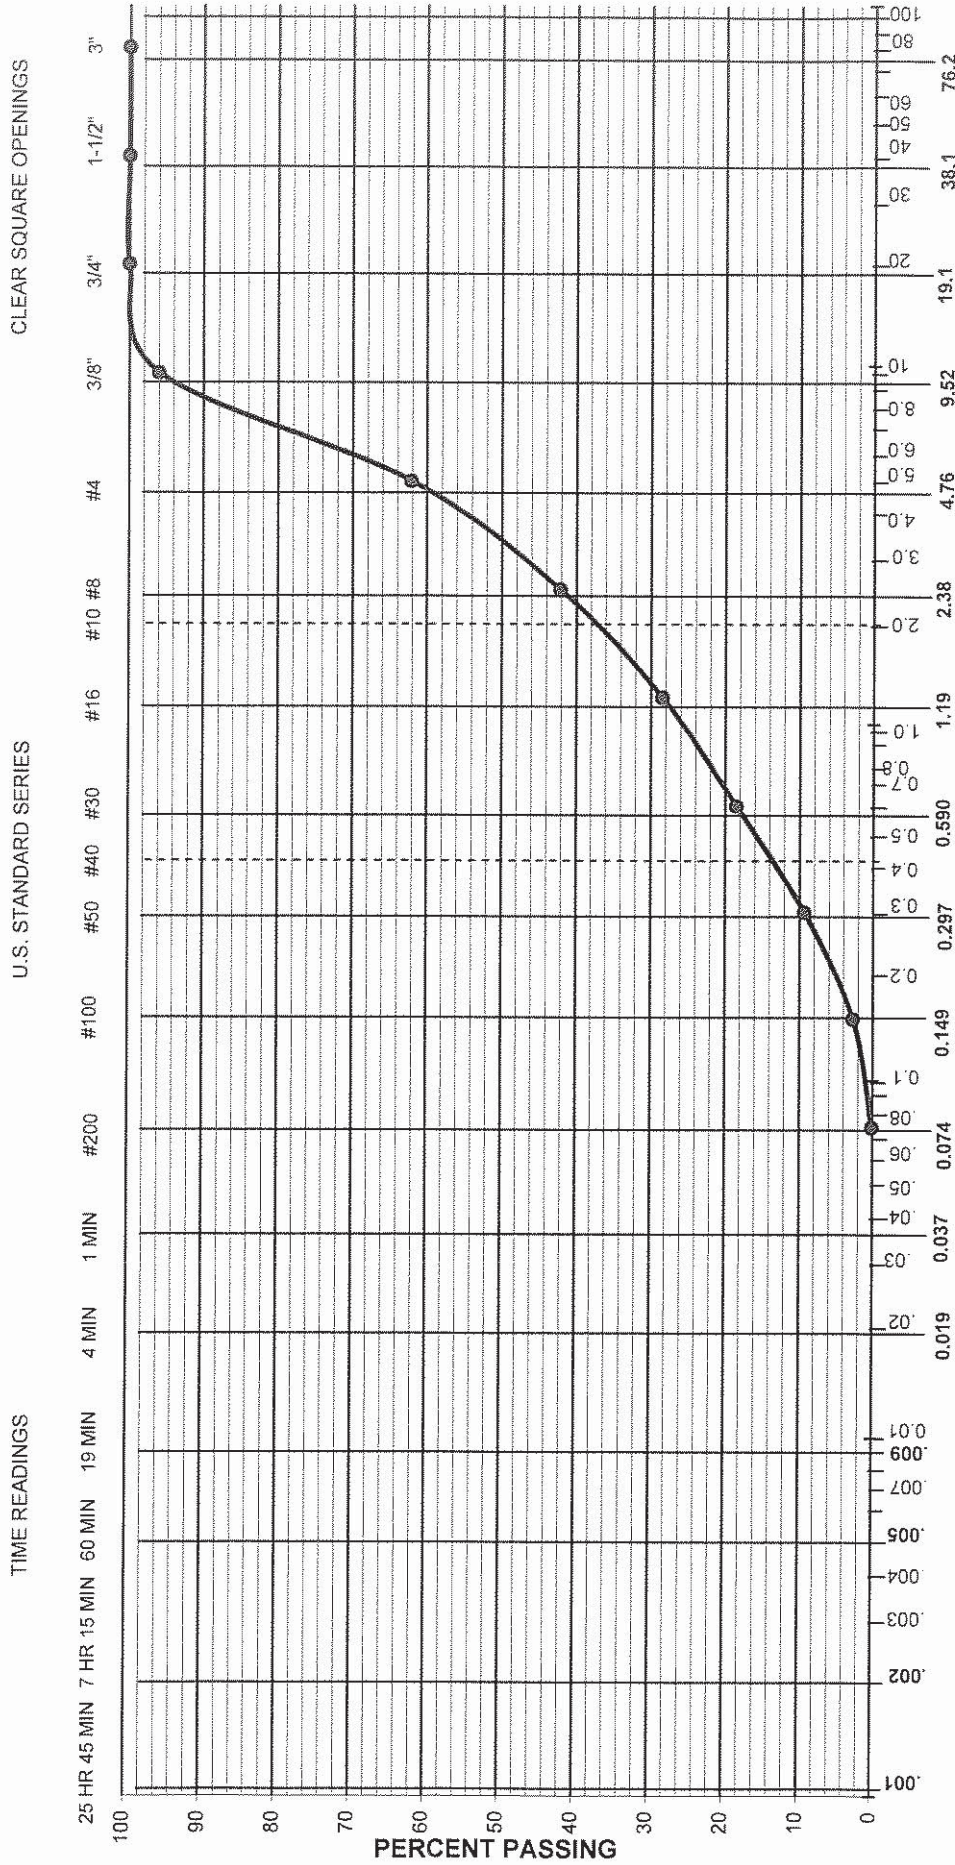
HYDROMETER ANALYSIS

SIEVE ANALYSIS

CLAY (PLASTIC) TO SILT (NON-PLASTIC)	SAND		GRAVEL		COBBLE
	FINE	MEDIUM	COARSE	FINE	COARSE

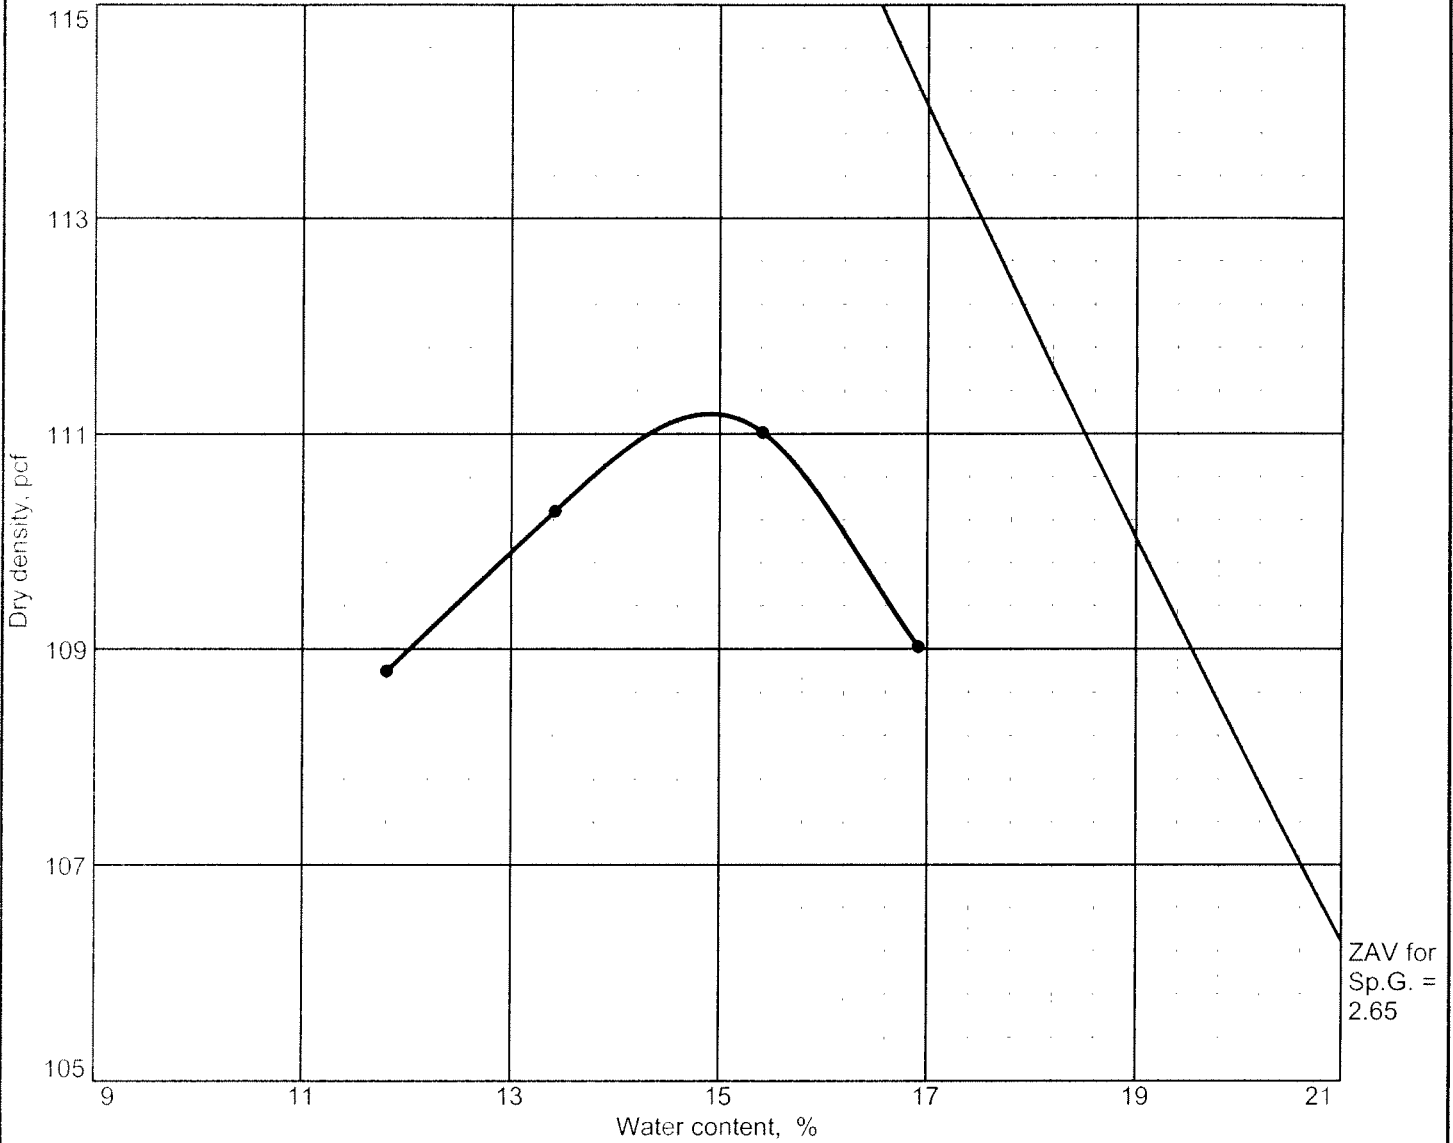
COMPACTION TEST REPORT

Test specification: ASTM D 1557 Procedure B Modified

TEST RESULTS	MATERIAL DESCRIPTION
Maximum dry density = 111 pcf Optimum moisture = 15 %	3/8" Structure Backfill produced from Inner City Recycling, Oakland CA, sampled 6/30/2011
Project No. 46226849 Client: Inner City Recycling Project: Inner City Recycling On Call Lab Testing Location: Inner City Recycling	Remarks: Curve #4308-3 SL1068
COMPACTON TEST REPORT SIGNET TESTING LABS, INC.	
Plate

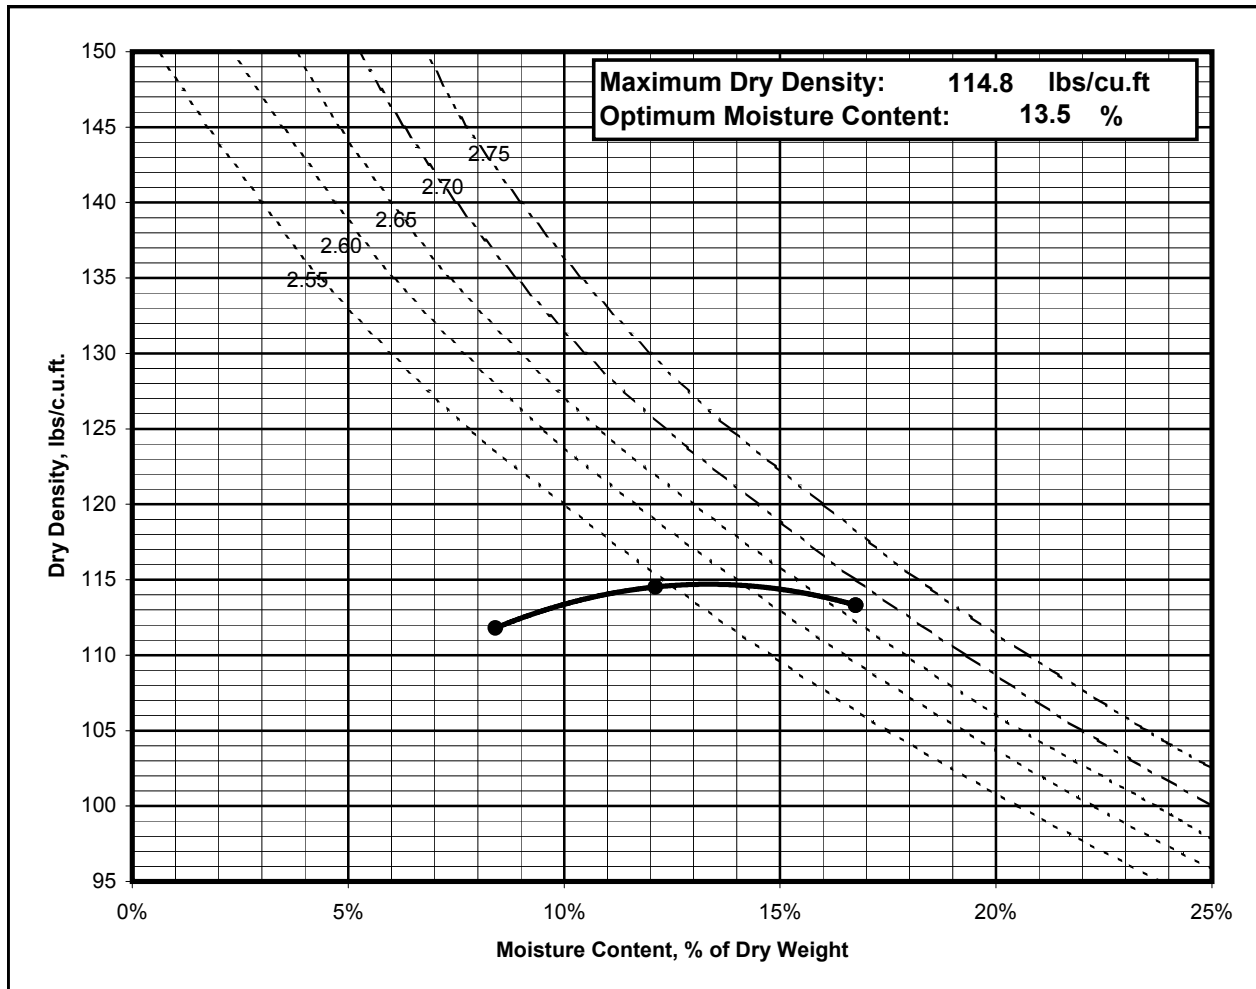
Project Number : 4-611-0436
 Project Name : Red Star Senior Living , Oakland, CA
 Sample Date : 08/29/11
 Test Date : 08/31/11
 Sample location : Import (Inner City Rec.)
 Sample/Curve Number : S-3 (11-1757)
 Soil Classification : 3/8 Agg.
 : --
 Test Method : 1557 A

1	2	3
Weight of Moist Specimen & Mold, gm	3864.6	3973.4	4032.4
Weight of Compaction Mold, gm	2032.1	2032.1	2032.1
Weight of Moist Specimen, gm	1832.5	1941.4	2000.3
Volume of mold, cu. ft.	0.0333	0.0333	0.0333
Wet Density, lbs/cu.ft.	121.2	128.4	132.3
Weight of Wet (Moisture) Sample, gm	327.5	328.5	327.5
Weight of Dry (Moisture) Sample, gm	302.1	293.0	280.5
Moisture Content, %	8.4%	12.1%	16.8%
Dry Density, lbs/cu.ft.	111.8	114.5	113.3

- 8/29/11 SALEM tests a material sample with location listed as “Import (Inner City Recycling)”; Sample / Curve No. S-3, and classified as “3/8 Agg” (aggregate). Note the maximum density and optimum moisture values as 114.8 pcf and 13.5%, respectively. [Attachment 3].
