Subject: Updated Environmental Summary
Broadway between 2nd and 3rd Streets
Oakland, California

Updated Environmental Summary

Broadway between 2nd and 3rd Streets Oakland, California

Clayton Project No. 33106-006824.00
November 22, 2006

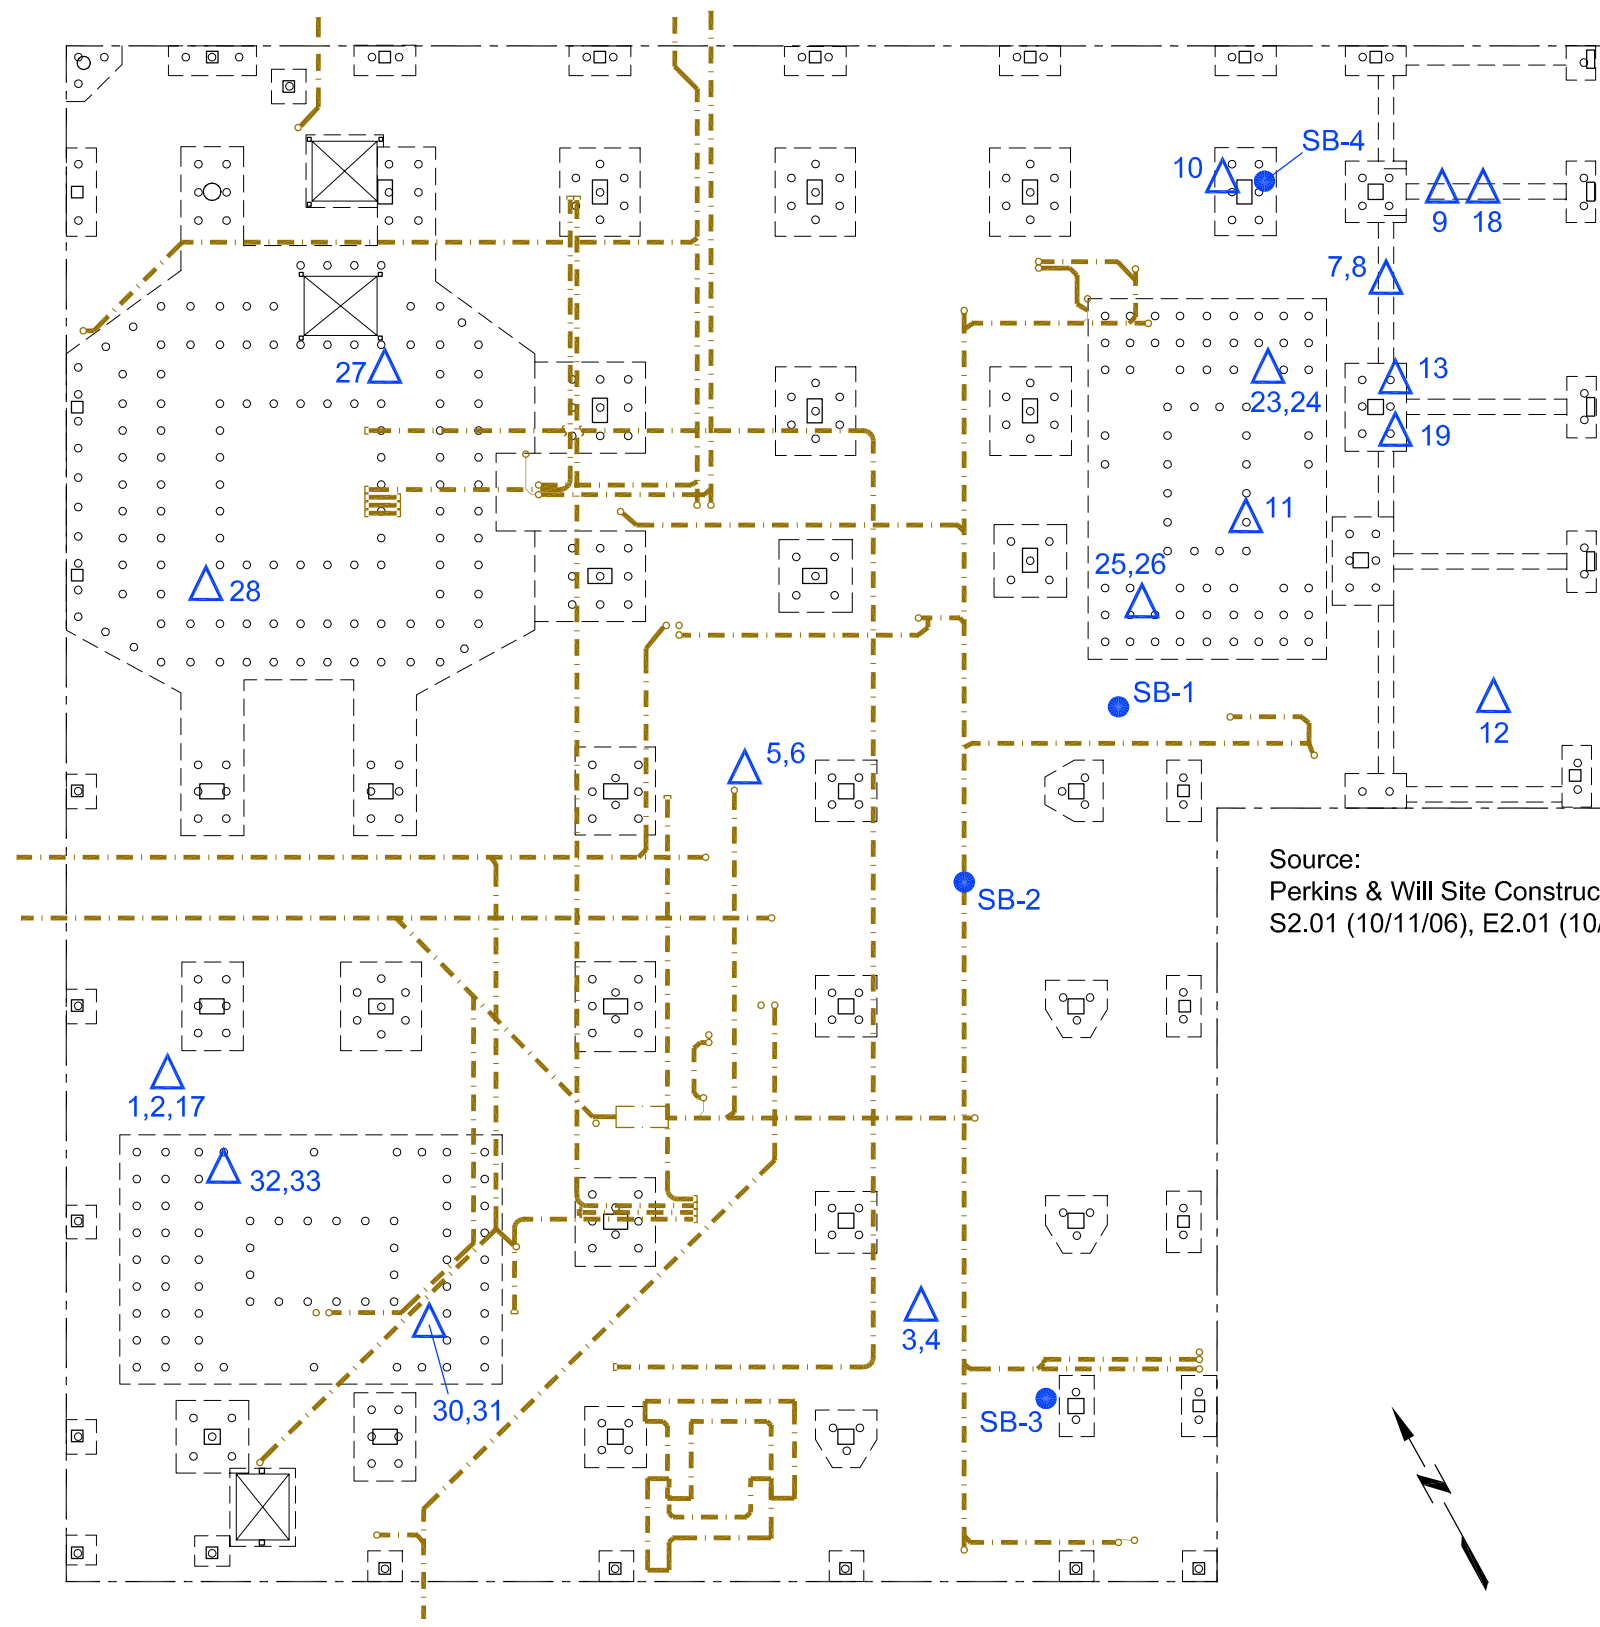
- Site Boundary
- Pile Cap Excavation
- Elevator Pit Excavation
- Utilities Excavation
- 1998 Soil and Groundwater Data
- March-October 2006 Soil Data

From March through October 2006, 38 soil (21 composite and 17 discrete) samples and 4 grab groundwater samples from the Site have been analyzed. These samples were collected from 21 borings and from eight soil stockpiles originating from Site redevelopment. Sampled areas include the former foundry. Data locations are depicted on Figure 3; data locations remaining after excavation are shown on Figure 4.

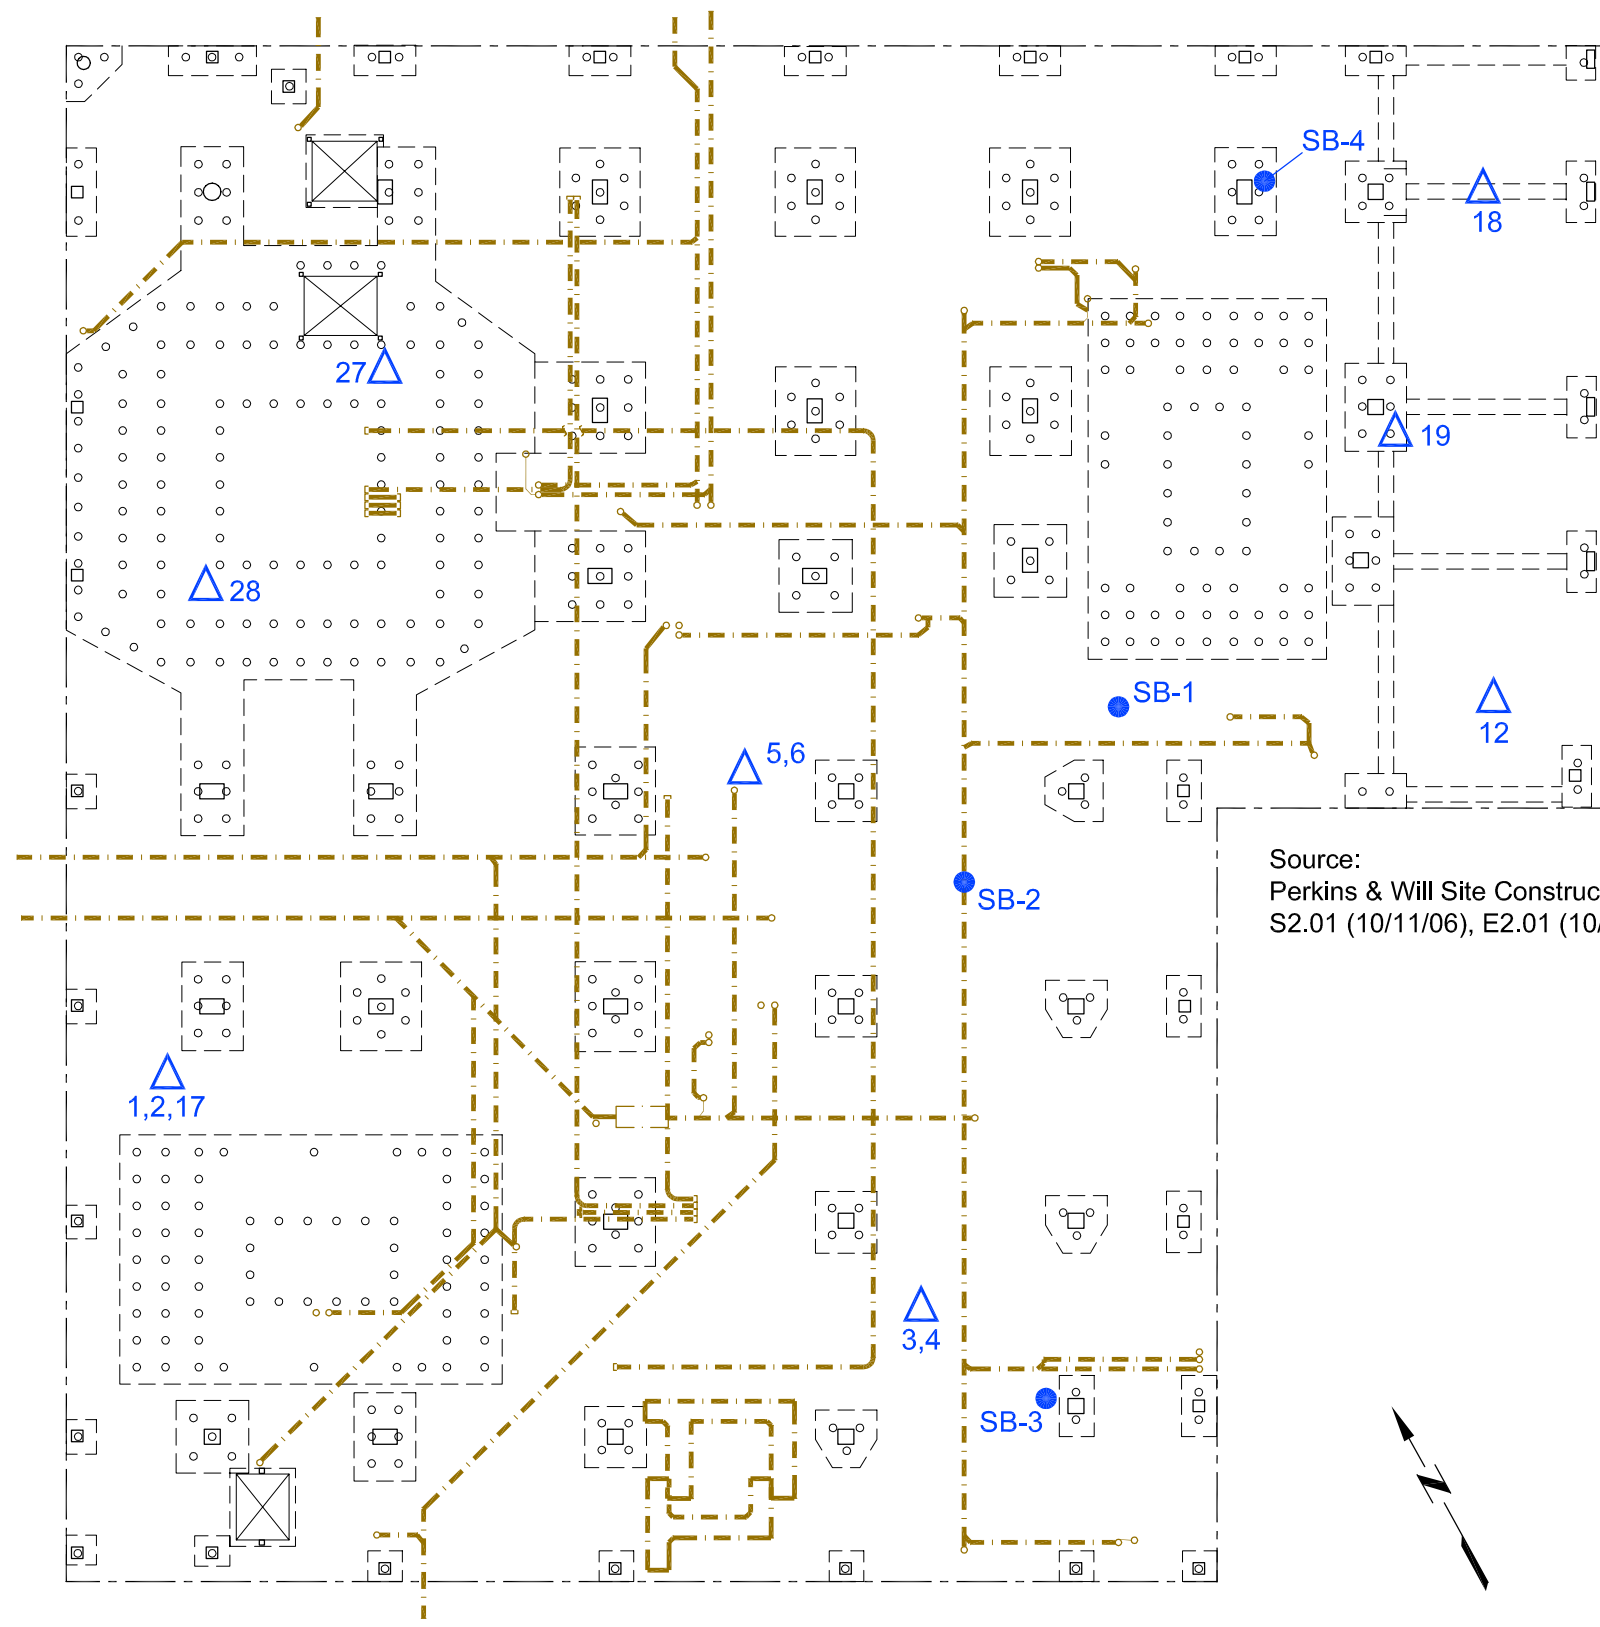
- LEGEND:**
- Site Boundary
 - Pile Cap Excavation
 - ⊠ Elevator Pit Excavation
 - - - Utilities Excavation
 - 1998 Groundwater Data
 - △ March-October 2006 Soil Data

Source:
Perkins & Will Site Construction Drawings
S2.01 (10/11/06), E2.01 (10/11/06), P2.01U (9/18/06)

The four grab groundwater samples were collected from direct-push borings located within the former foundry. These samples were analyzed for halogenated volatile organic compounds (HVOCs). No HVOCs were detected in groundwater beneath the Site (Table 3). This data will remain after excavation.

- Ongoing redevelopment activities will result in the removal of substantial volumes of Site soil within the upper 10 feet bgs. Construction plans require scraping the top foot of soil across the Site as well as excavating 500 pile foundations, associated subgrade connecting beams, and utility trenches – this work is currently underway. Such activities will result in less metals remaining on the Site after construction. To illustrate, sampled stockpiles contained six of the 10 samples with elevated concentrations of lead, and only one of these will remain after excavation.

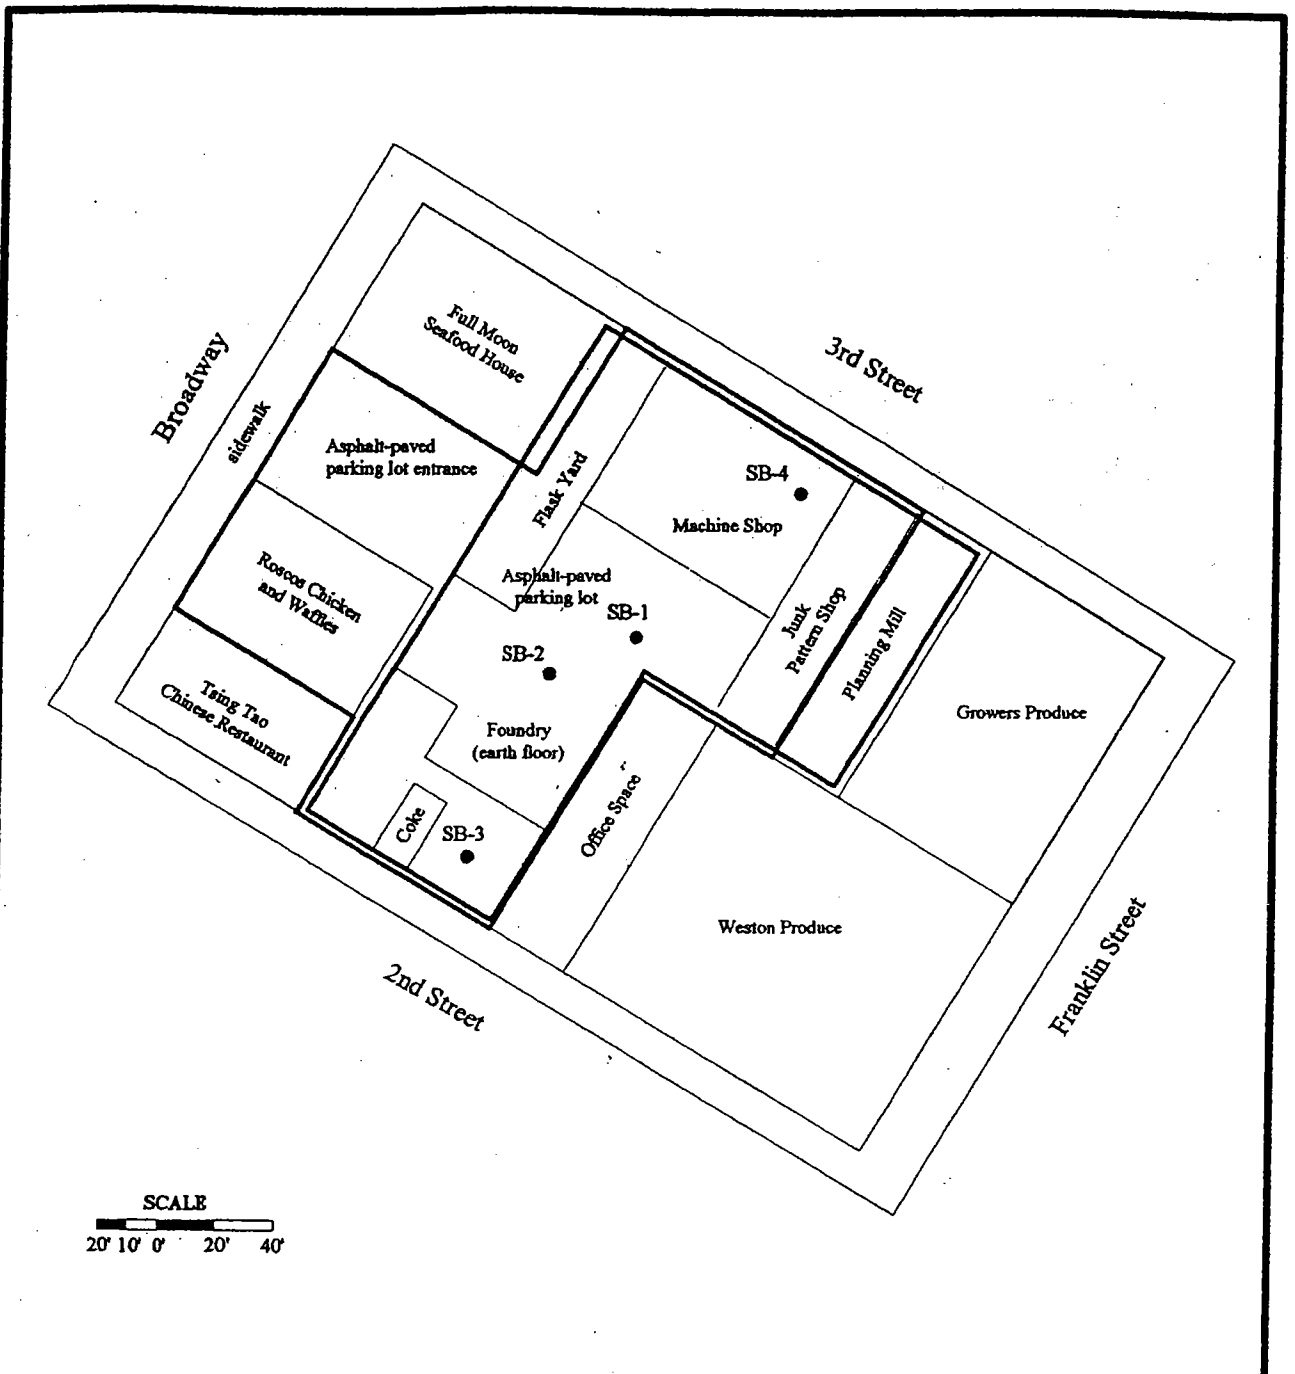
Location of former Empire Foundry

Soil borings SB-1 through SB-4 were placed within the parking lot area of the Property. As Figure 2 shows, the present parking lot area covers most of the operations area once occupied by the former Empire Foundry plant. Soil borings SB-1 through SB-4 were spatially placed throughout the parking lot area to provide a representative profile of subsurface soil and groundwater quality conditions beneath the area of the Property most likely to have been affected by operations conducted at the former foundry. SB-1 and SB-2 were placed within an area identified on a 1912 Sanborn Map (see Appendix B) as consisting of an earth floor, and SB-3 and SB-4 were placed along the north and south portions of the Property to assess soil and groundwater quality conditions across the width of the Property, as well as beneath different areas of the former foundry plant.

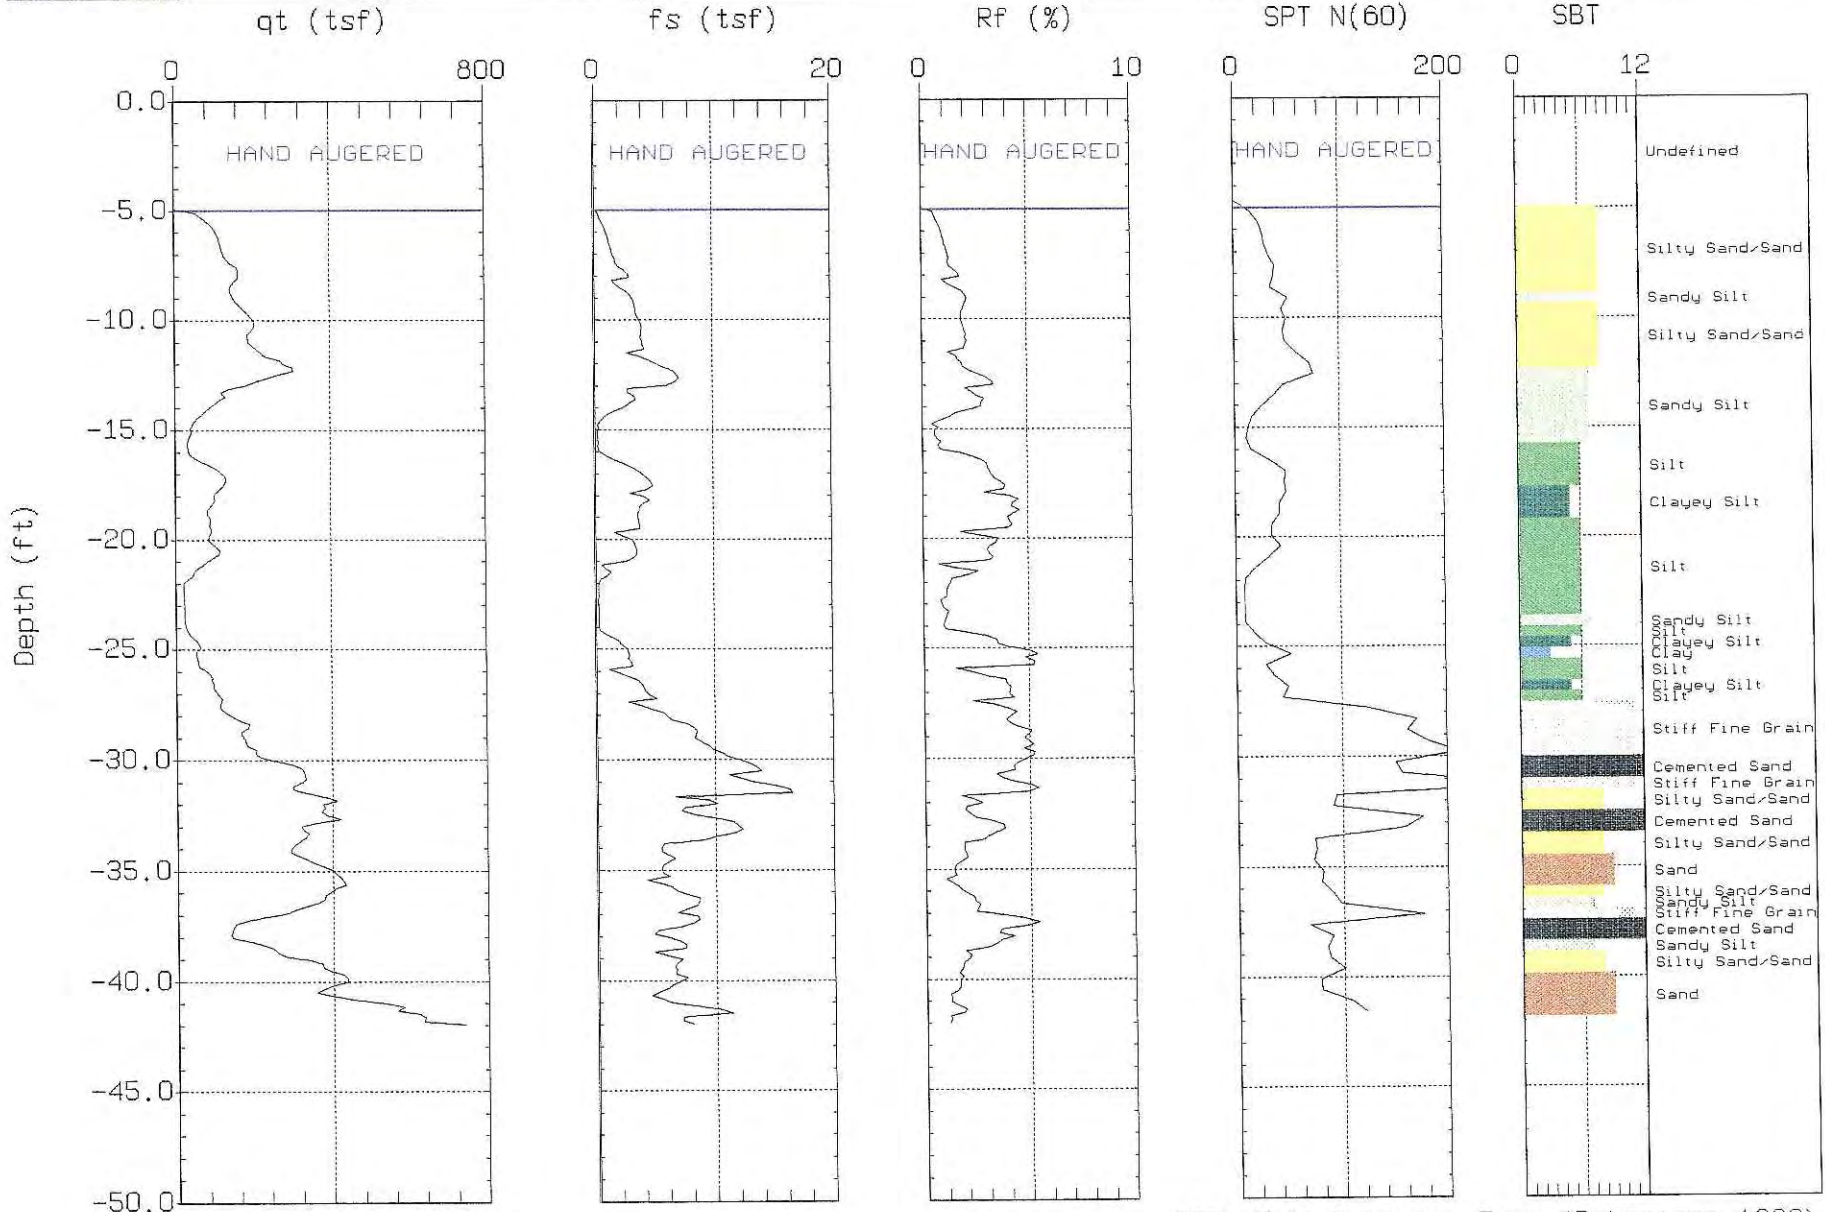
Site: 222 BROADWAY ST.
Location: CPT-02A

Max. Depth: 41.99 (ft)
Depth Inc.: 0.164 (ft)

SBT: Soil Behavior Type (Robertson 1990)

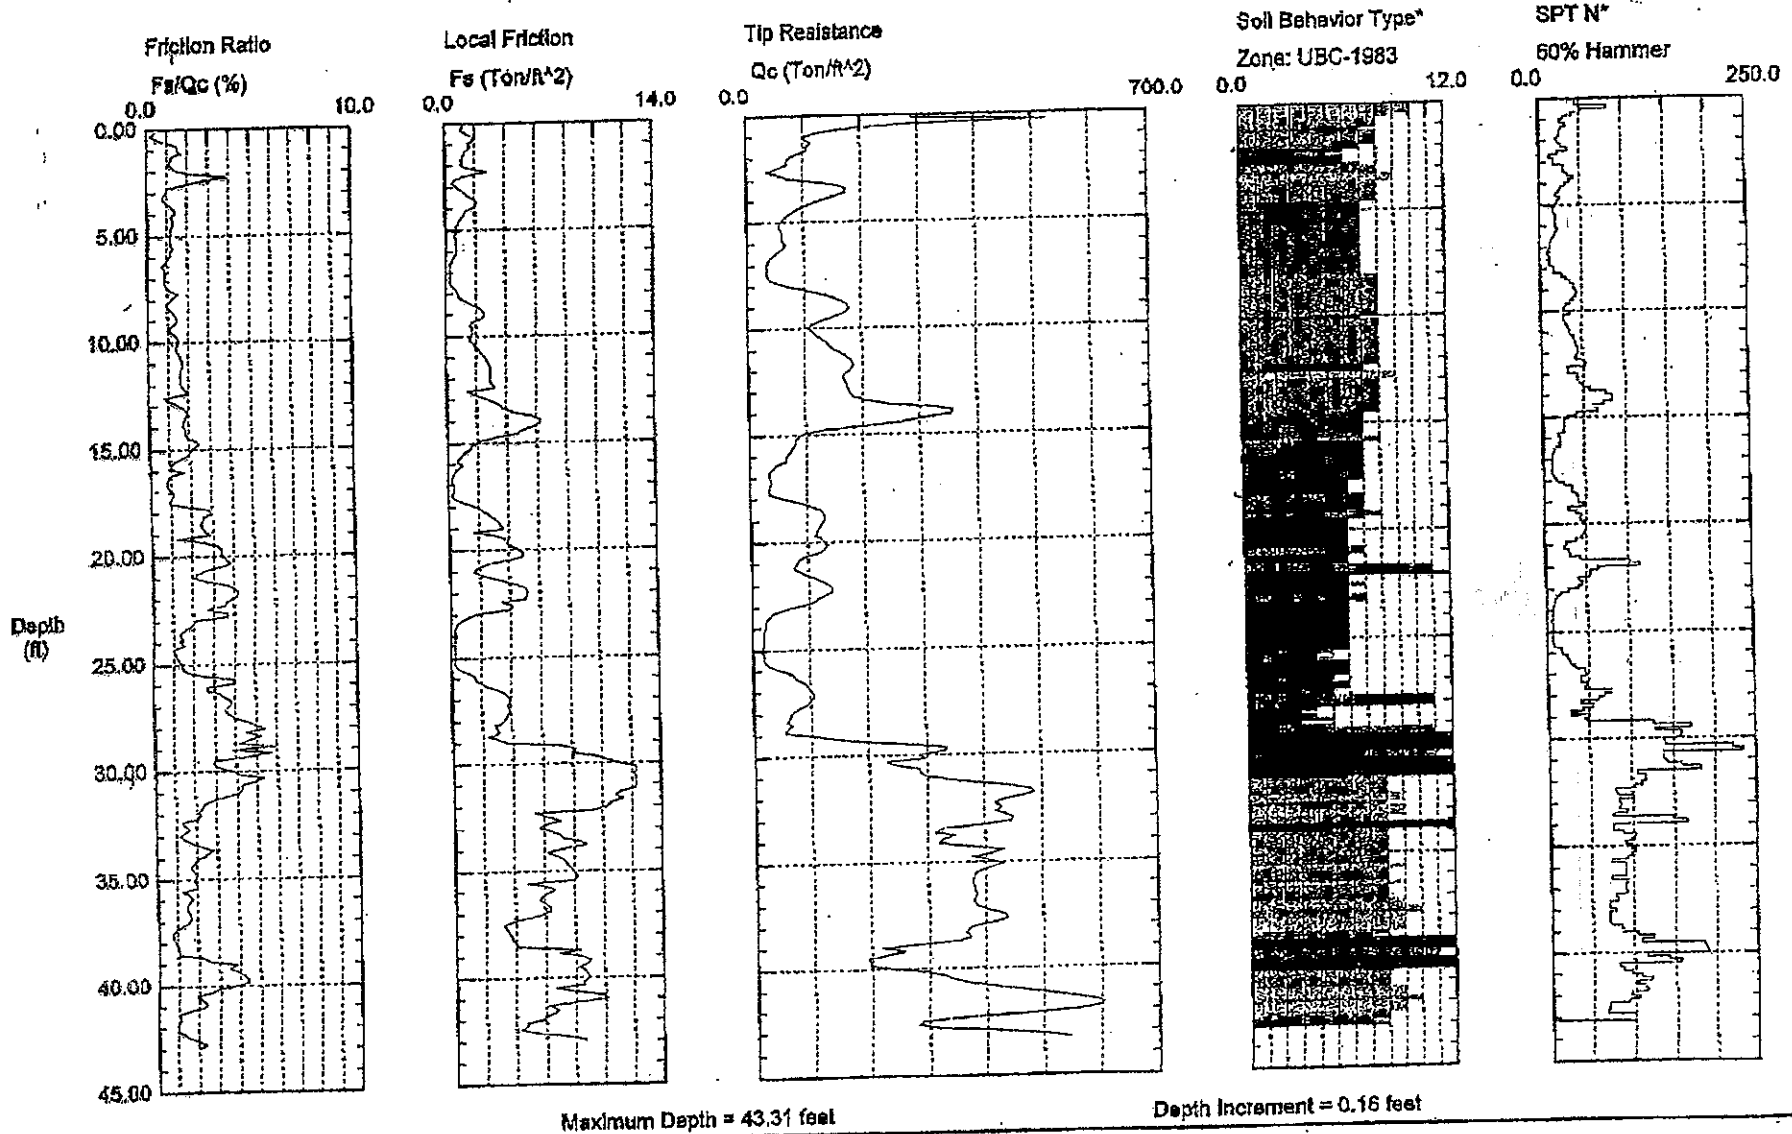
CONE PENETRATION TEST CPT-1
BROADWAY & 3RD STREET
Oakland, California

CPT Date/Time: 02-15-01 09:17
Location: CPT-1
Job Number: P10564

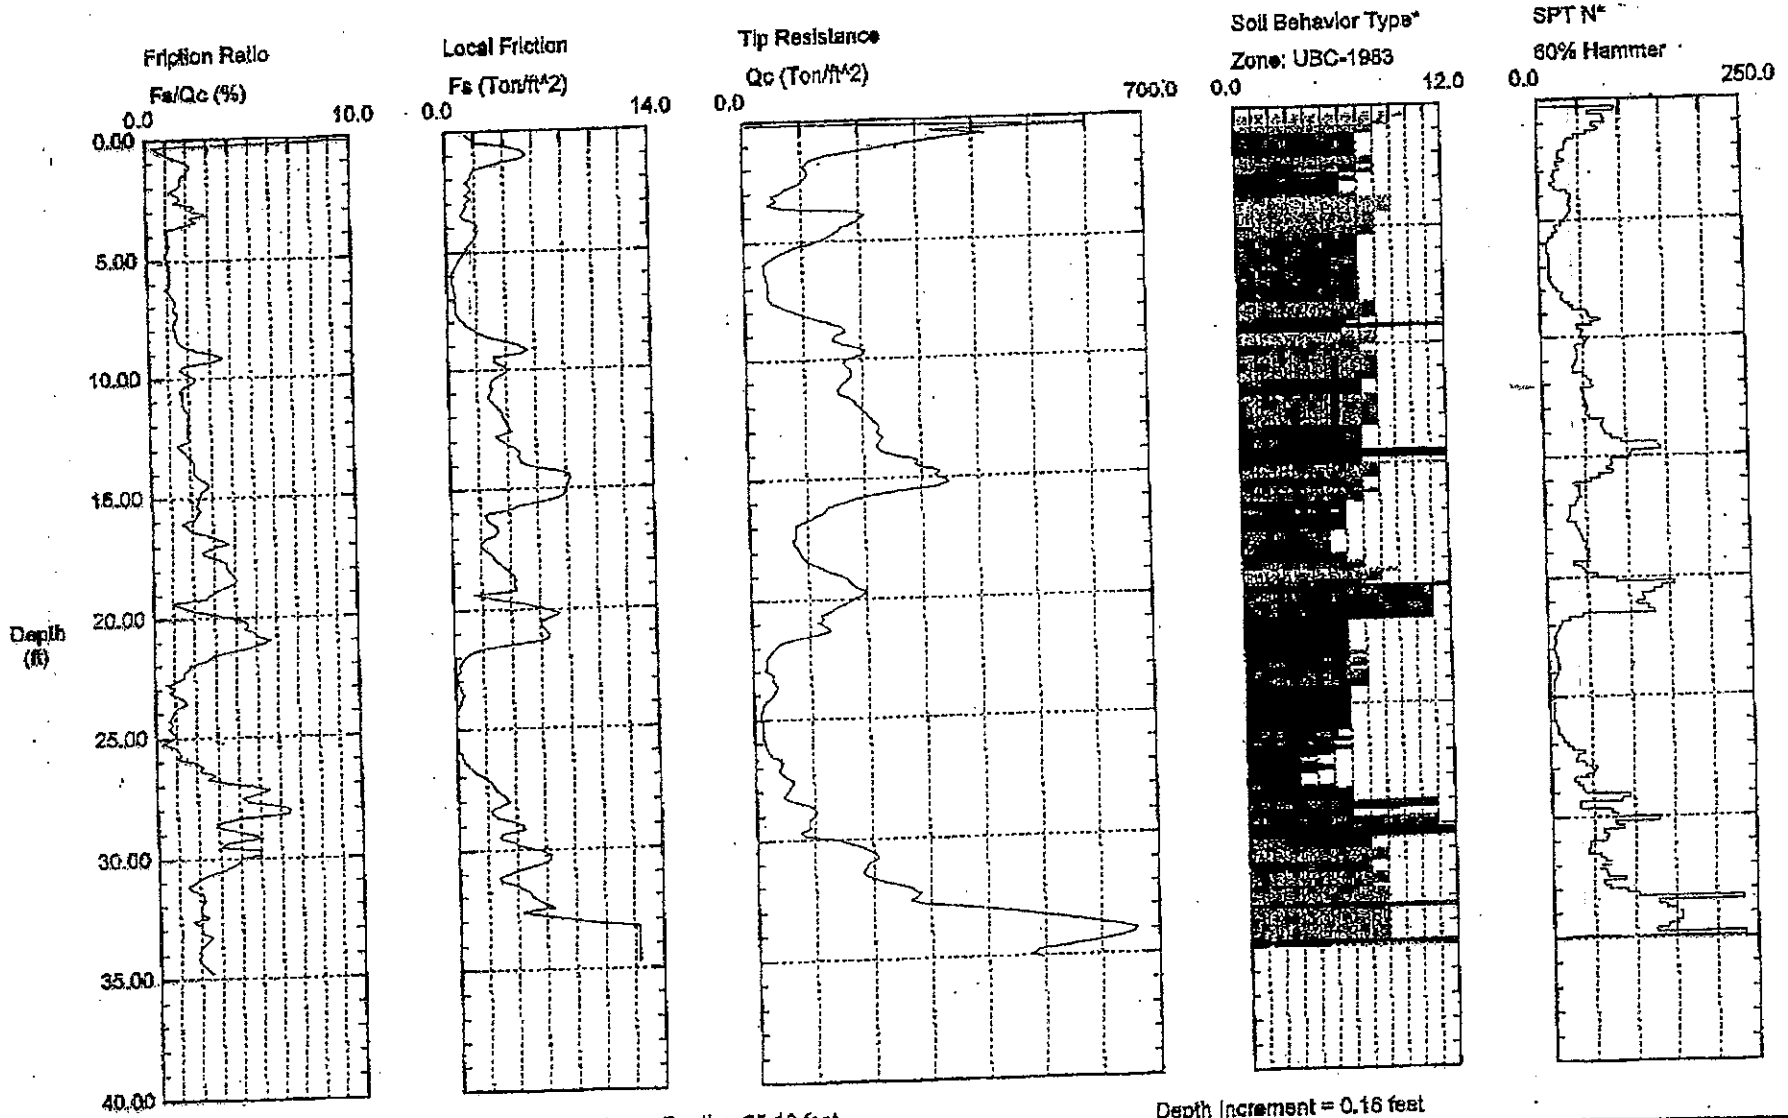
CPT Date/Time: 02-16-01 10:39
Location: CPT-2
Job Number: P10564

Maximum Depth = 35.10 feet

Depth Increment = 0.16 feet

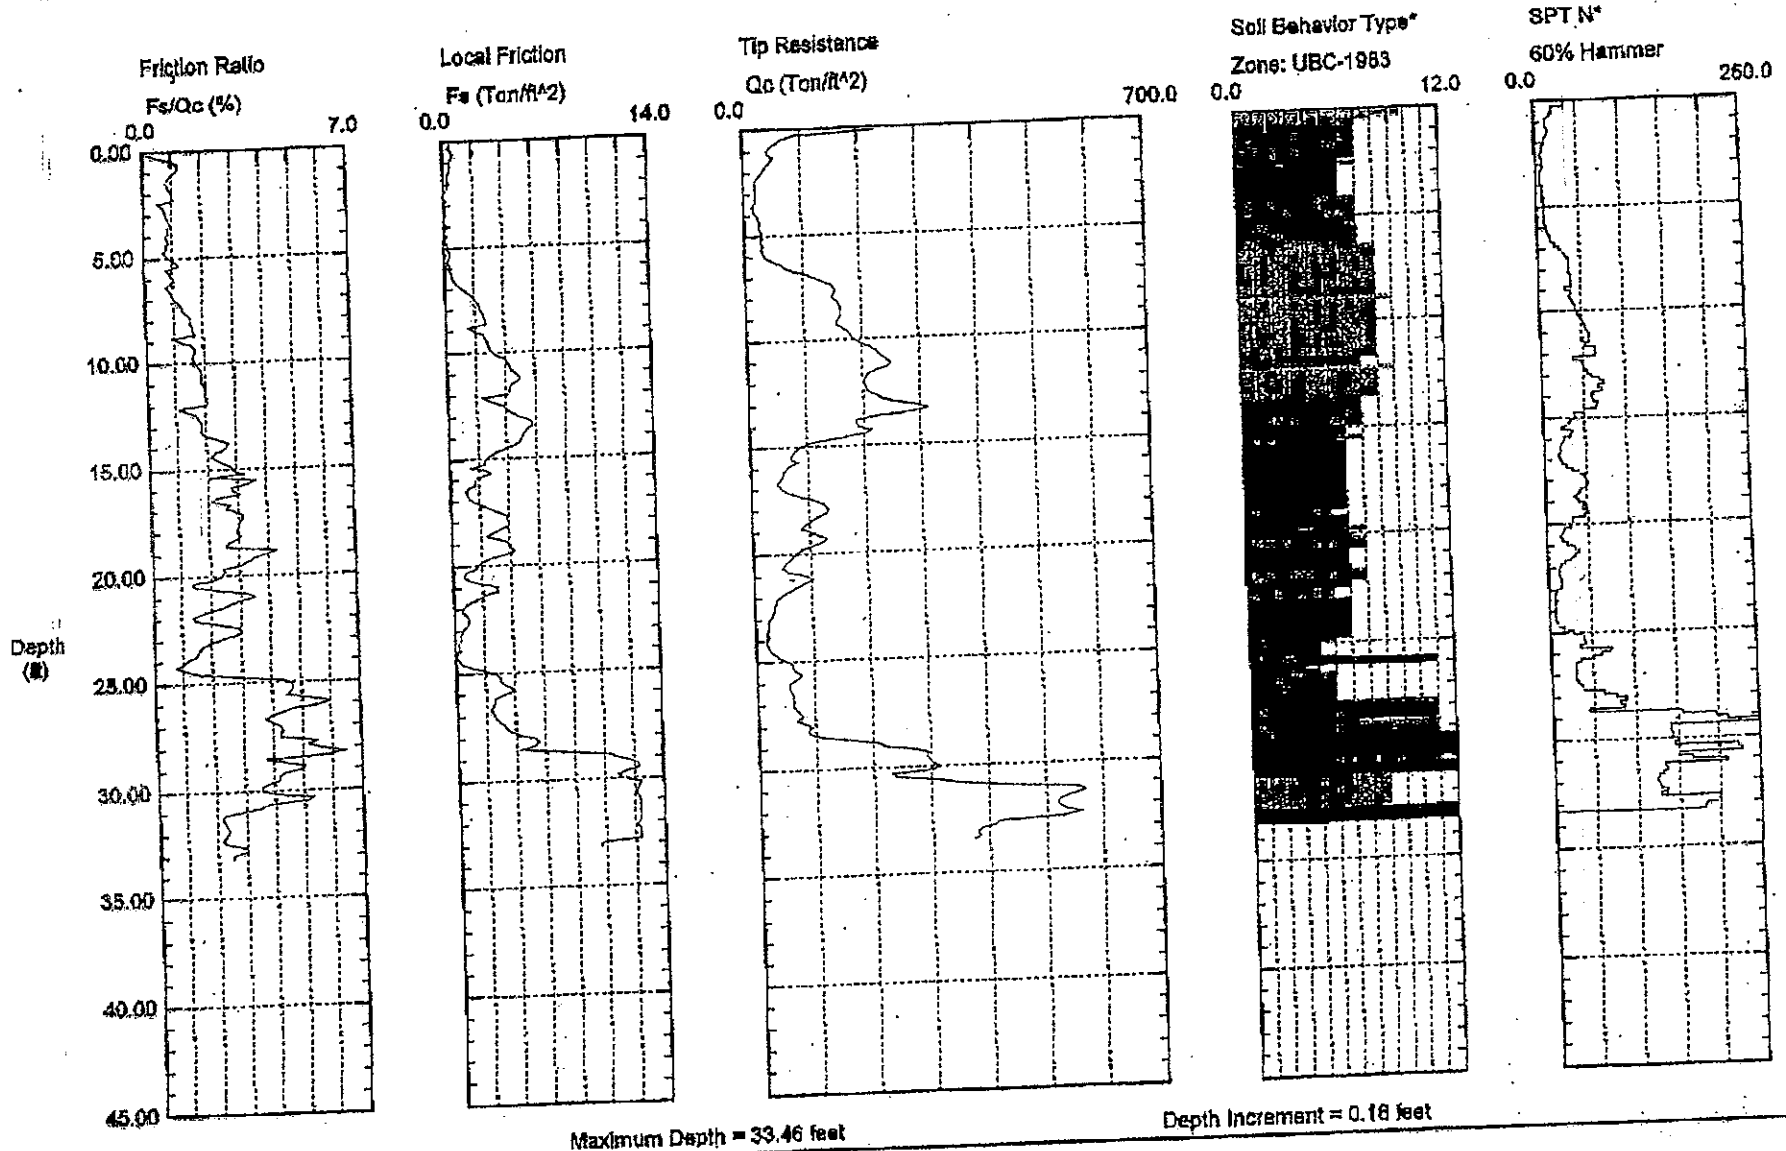
CONE PENETRATION TEST CPT-3
BROADWAY & 3RD STREET
Oakland, California

CPT Date/Time: 02-15-01 12:06
Location: CPT-3
Job Number: P10564

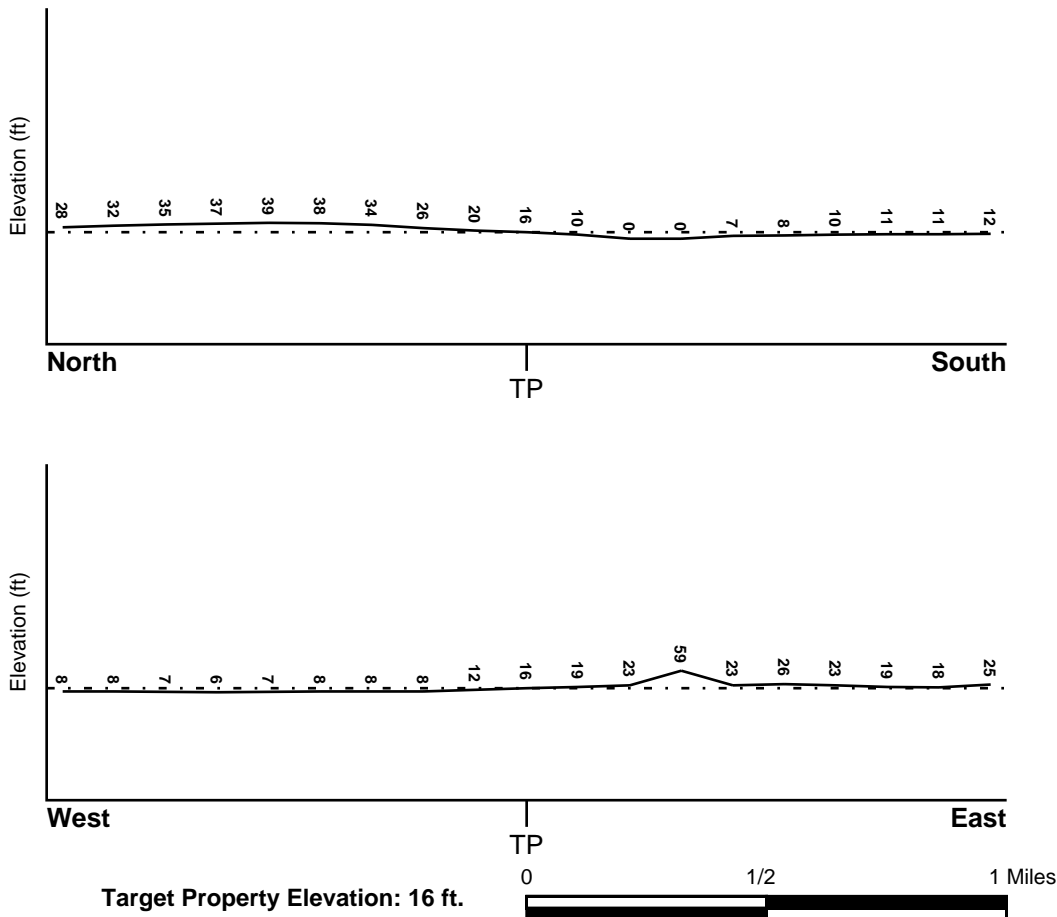
SURROUNDING TOPOGRAPHY: ELEVATION PROFILES

General Topographic Gradient: General SW

Source: Topography has been determined from the USGS 7.5' Digital Elevation Model and should be evaluated on a relative (not an absolute) basis. Relative elevation information between sites of close proximity should be field verified.
