**Groundwater Monitoring Report, First Semi-Annual 2014 Event**

**Sparkle Cleaners**

**Eastmont Town Center**

**GROUNDWATER MONITORING REPORT  
FIRST SEMI-ANNUAL 2014 EVENT  
SPARKLE CLEANERS  
EASTMONT TOWN CENTER  
7000 BANCROFT AVENUE  
OAKLAND, CALIFORNIA**

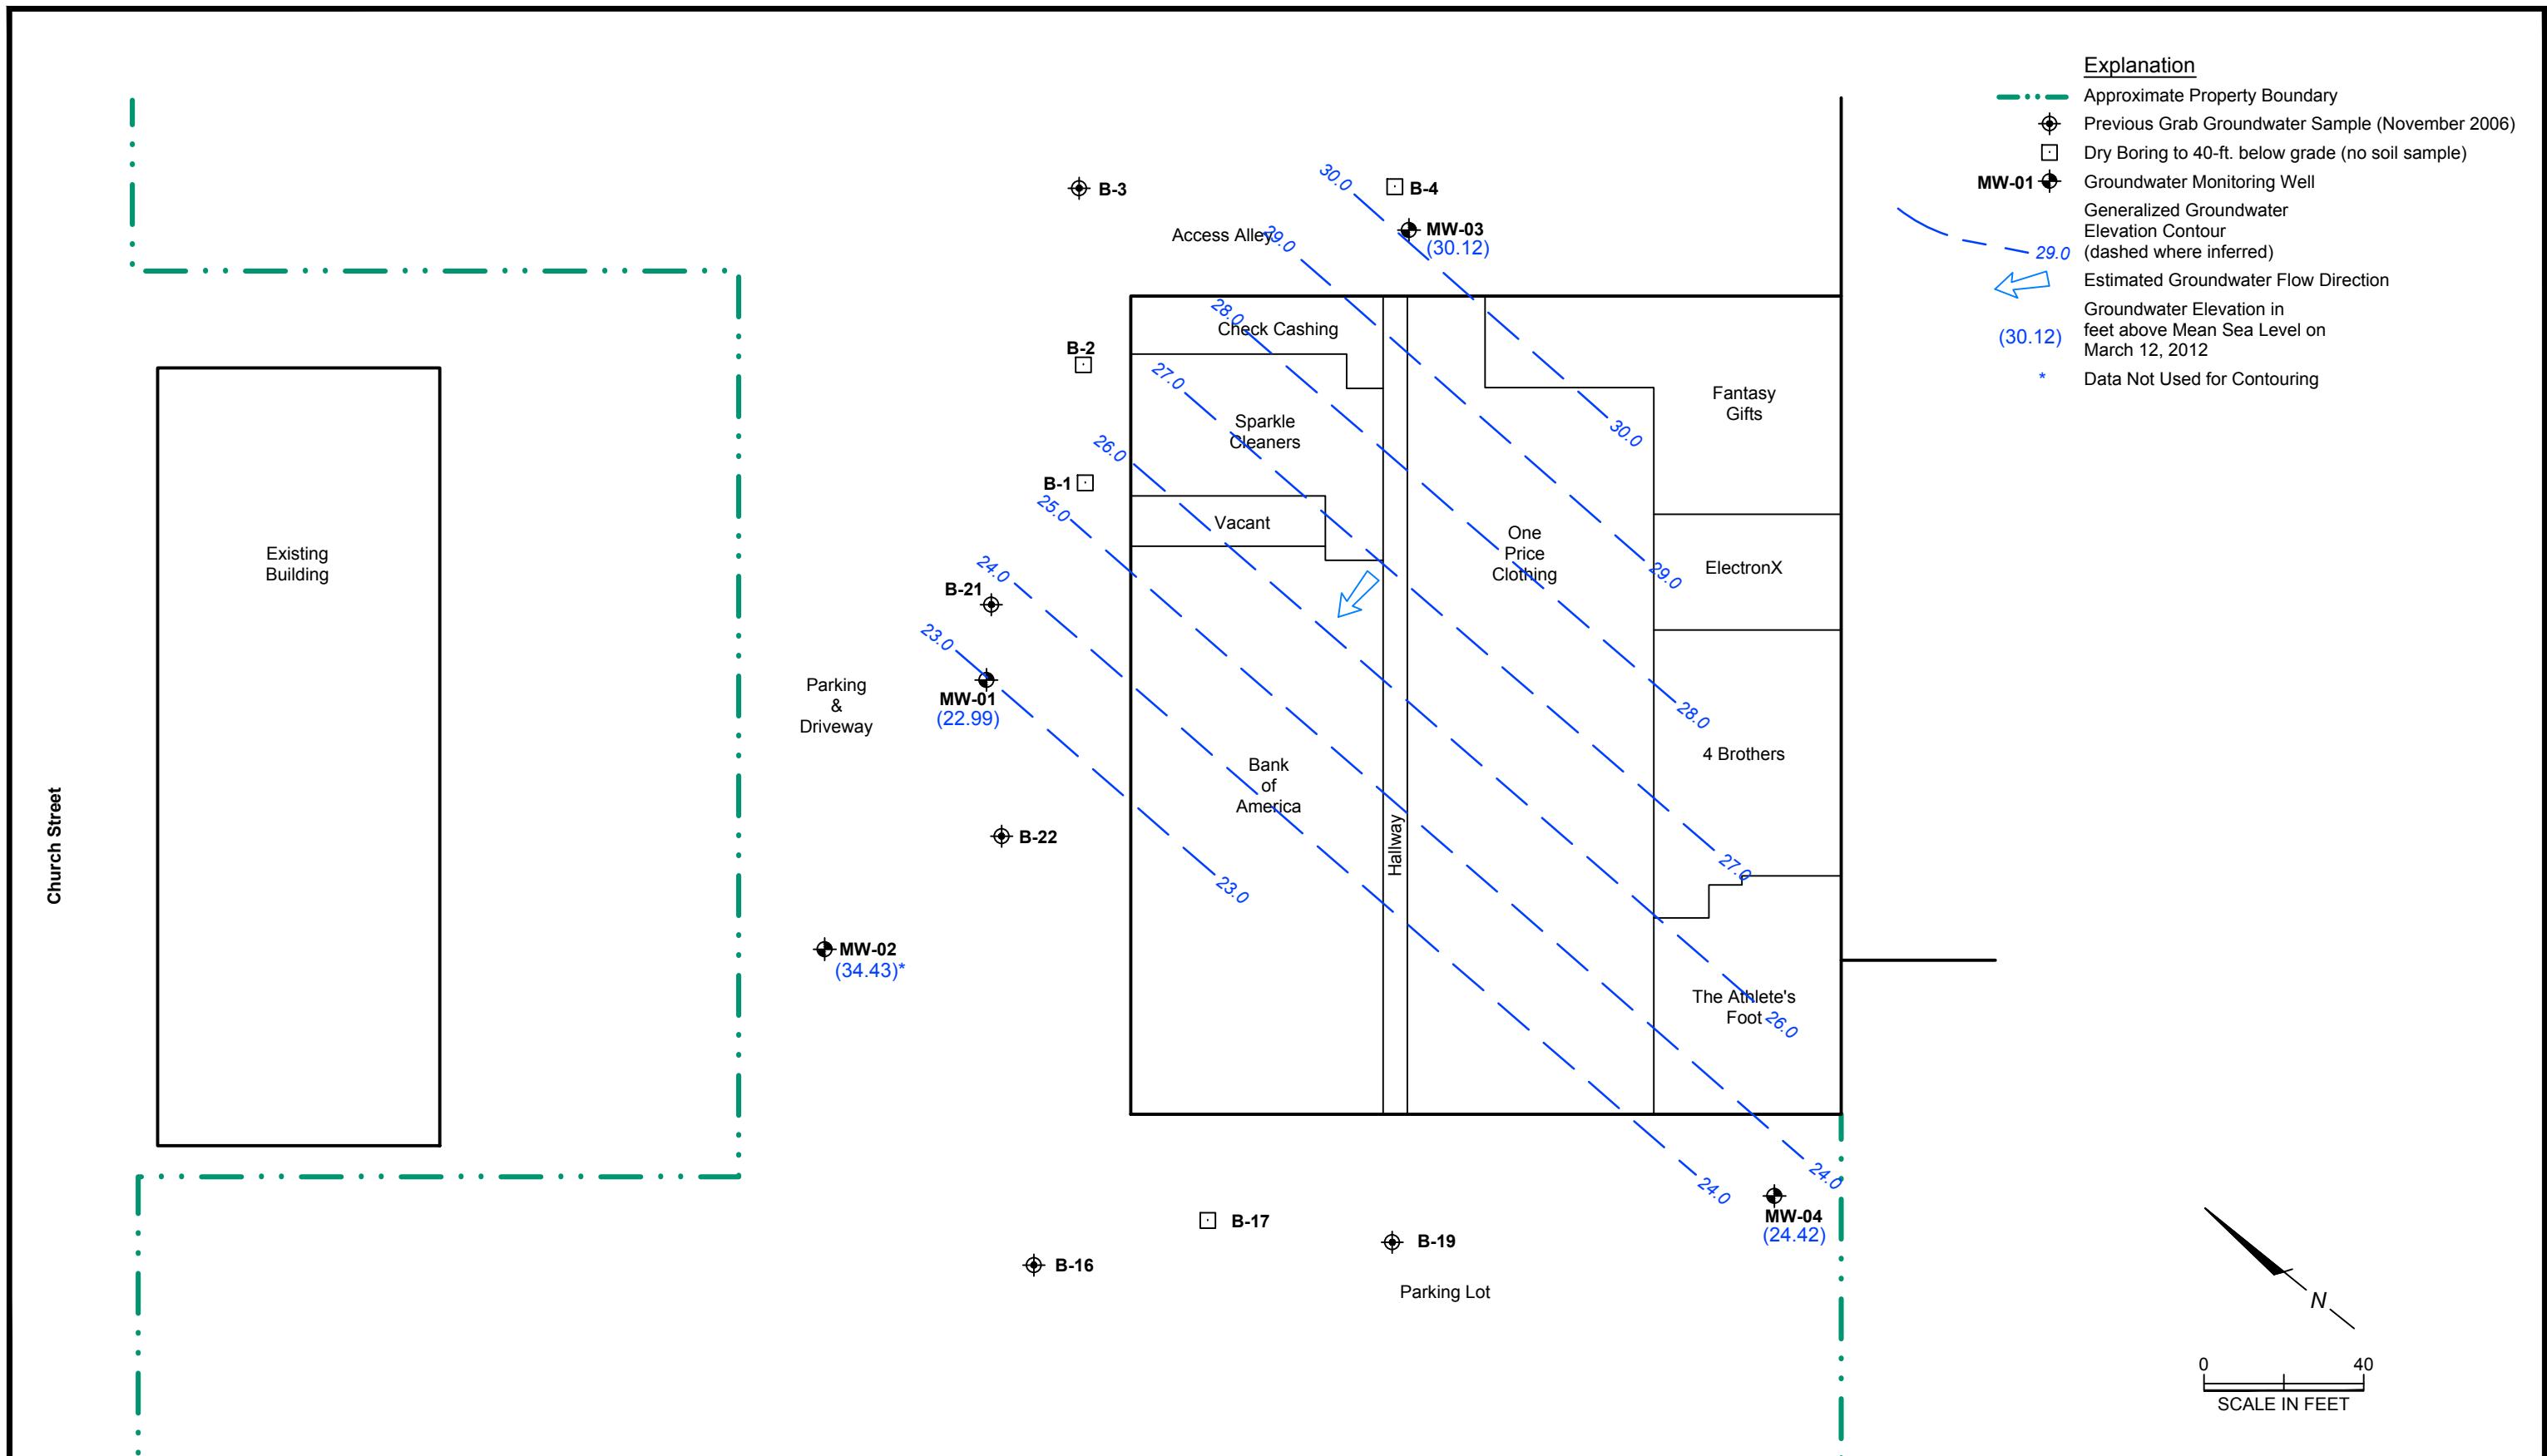
Groundwater elevations measured during the current monitoring event ranged from 22.99 feet MSL in well MW-01 to 34.43 feet MSL in well MW-02 (see Table 2 and Plate 2). As indicated on Plate 2, the elevation data from well MW-02 is not used for contouring because the groundwater elevation in this well is significantly higher than the elevations in the other wells. As described in the previous monitoring reports, the cause of the higher water-level elevation at well MW-02 appears to be from a screen interval that is at least 9 feet shallower (i.e., relative to the ground surface) than the other three wells. Well MW-02 was constructed in this manner because groundwater was observed at a shallower depth while drilling the borehole for this well.

Based on the groundwater elevation data from wells MW-01, MW-03, and MW-04, the hydraulic gradient during the current monitoring event was approximately 0.046 foot per foot to the west (see Plate 2). In addition, the analytical results discussed below suggest a westerly to northwesterly direction for groundwater flow.

Based on the groundwater elevation data from wells MW-01, MW-03, and MW-04, groundwater flow at the Site during this sampling event continues to be westerly (see Plate 2). The only VOC constituents detected above laboratory reporting limits in groundwater during this monitoring event were PCE, TCE, and cis-1,2-DCE. The maximum concentrations of PCE and TCE were detected in well MW-01 at 130 µg/L and 3.4 µg/L, respectively. PCE and TCE were also detected at 130 µg/L and 3.3 µg/L, respectively, in the duplicate sample from well MW-01. These concentrations are generally similar to those observed during previous monitoring events. Groundwater monitoring data collected since removal of the vadose zone source area in 2007 indicate that VOC concentrations are fairly stable in downgradient monitoring wells MW-01 and MW-02.
