**FIRST QUARTER 2011  
GROUNDWATER MONITORING  
REPORT AND SITE CLOSURE PETITION**

**R & H AUTO REPAIR  
5315 SAN PABLO AVENUE  
OAKLAND, CALIFORNIA**

Project No. 2010-06

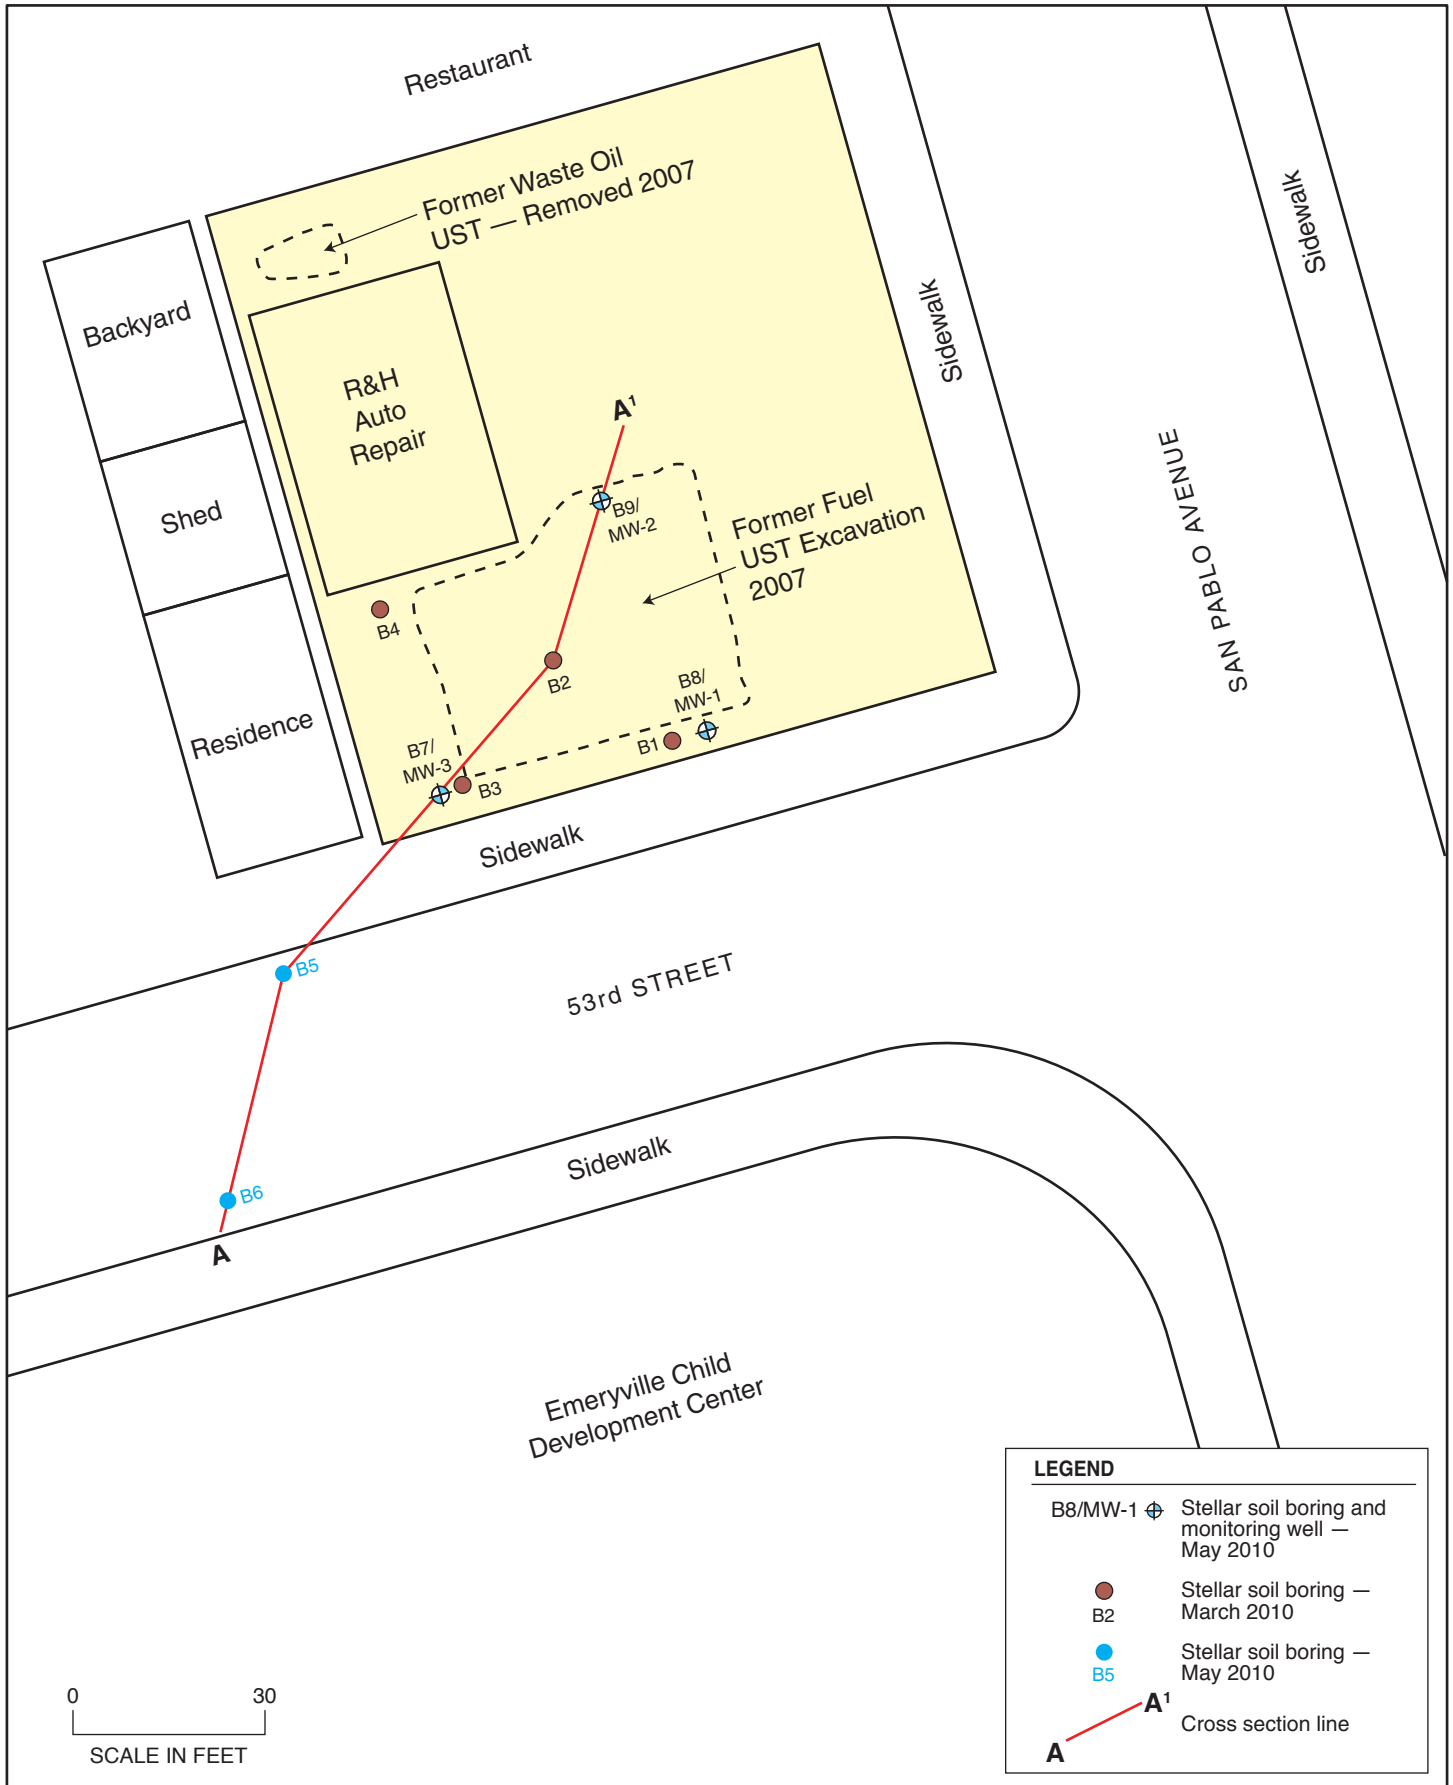
Figure 1 shows the site location. Figure 2 shows the site plan and locations of current groundwater monitoring wells, previous investigative borings and former underground fuel storage tanks (UFSTs).

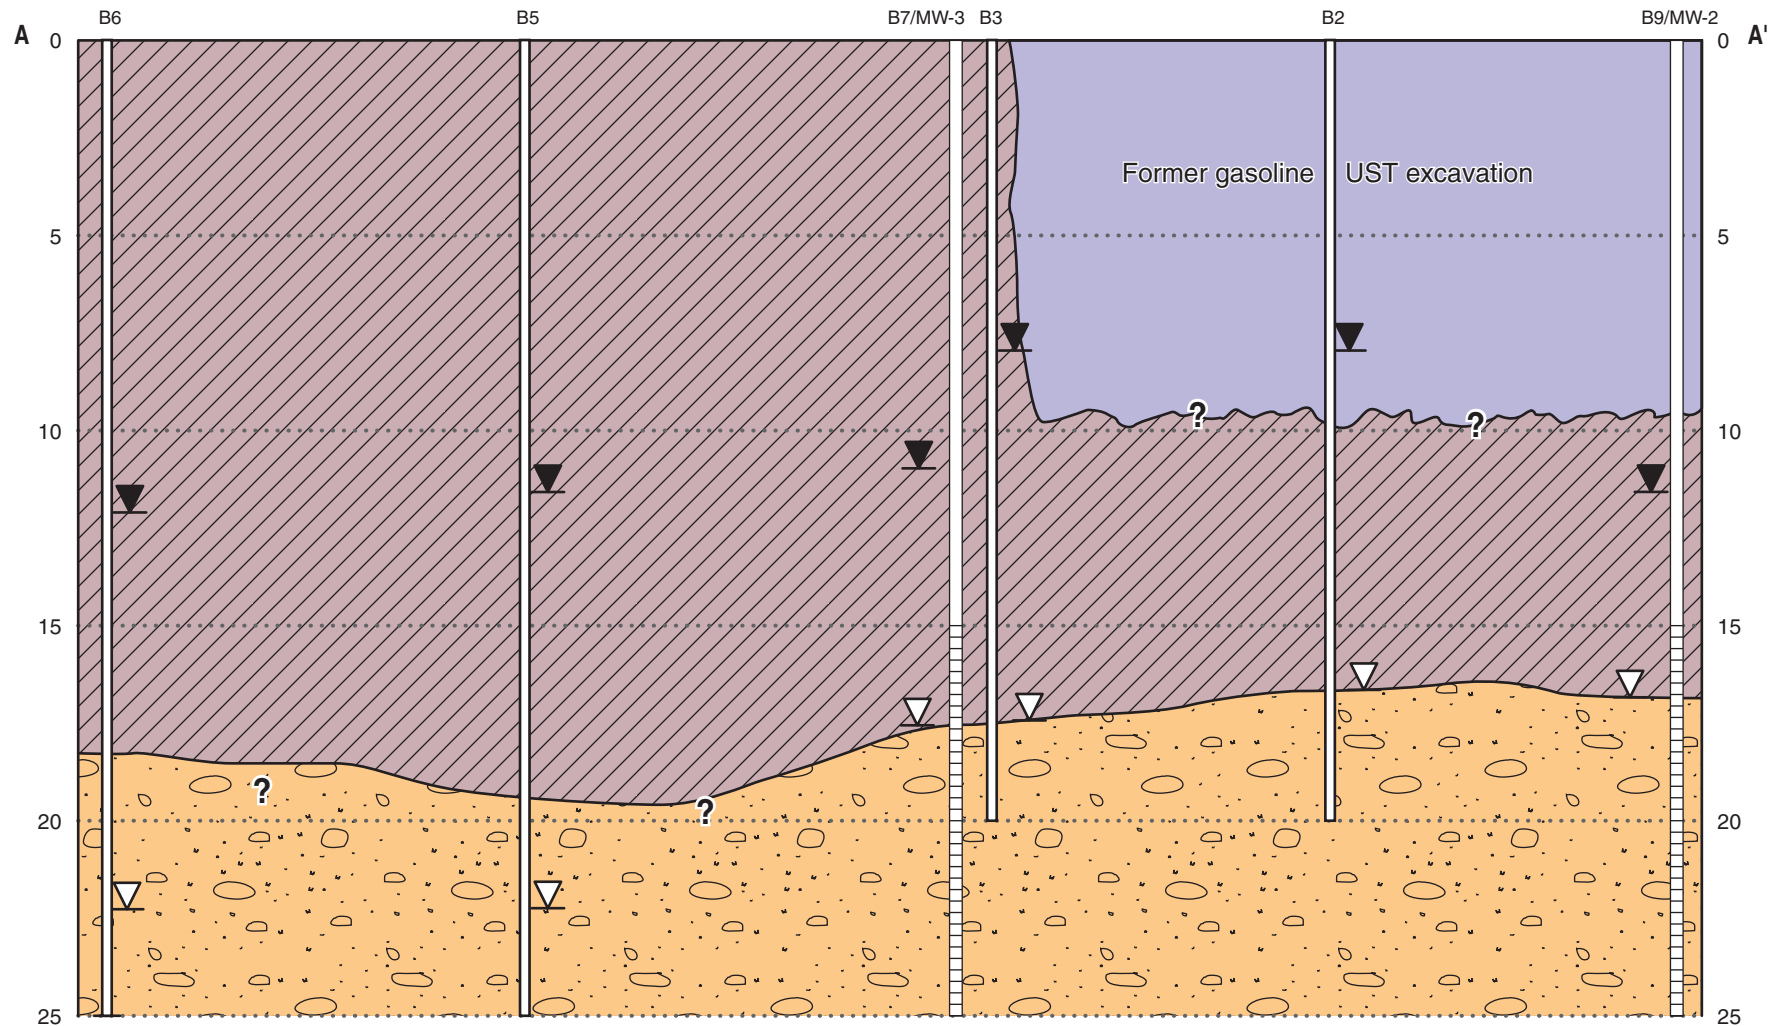
Site-specific lithology has been characterized to a depth of 20 feet bgs in onsite borings B1, B2, and B3; to a depth of 22 feet bgs in boring B4; and to 25 feet bgs in onsite and offsite borings B5 through B9. Subsurface lithology can be described as silty clay to gravelly clay fill with fragments of brick to approximately 2.5 feet bgs. The upper fill is underlain by native, low permeability, stiff, expansive, silty clay to about 17 feet bgs. Between 17 feet and 25 feet bgs, interbedded layers of moist to saturated sandy silt, silty sand, and clayey gravel are present. Geologic cross-section A-A' depicting the shallow site lithology is shown on Figure 3.

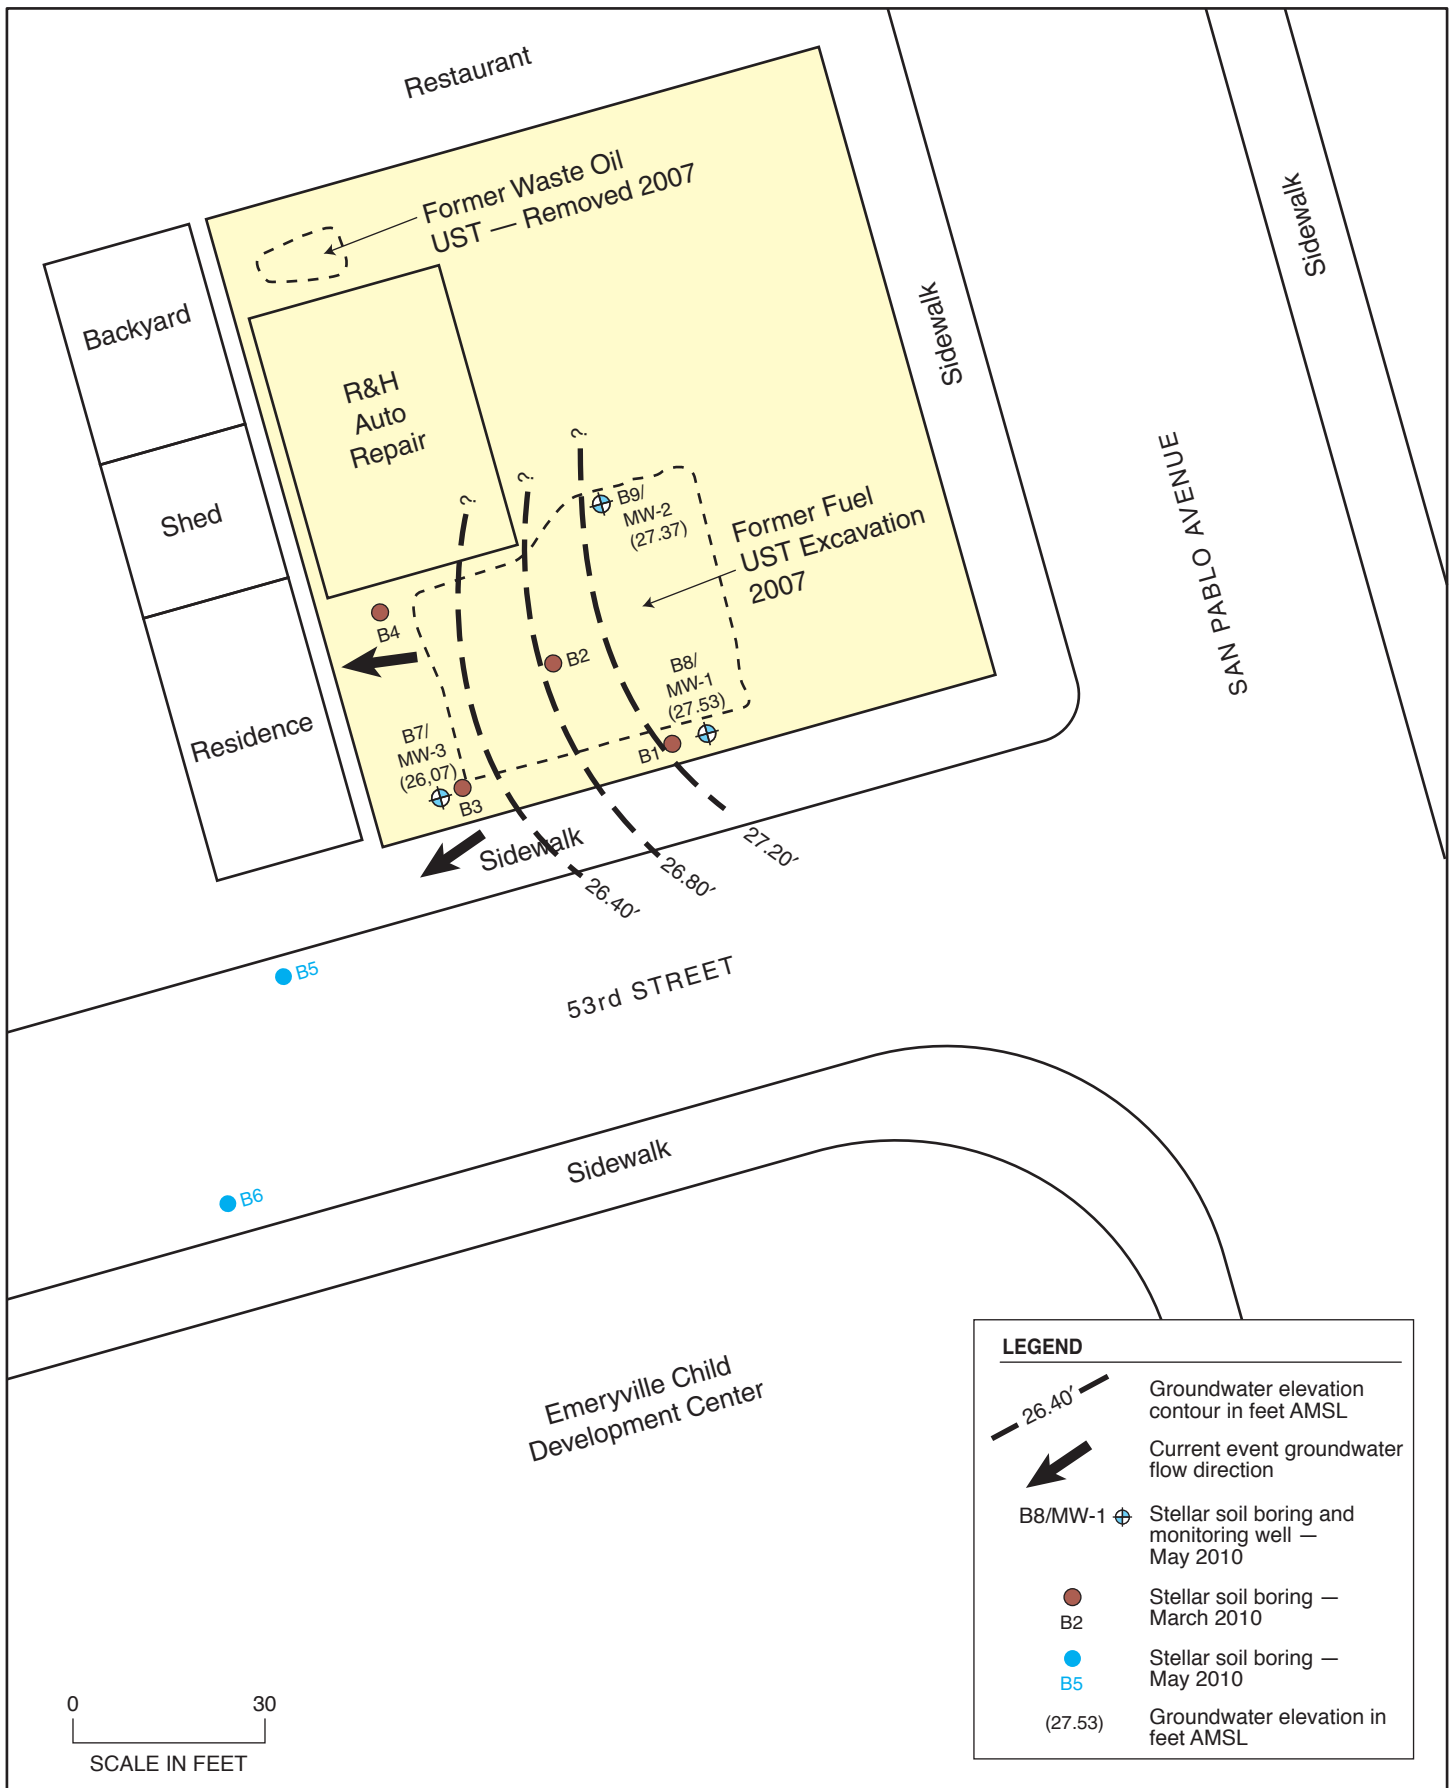
Regional groundwater flow in the area of the property is approximately to the southwest, toward San Francisco Bay. The initial groundwater monitoring event conducted by Stellar Environmental on May 13, 2010, which used wells MW-1 through MW-3 as data points, demonstrated a southwesterly groundwater flow direction with a relatively flat hydraulic gradient of approximately 0.01 feet/foot. The groundwater flow direction and gradient for the current monitoring event is generally consistent with the initial event, although for the current event the gradient was approximately 0.03 feet/foot, steeper than previous events.

Figure 4 is a groundwater potentiometric surface map for the current groundwater monitoring event that occurred on February 11, 2011 (activities discussed in Section 3.0).
